28th March 2017

Waverley Council
Level 6
55 Grafton Street
BONDI JUNCTION NSW 2022

**BRONTE SURF LIFE SAVING CLUB
STRUCTURAL CONDITION REPORT**

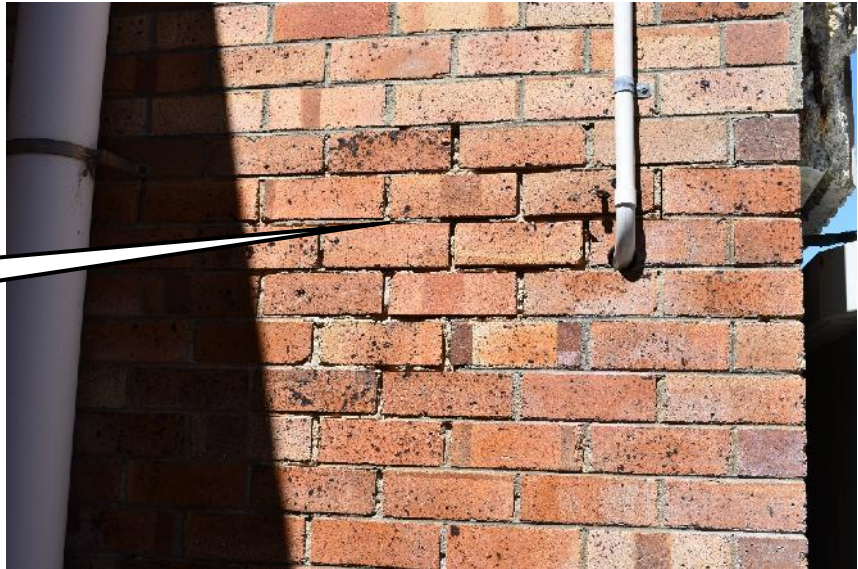
Brickwork mortar loss
bed joints & perpends

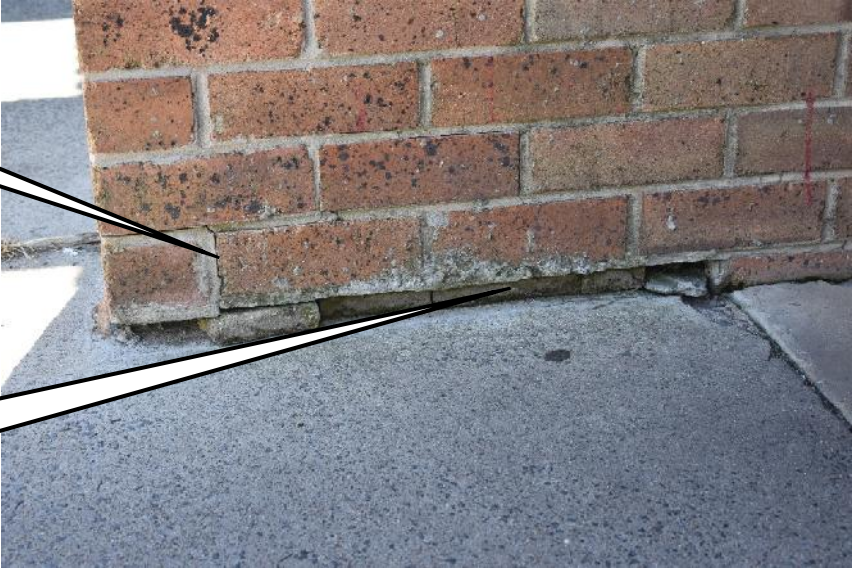
<p>A7</p> <p>0.3mm cracking</p> <p>Loose bedding bricks, offset 50mm from face</p>

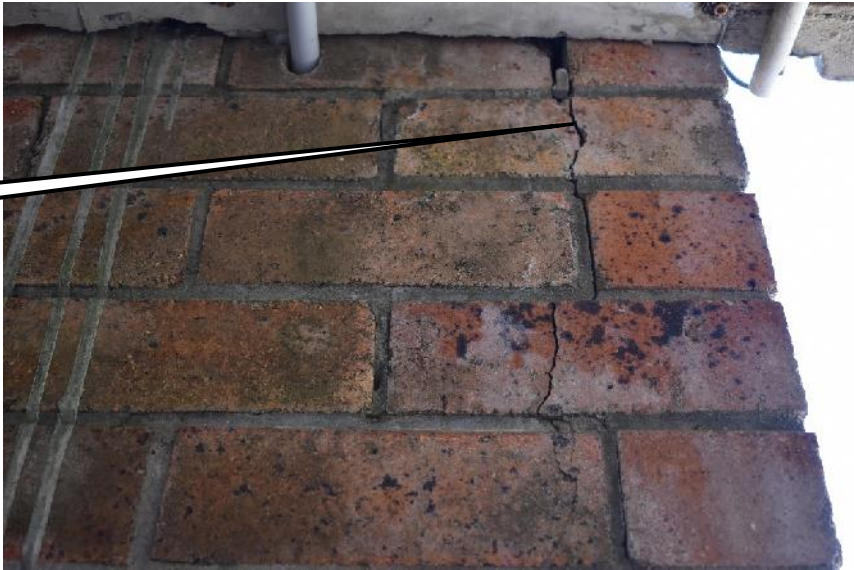
<p>A10</p> <p>2.5mm vertical crack</p>

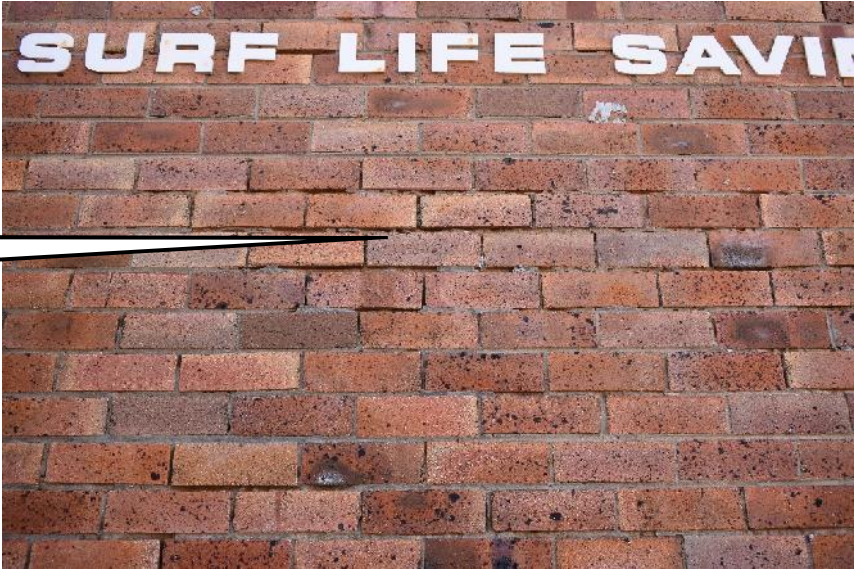
<p>A12</p> <p>Brickwork mortar loss bed joints & perpend</p>

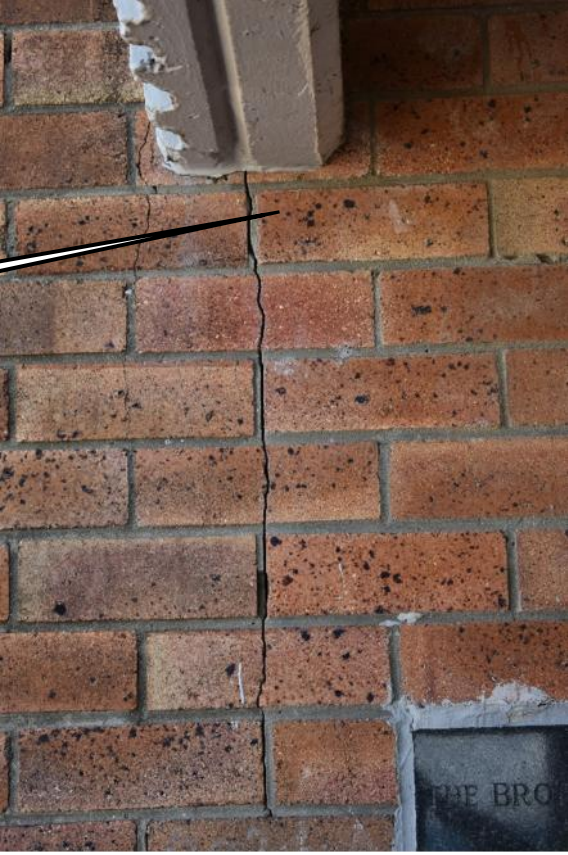
<p>A14</p> <p>3mm vertical crack</p>

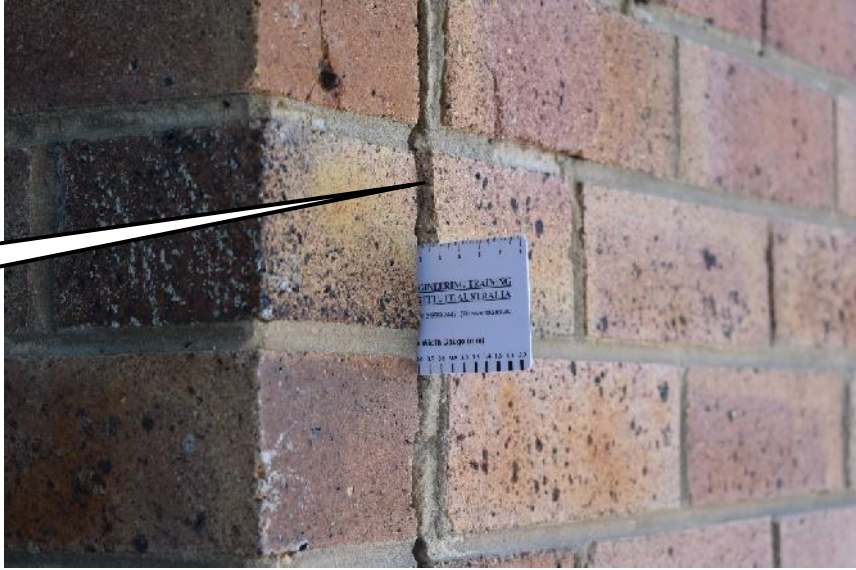
Some of the brickwork has vertically cracked at the wall corners. This is due to the phenomena of brick growth, which takes place as clay bricks absorb moisture over time and expand. However, given the 15-year period since reconstruction, most of the brick growth will be complete and the bricks should be relatively stable. These vertical cracks have formed weakened planes in the wall panels and allowed the bricks to displace (laterally shear) due to concrete slab shrinkage and thermal effects (see Photo A16).

<p>A16</p> <p>Vertical crack with 10mm displacement</p>

The brickwork cracked corners should be locally demolished and rebuilt. In doing so, the cavities should be inspected to ensure that the cavity ties are still effective. If the cavity ties were not R4 durability (to AS2699.1) then they are highly likely to be corroded or non-existent. In this case new stainless steel mechanically fixed ties would need to be installed (Helifix or similar).

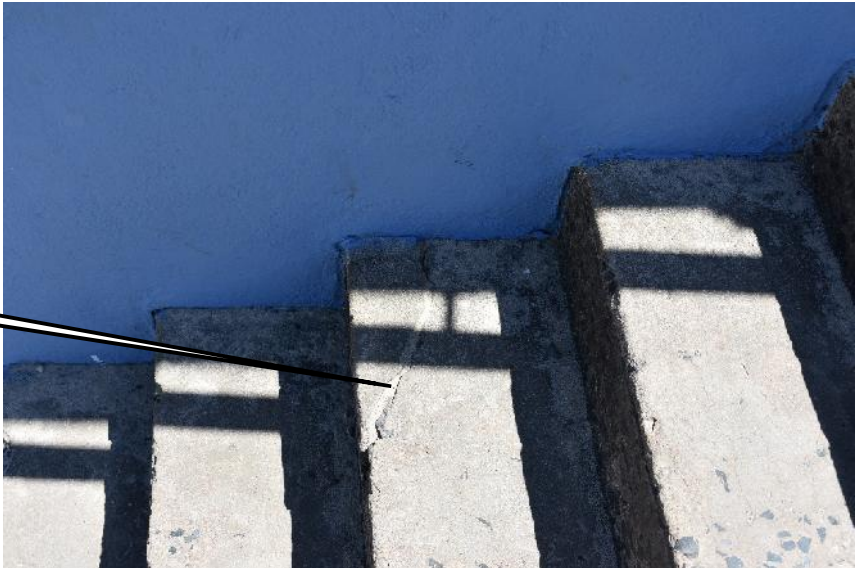
<p>A18</p> <p>Cracked stair tread</p>

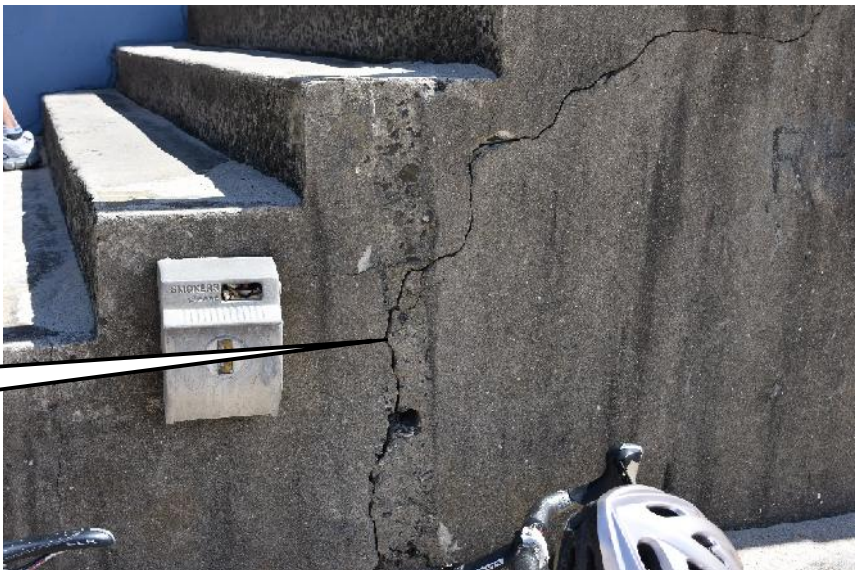
<p>A19</p> <p>Cracked wall and stair slab soffit</p>

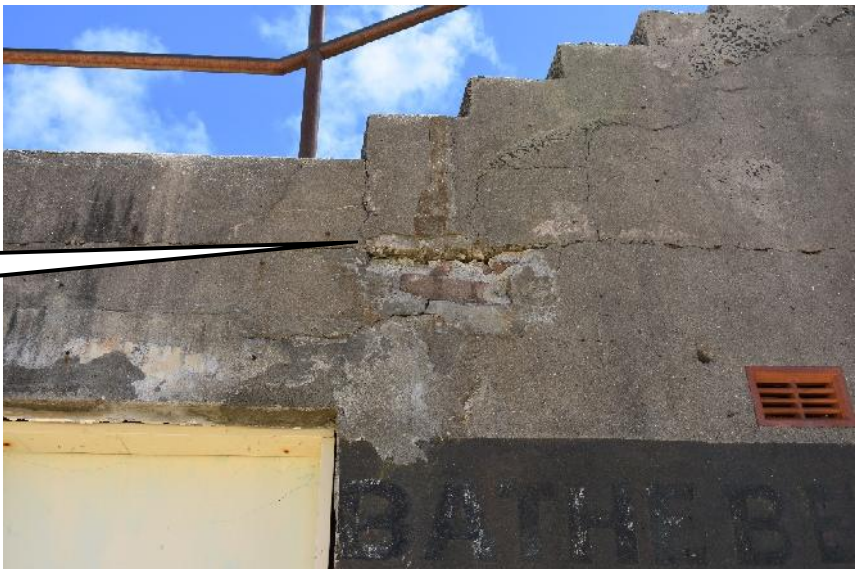
<p>A20</p> <p>Cracked wall and stair slab soffit</p>

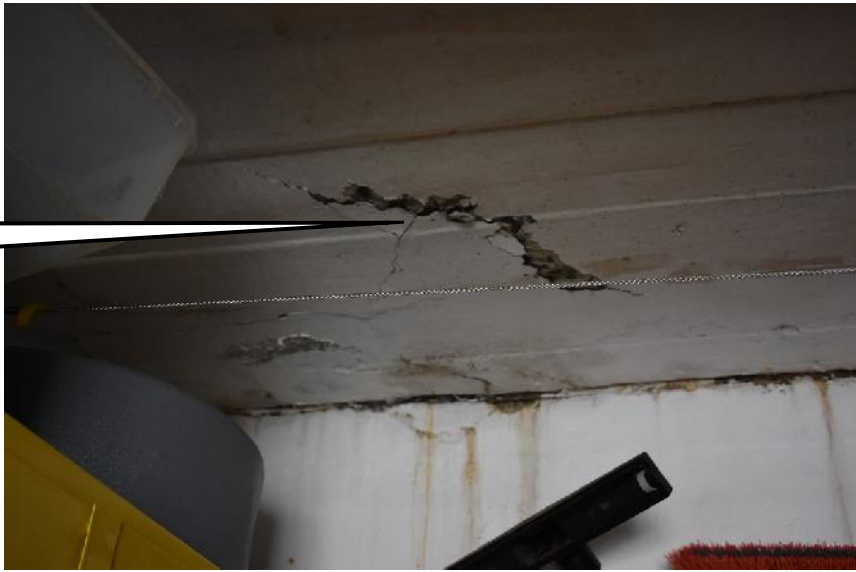
<p>A24</p> <p>Severe cracking and spalling</p>

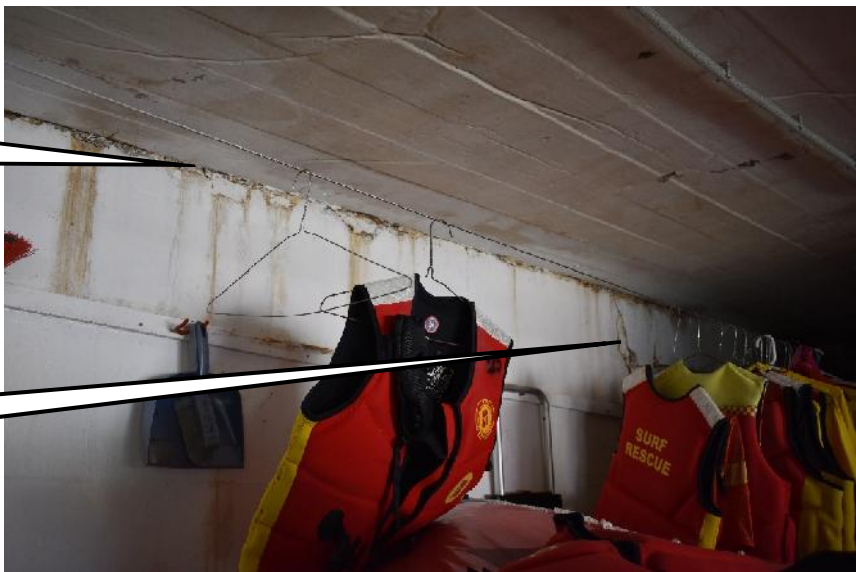
<p>A25</p> <p>Cracking between wall and slab</p> <p>Cracking down the wall</p>

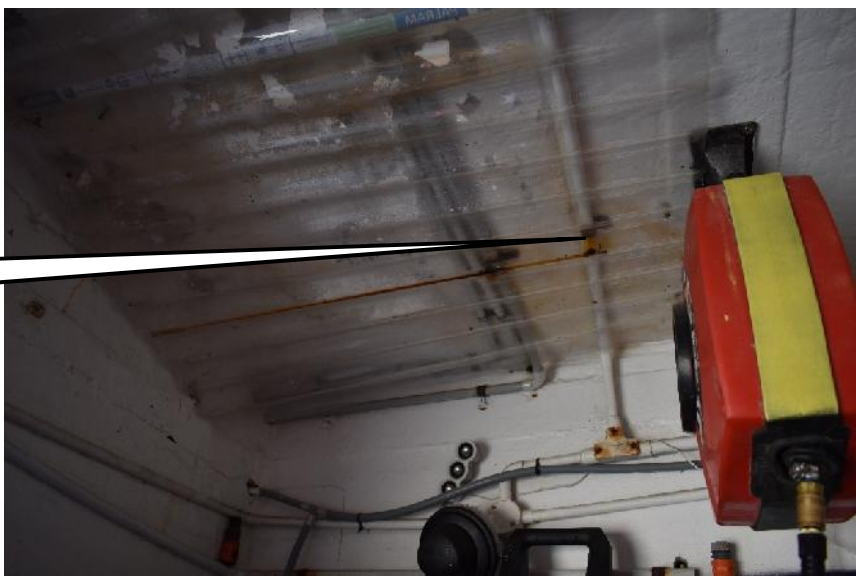
<p>A26</p> <p>Leaking conduit fixing and under roofing</p>

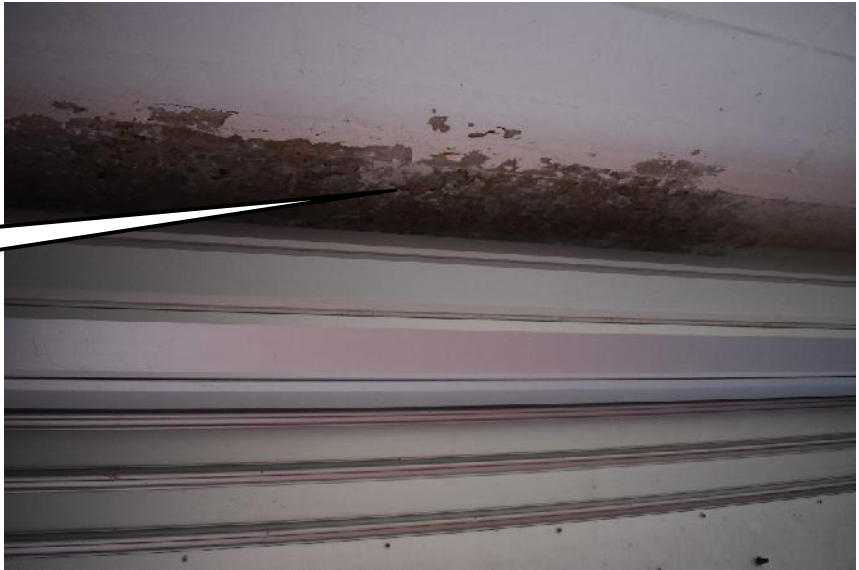
<p>A27</p> <p>Spalling over roller shutter</p>

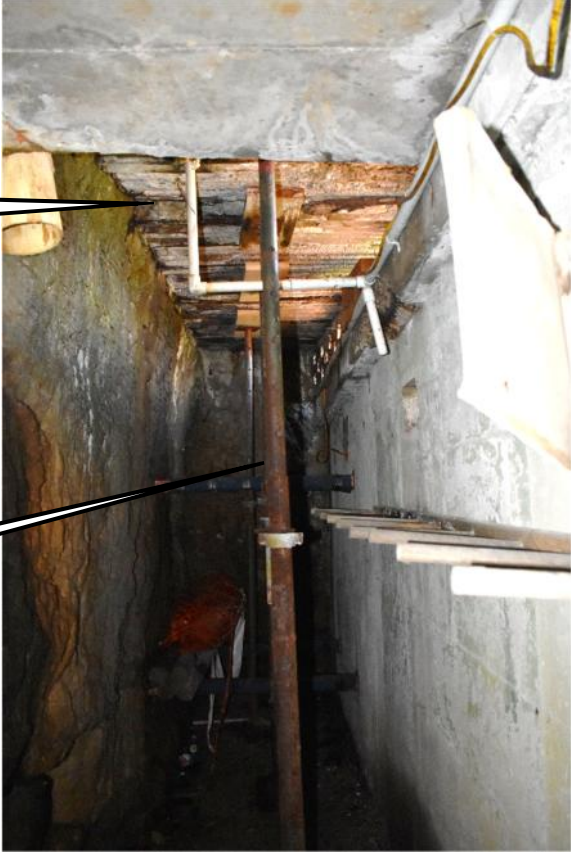
<p>A28</p> <p>Severely corroded reinforcement and concrete spalling</p> <p>Acrow prop supports</p>

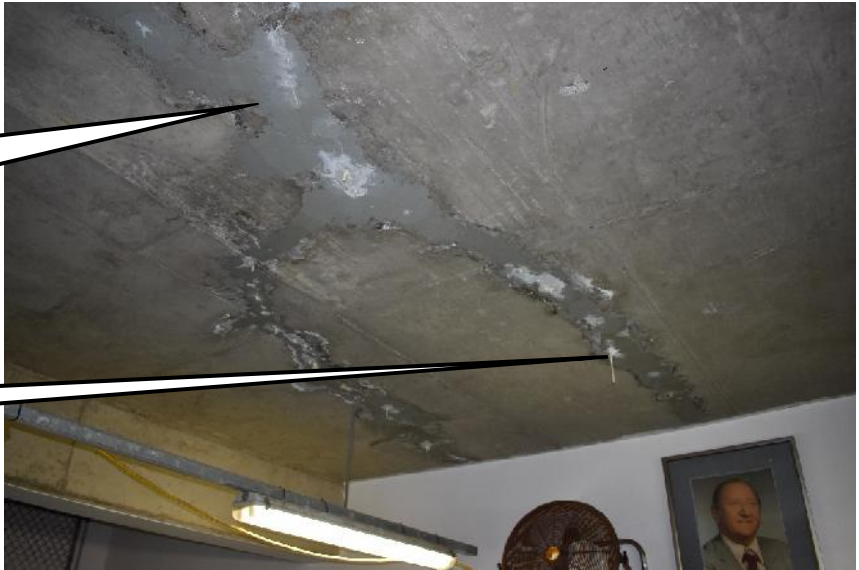
<p>A29</p> <p>Cracking with attempted patch repair</p> <p>Leaking calcification</p>

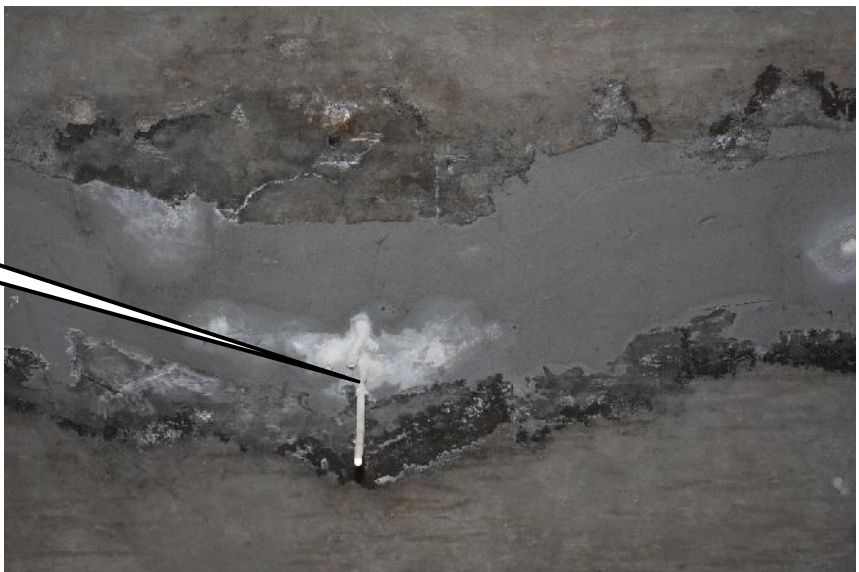
<p>A30</p> <p>Leaking calcification, not rust stained</p>

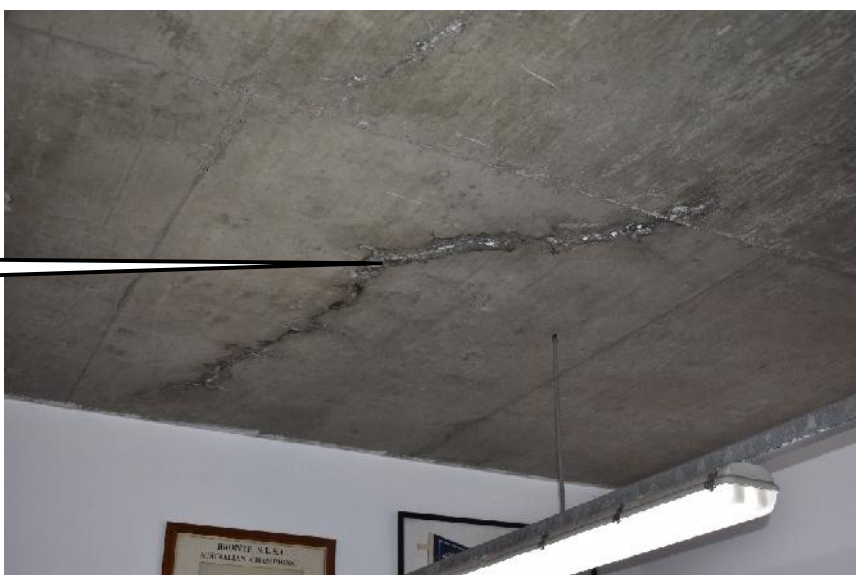
<p>A31</p> <p>Leaking cracked slab</p>

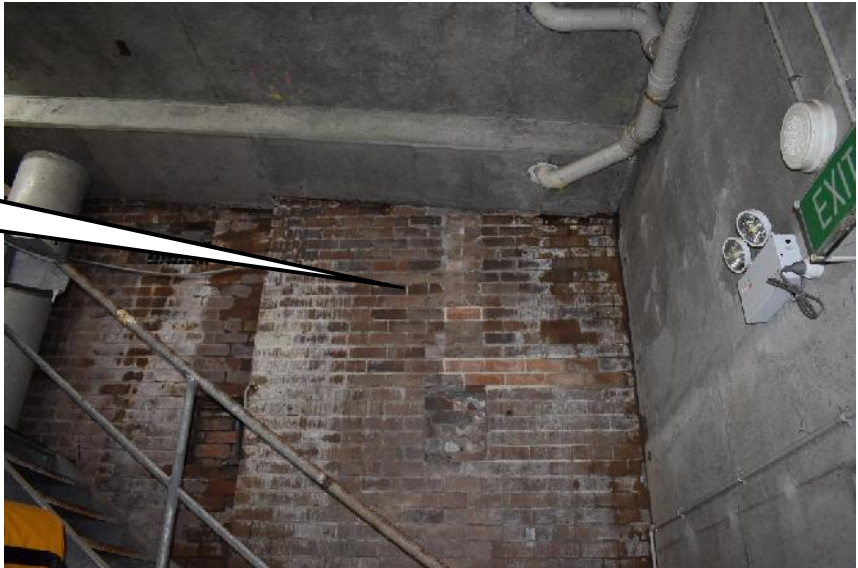
<p>A32</p> <p>Long-term leaking between brick wall and roof slab</p>

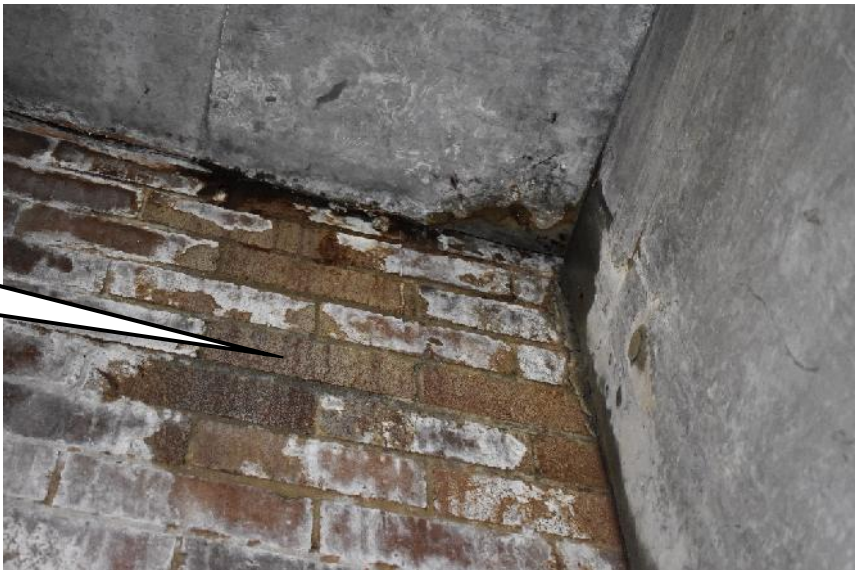
<p>A33</p> <p>Long-term leaking between brick wall and roof slab</p>

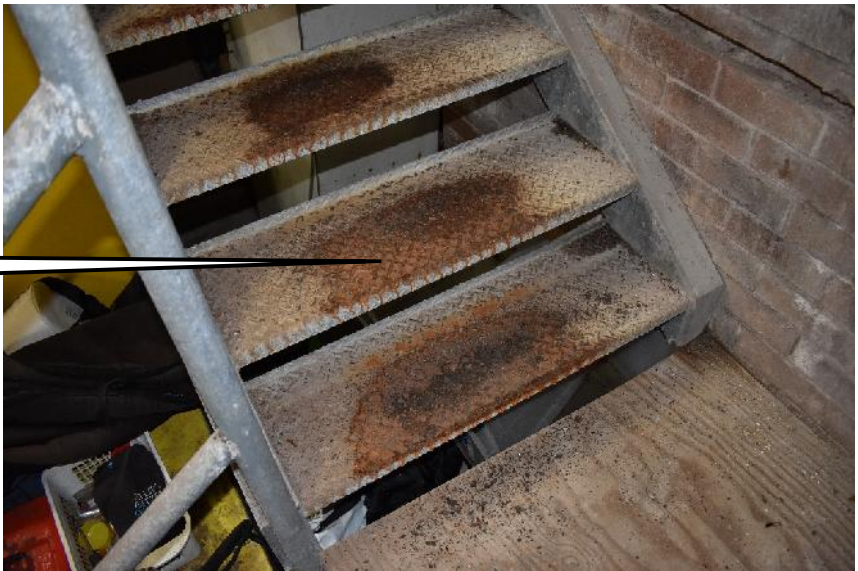
<p>A34</p> <p>Corroded stair treads</p>

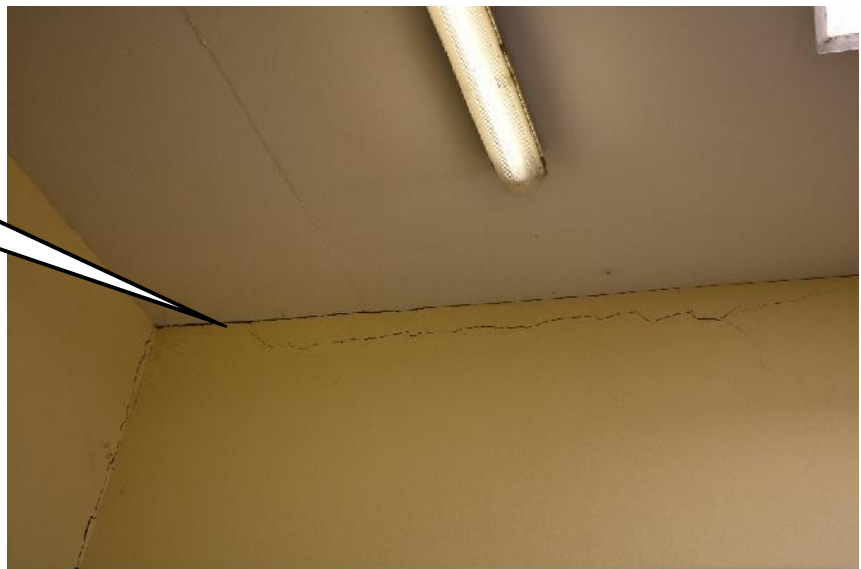
Cracked wall corner,
5mm outward
displacement

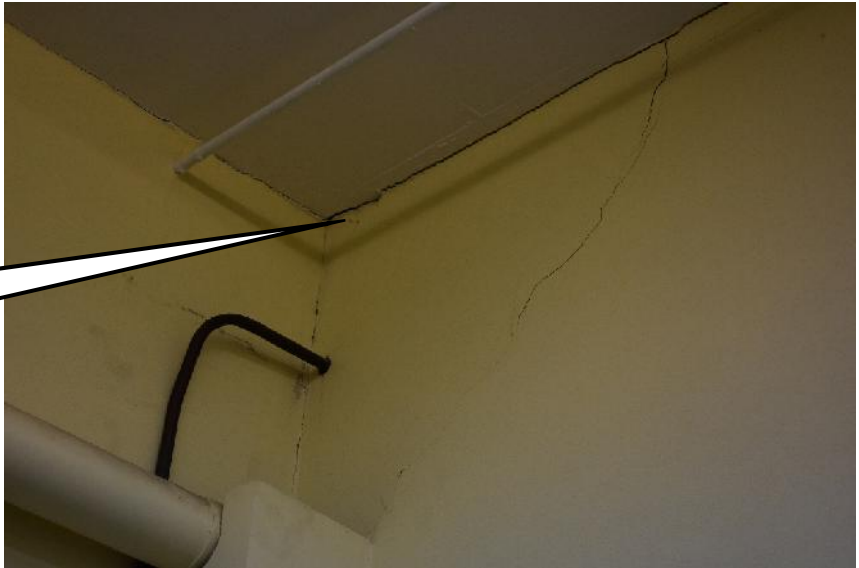
<p>A39</p> <p>Cracked wall corner, 5mm outward displacement</p>

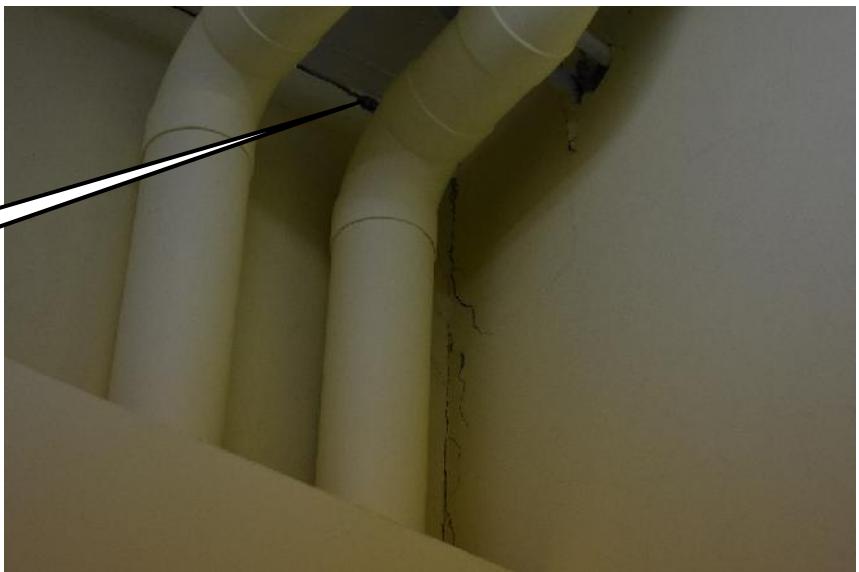
<p>A40</p> <p>Cracked wall corner</p>

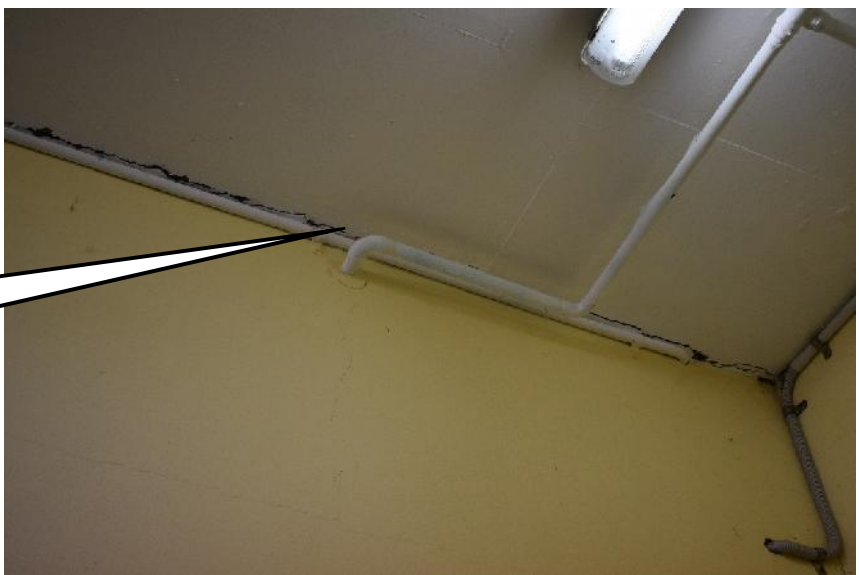
<p>A41</p> <p>Cracked wall corner, 3mm outward displacement</p>

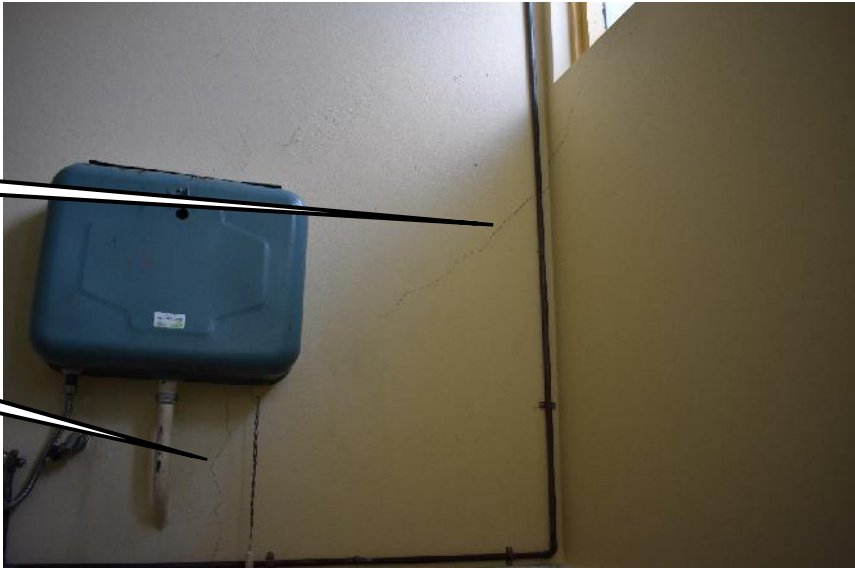
<p>A42</p> <p>0.3mm crack</p> <p>0.3mm crack</p>

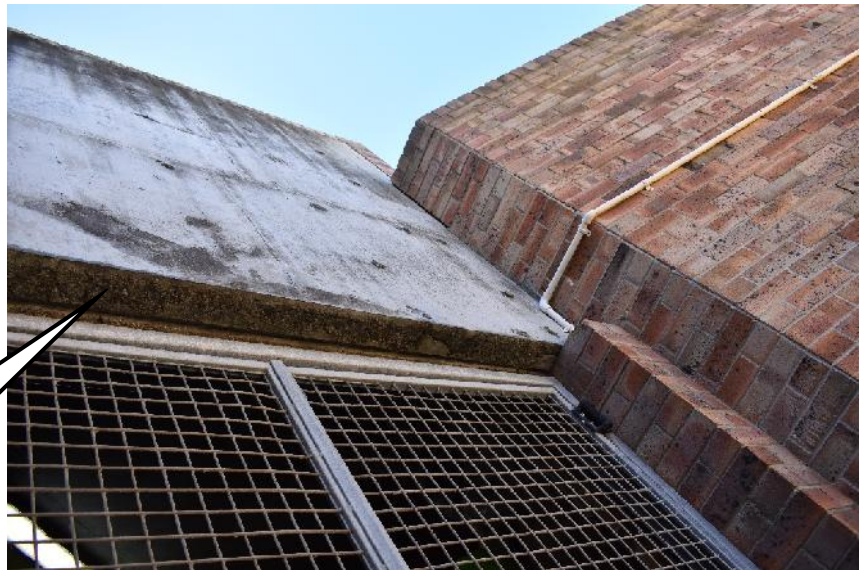
B1

Debris cast into
concrete during pour

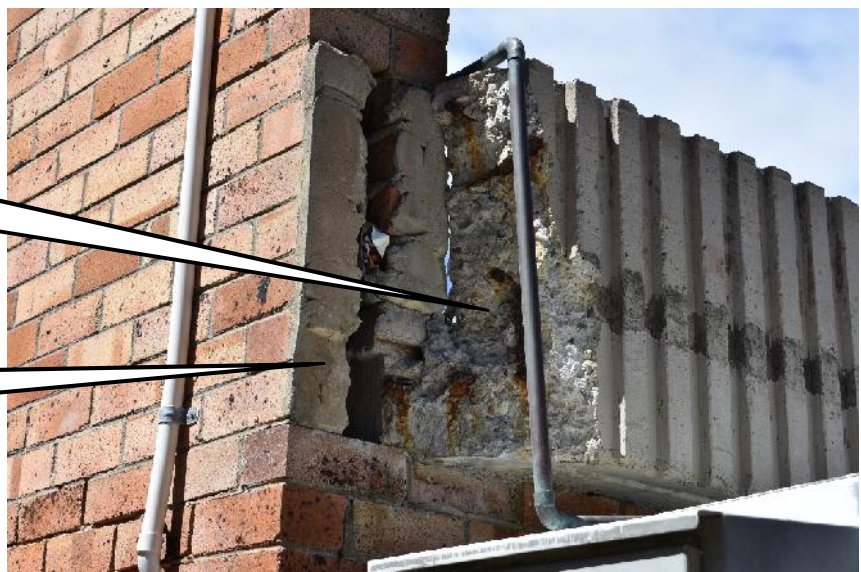
B2

Heavily spalled
concrete and corroded
reinforcement

Missing concrete
parapet

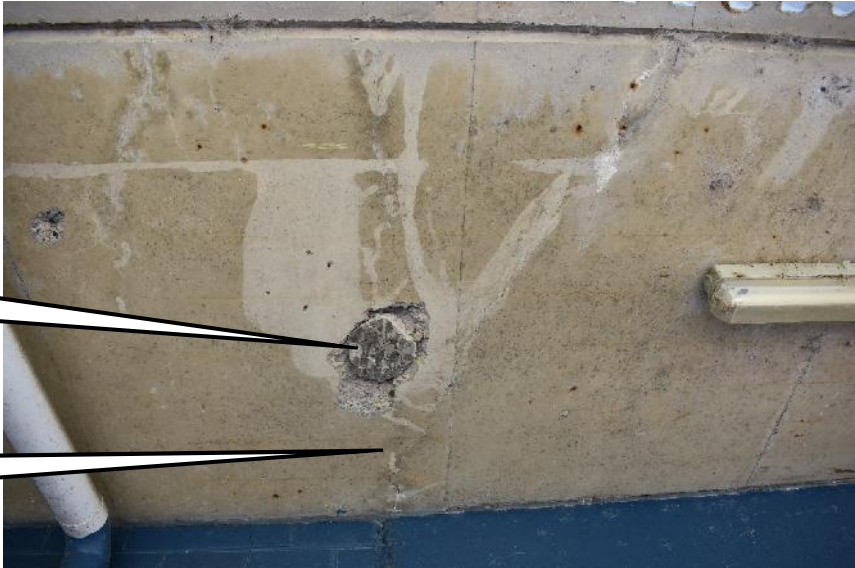
<p>B3</p> <p>Poorly installed core plug</p> <p>Cracked slab with signs of leakage</p>

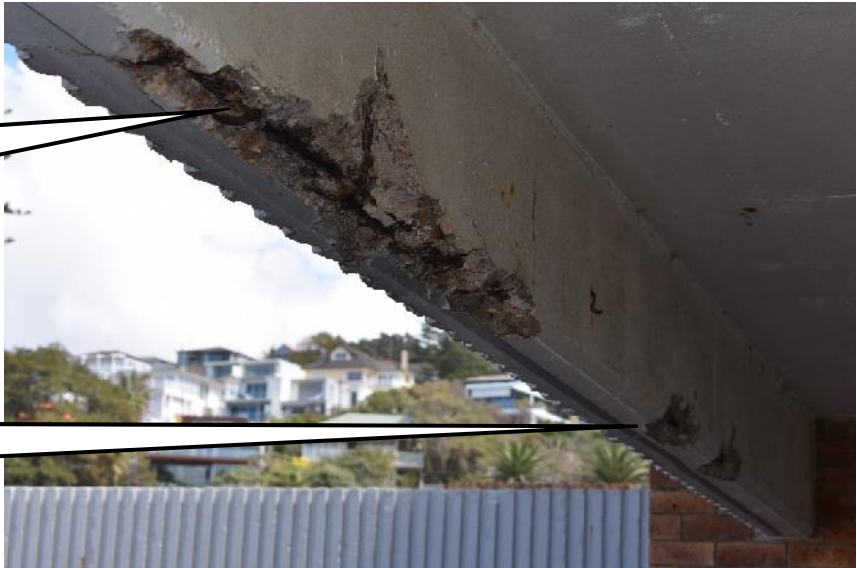
The membrane has not been sufficient to prevent spalling and corrosion (see Photos B12, B14 & C6).

<p>B12</p> <p>Spalling concrete and corroded reinforcement</p> <p>Spalling concrete and corroded reinforcement</p>

The spalled areas can be treated by cutting back, splicing new reinforcement and patch repairing the spalls with high build cementitious render.

The high-risk parapets and awnings should have the membrane removed by grit blasting or high pressure water. Unsound areas patch repaired as above, and the concrete surface applied with a migratory corrosion inhibitor.

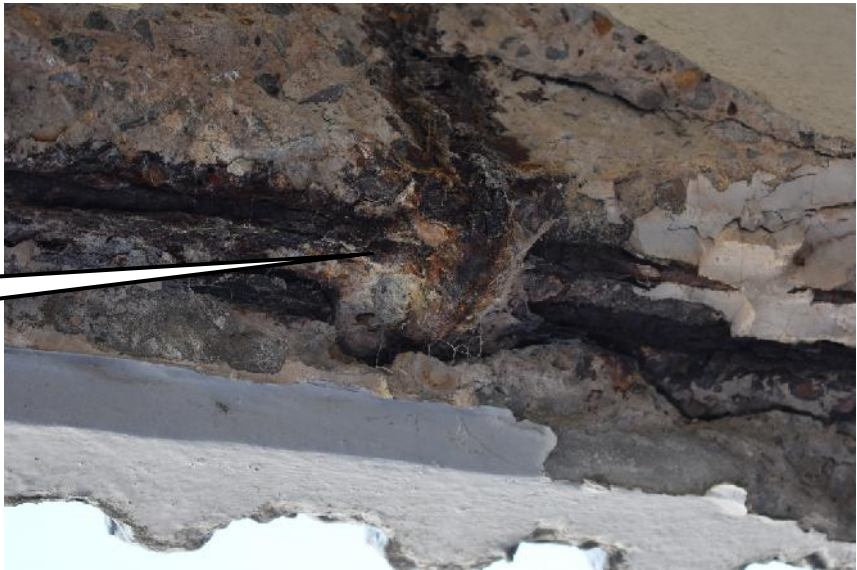
<p>B13</p> <p>Heavily corroded reinforcement</p>

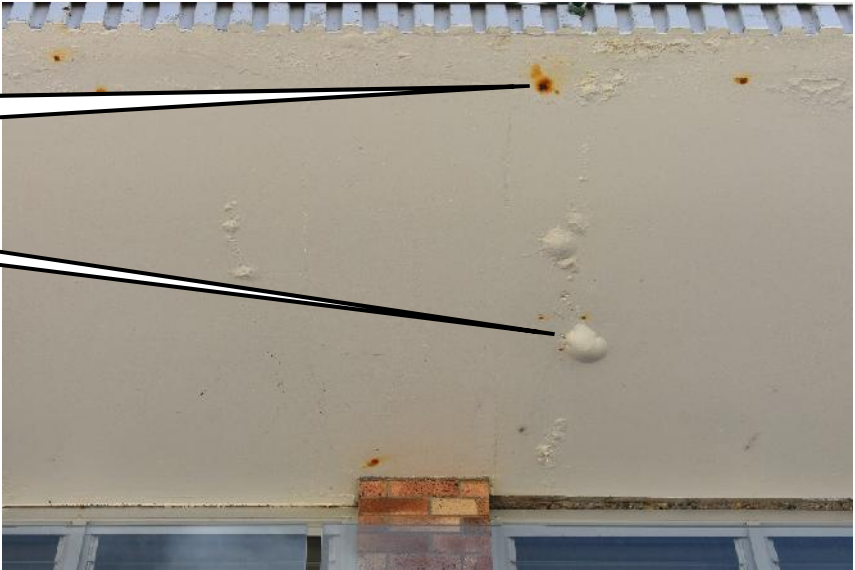
The roof membranes are leaking in many locations allowing salt water to soak into the slabs, entering through various cracks and causing reinforcement corrosion. Some slab soffit membranes have bubbled and have rust marks in numerous locations (see Photos C2 to C5).

<p>C4</p> <p>Corroding reinforcement</p> <p>Water leakage</p>

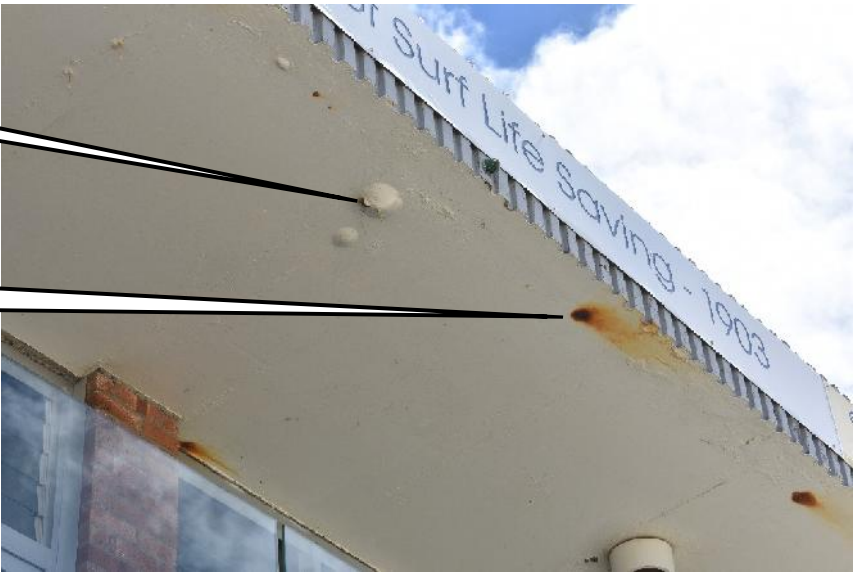
<p>C5</p> <p>Water leakage</p> <p>Corroding reinforcement</p>

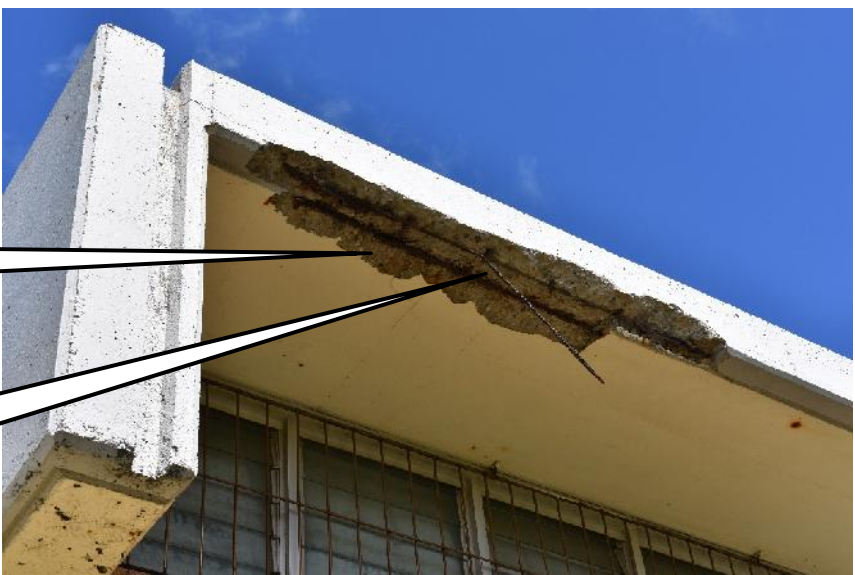
<p>C6</p> <p>Severe concrete spalling</p> <p>Corroding reinforcement and bar loss</p>

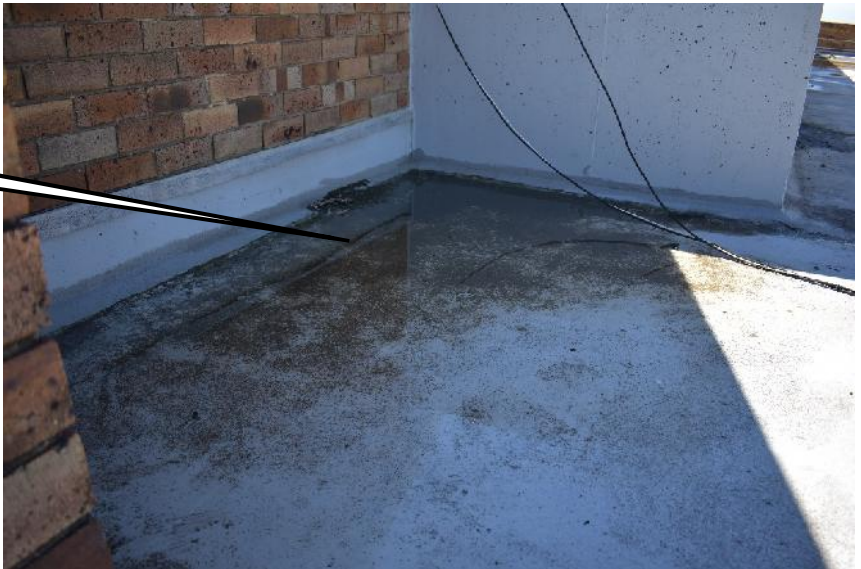
<p>C14</p> <p>Ponding water</p>

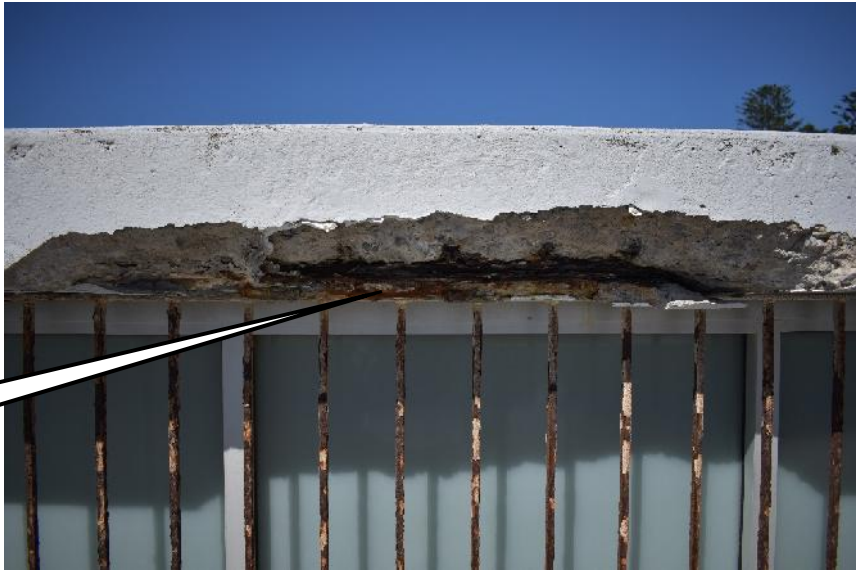
<p>C15</p> <p>Large concrete spall with complete bar loss</p>

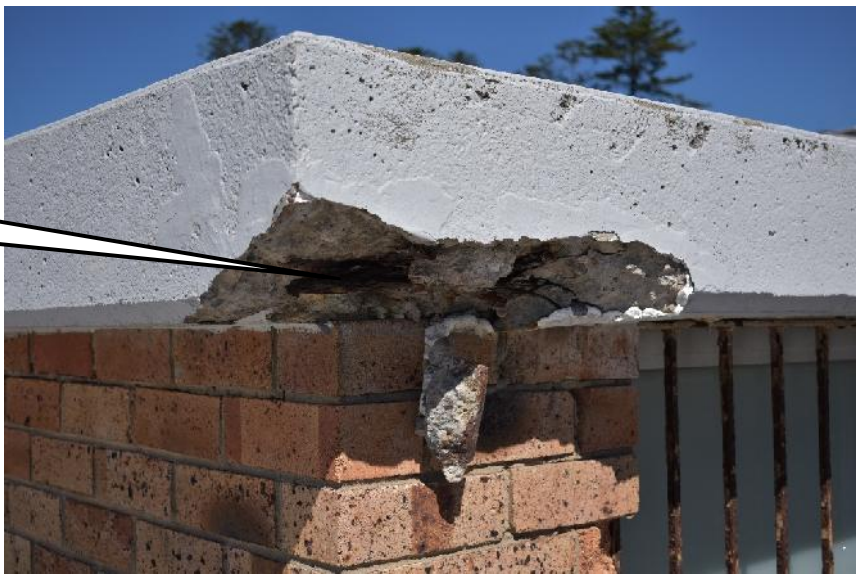
<p>C16</p> <p>Concrete spall with complete bar loss</p>

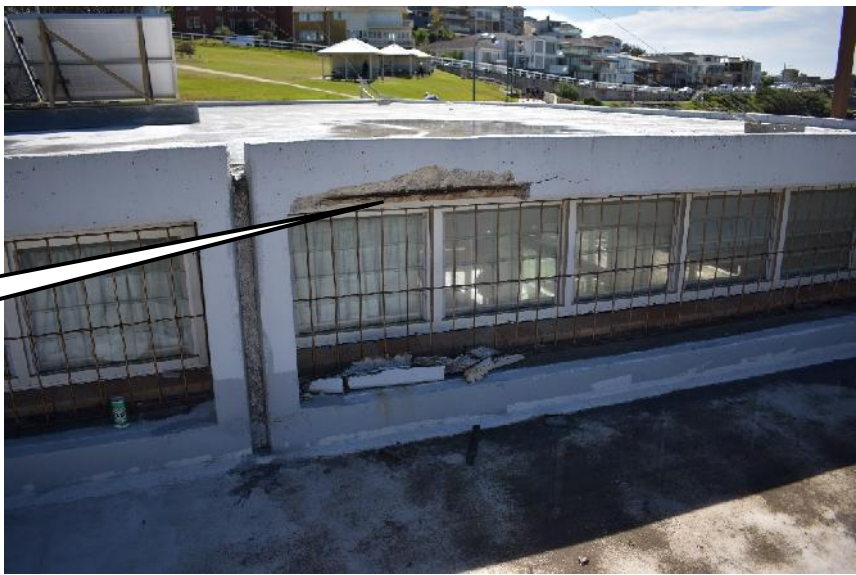
<p>C17</p> <p>Large concrete spall with complete bar loss</p>

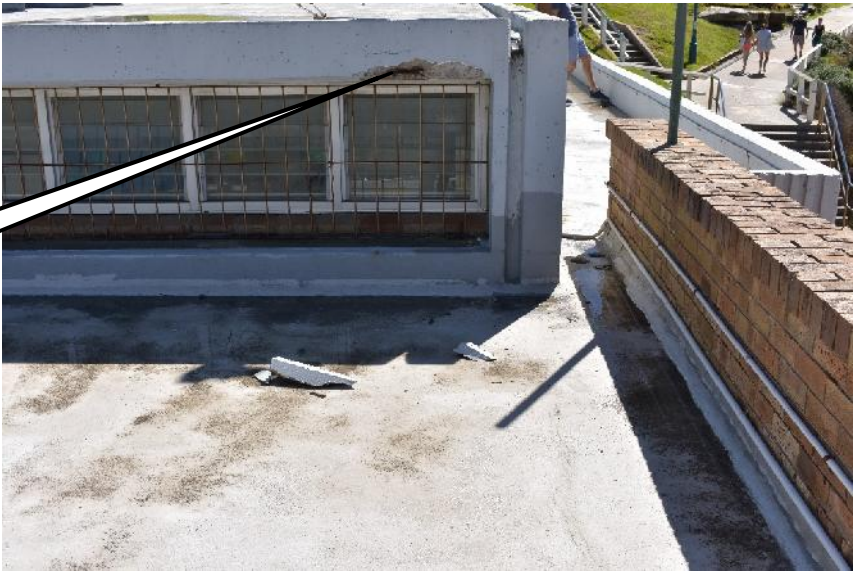
<p>C18</p> <p>Large concrete spall with complete bar loss</p>

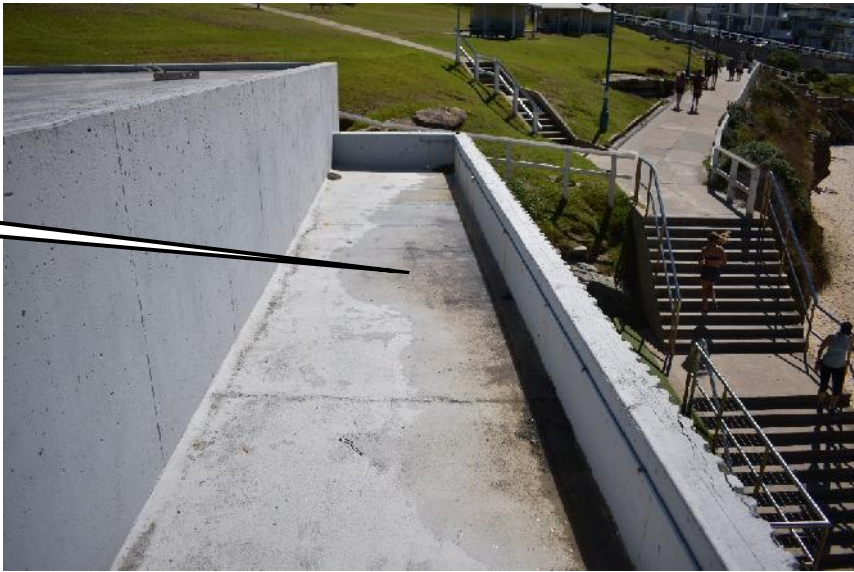
<p>C19</p> <p>Water ponding</p>

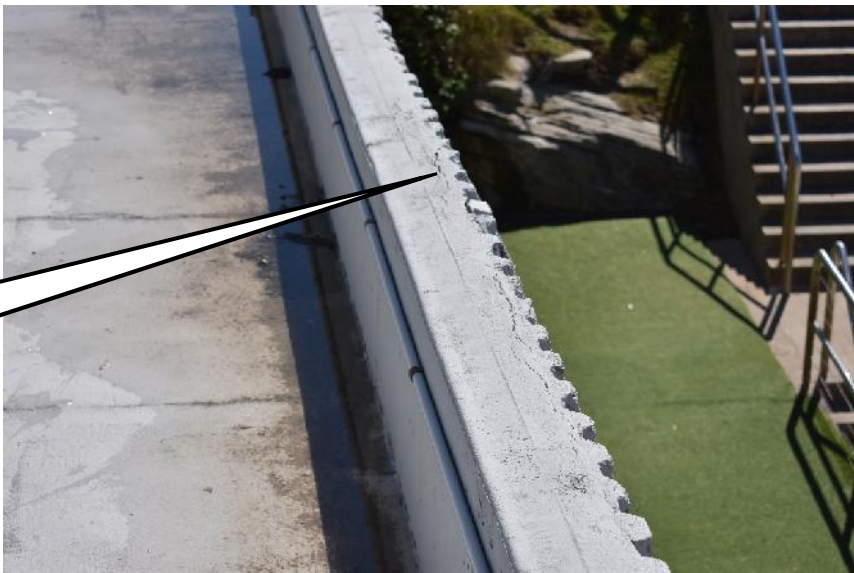
Some parapets have partly spalled concrete which presents a public safety danger. Two areas on the eastern face of the upper roof are loose and held in position by the signage (refer Photos C20 & 21). There may be other areas not observed in this review. As a priority all parapets must be promptly made safe by removal of any loose spalling concrete.

<p>C20</p> <p>Severe cracking Signage holding spall in place</p>
