Structural Assessment of Building

223-227 Bronte Road

Charing Cross

Structural Assessment of Building 223-227 Bronte Road, Charing Cross

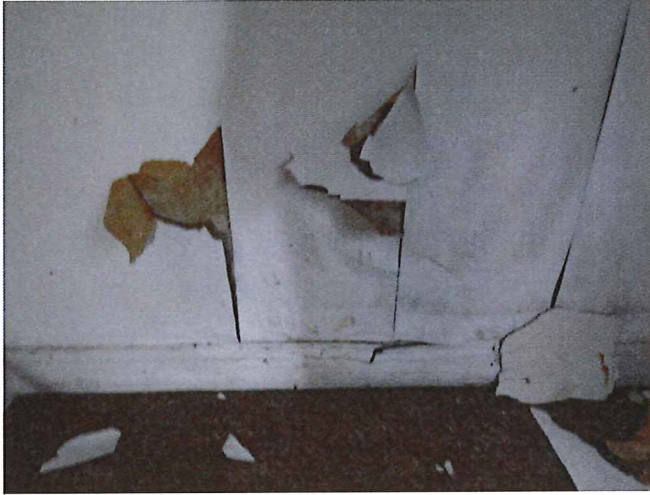
There was evidence of water damage to the walls, as can be seen in attached photographs 5, 6 and 8, which were taken in Apartment 2, being the central apartment on the lower level.

Photo 5 - Example of water damage to walls to lower level apartments. This wall is the rear wall of the bedroom to apartment 2.

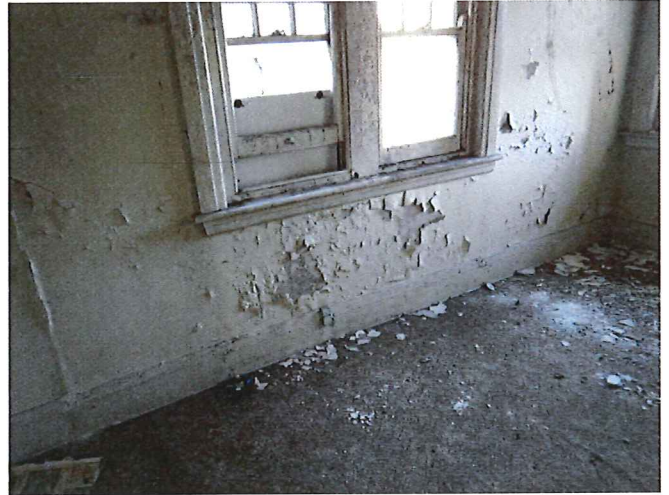
Photo 6 - Example of water damage to walls to lower level apartments. This wall is the side wall of the bedroom to apartment 2.

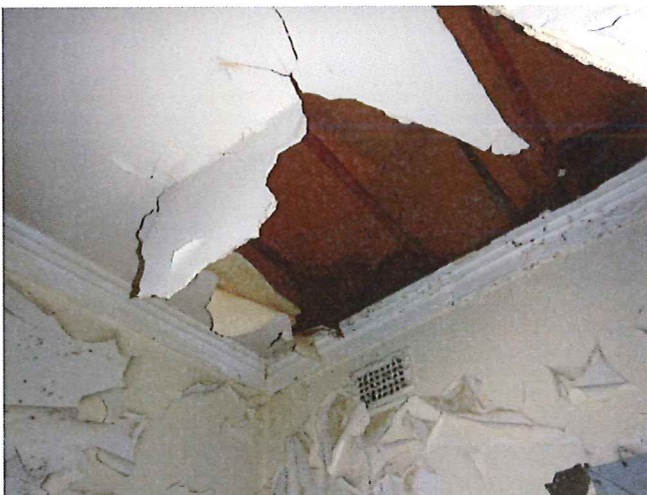
Photo 7 - Water damage to ceiling in unit 2

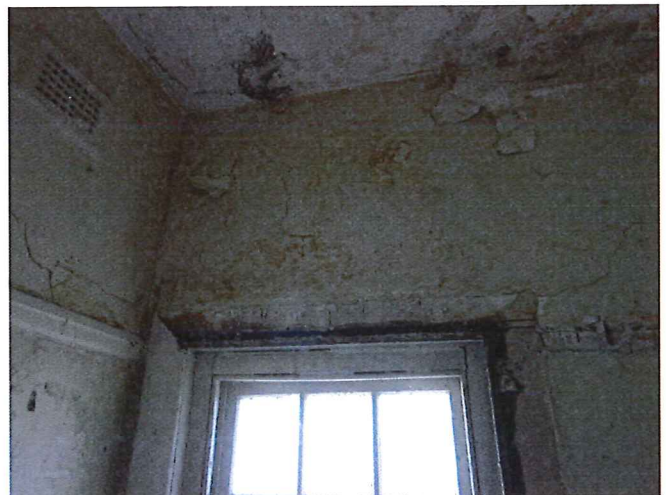
Photo 8 - Frame work around windows is in poor condition.

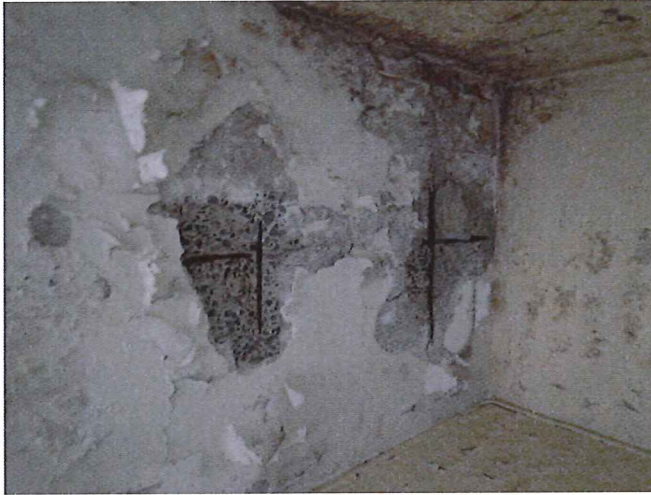
The suspended concrete slabs which form the roof terraces extending over the rear of the lower and upper level apartments are in extremely poor condition. The concrete elements show signs of significant water penetration and concrete cancer. Photographs 9 through 14 show examples of the extent of concrete cancer to the slabs. This was a consistent issue with all the slabs which form the terraces over the apartments.

Photo 9 - Evidence of concrete cancer to suspended slabs. This is a significant issue throughout the building through all concrete slabs.

- Demolition and replacement of all concrete roof structures. (It should be noted that these make up well over 65% of the roofs to the apartments.)
- Demolition and rebuilding of all access stairs.
- New damp-proof courses to be installed throughout.
- All lintels to be replaced.
- All services such as plumbing, electrical and fire to be replaced.
- Assessment of all timber floors and remedial works completed as required.
- Repairs to the metal roof structure as required.
- Replacement of all windows.

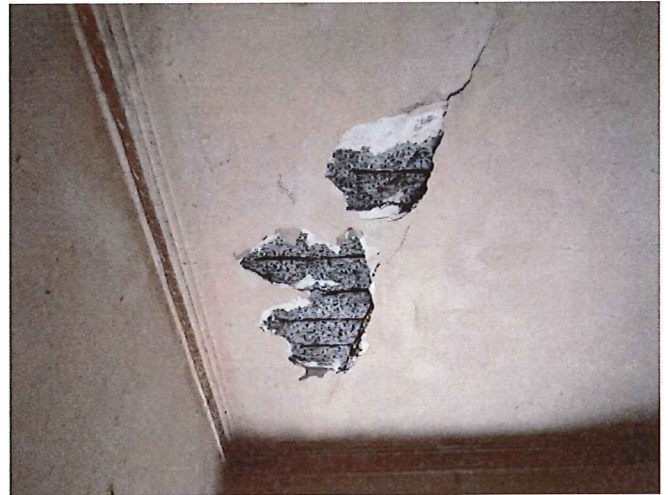
Photo 10 - Evidence of concrete cancer to suspended slabs. This is a significant issue throughout the building through all concrete slabs.

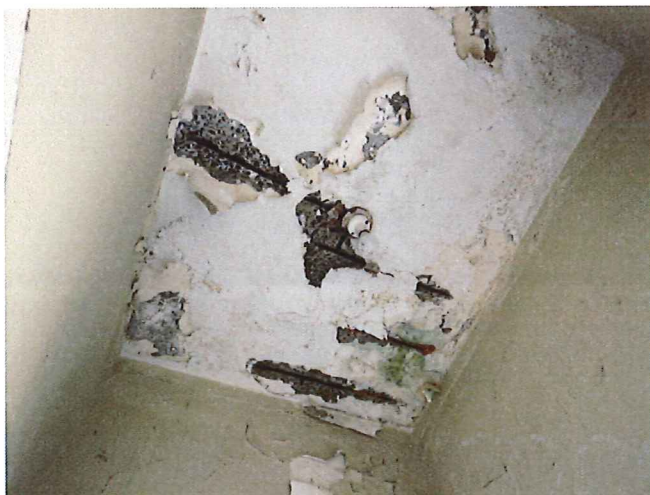
Photo 11 - Evidence of concrete cancer to suspended slabs. This is a significant issue throughout the building through all concrete slabs.

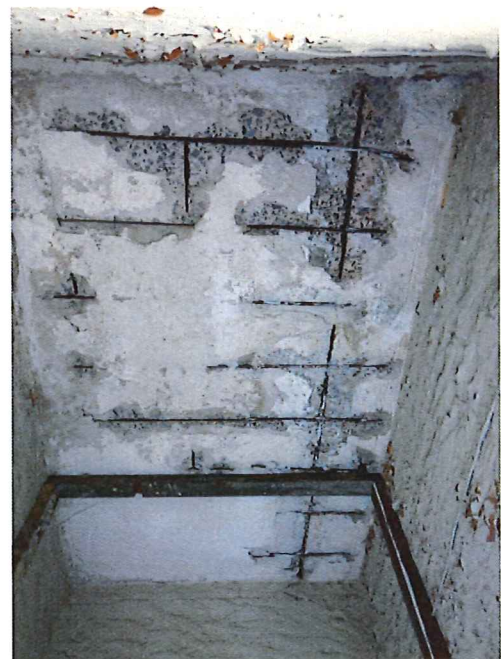
Photo 12 - Evidence of concrete cancer to suspended slabs. This is a significant issue throughout the building through all concrete slabs.

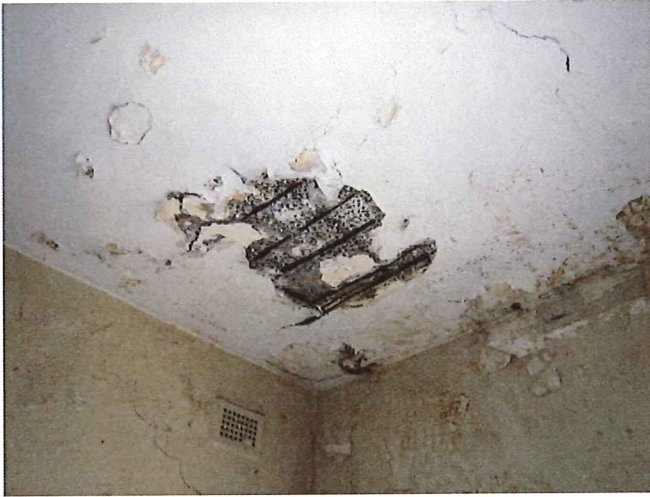
Photo 13 - Evidence of concrete cancer to suspended slabs. This is a significant issue throughout the building through all concrete slabs.

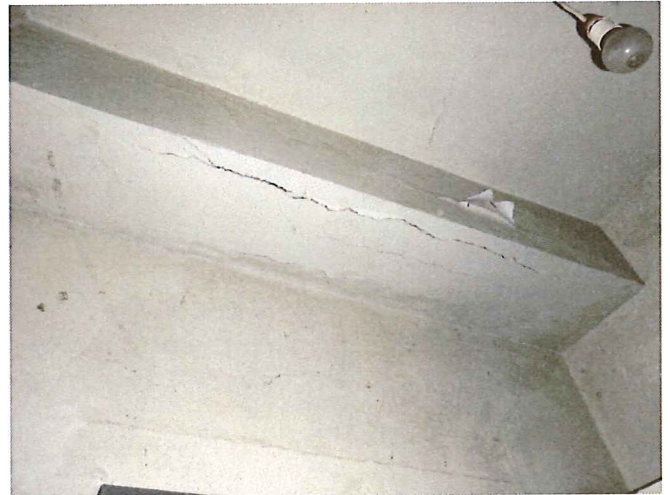
Photo 14 - Evidence of concrete cancer to the steel beams.

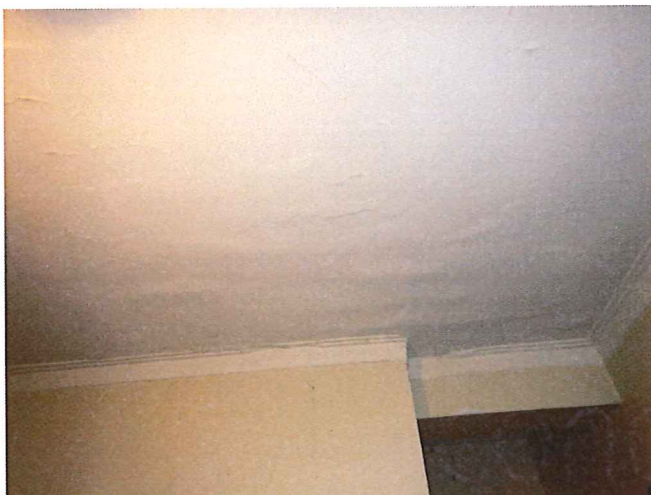
In some of the apartments there were sections of the render to the underside of the slabs that appeared to be concealing additional concrete cancer, however the render had yet to delaminate. As can be seen in attached photographs 15 and 16, the delamination of the render/concrete is only a matter of time.

Photo 15 - The undulations in the render to the underside of the slabs are impacted by concrete cancer and spalling of the concrete is immanent

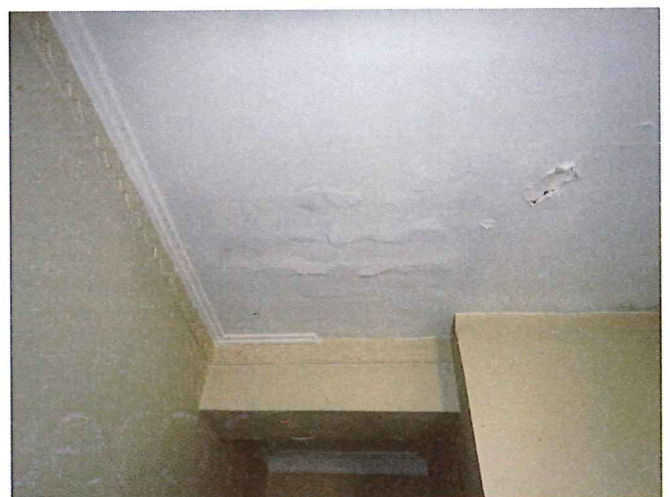
Photo 16 - The undulations in the render to the underside of the slabs are impacted by concrete cancer and spalling of the concrete is immanent

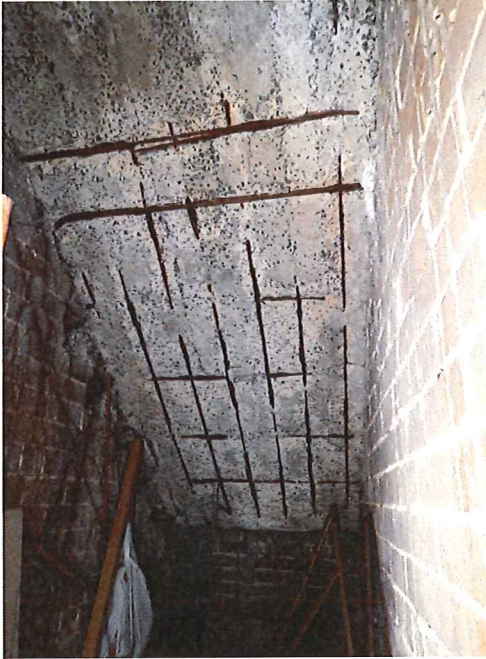
The access to the rear apartments is via a series of reinforced concrete staircases. These staircases are in a severely dilapidated state. Photographs 17 and 18 show evidence of concrete cancer to the staircases. The concrete cancer to the lower staircase is in an extremely advanced state (photograph 17). The damage to the upper level staircase has been repaired in the past, however the concrete structure is likely to have been compromised as a result of the past damage.

Photo 17 - Severe concrete cancer to underside of stair at south western corner of building

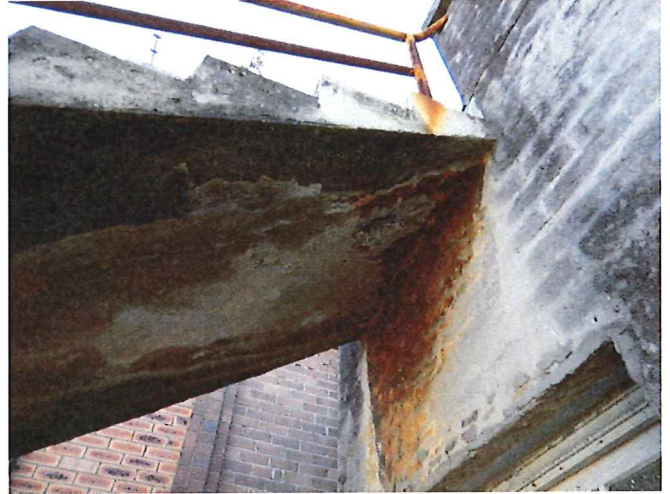
Photo 18 - Evidence of concrete cancer to the underside of the upper level stair leading to the roof top deck

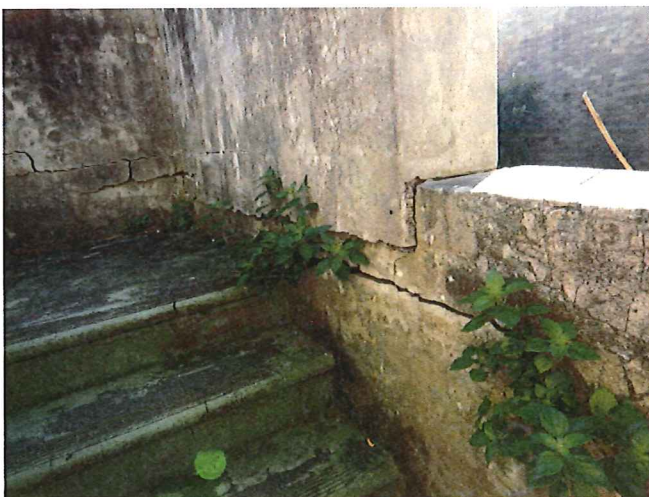
The balustrades to the lower level section of staircase are masonry, and are in extremely poor condition, as can be seen in attached photographs 19 and 20. These balustrades are crumbling due to the impact of time and the environment. It is clear in photographs 19 and 20 that there is foliage growth within the cracks in the masonry balustrades.

Photo 19 - Cracking to masonry balustrade running up external stair

It is our recommendation that access to these areas where the balustrades are falling apart be closed off immediately.

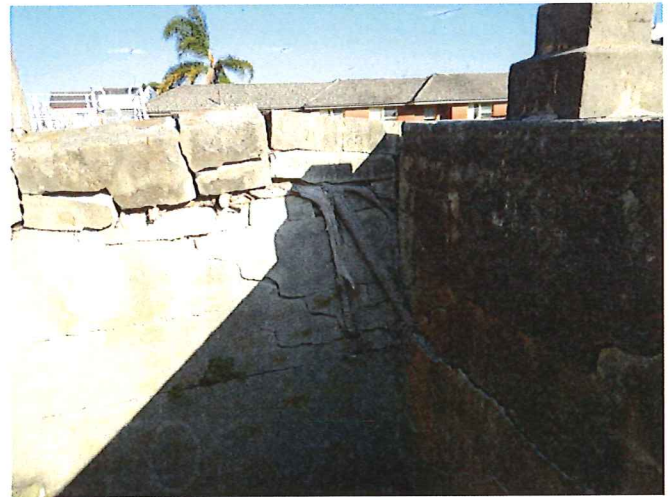
Photo 20 - Cracking to masonry balustrade running up external stair

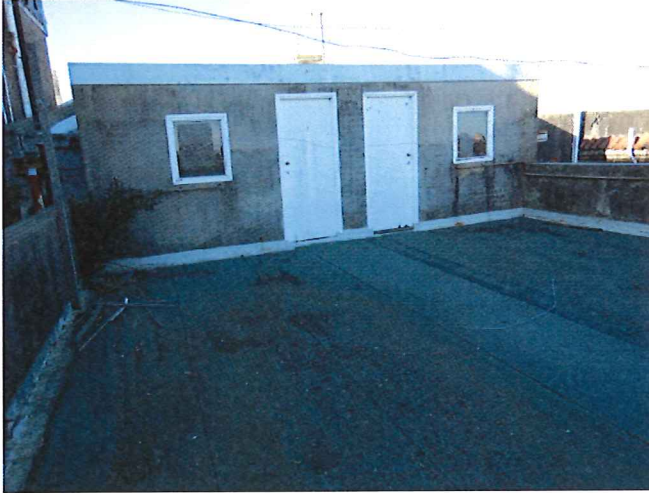
As noted previously, the roof structures over the rear portion of the building are waterproofed concrete terraces, an example of which can be seen in photographs 21 through 23. When assessed from below, these concrete structures were seen to be in an extremely poor condition.

Photo 21 - Concrete terrace, underside of which is showing signs of significant concrete cancer

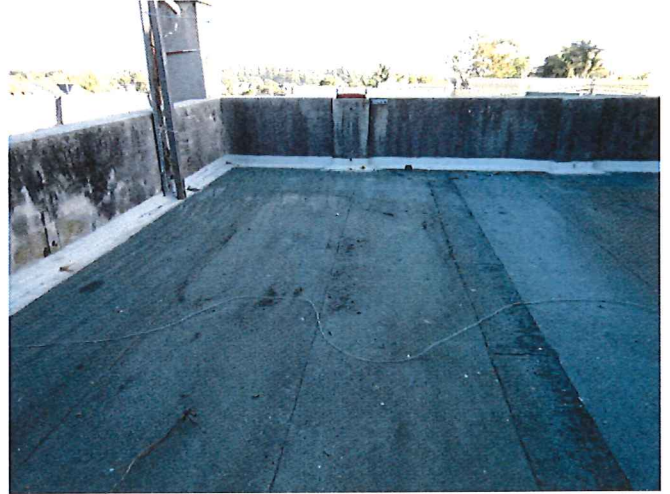
Photo 22 - Concrete terrace, underside of which is showing signs of significant concrete cancer

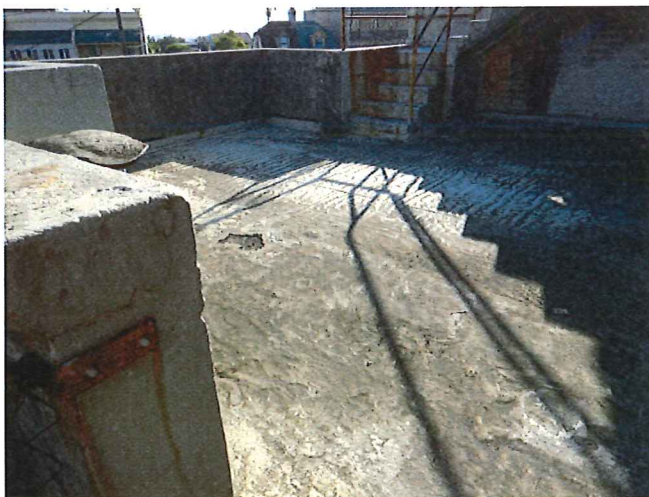
Photo 23 - Concrete terrace, underside of which is showing signs of significant concrete cancer

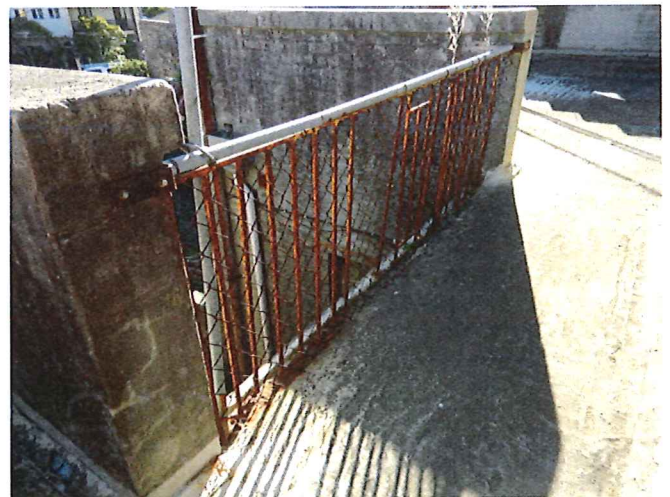
The balustrades to some of the upper level sections of terrace are in poor condition, as can be seen in photograph 24.

Photo 24 - Balustrade to upper level walkway is in extremely poor condition and needs to be replaced

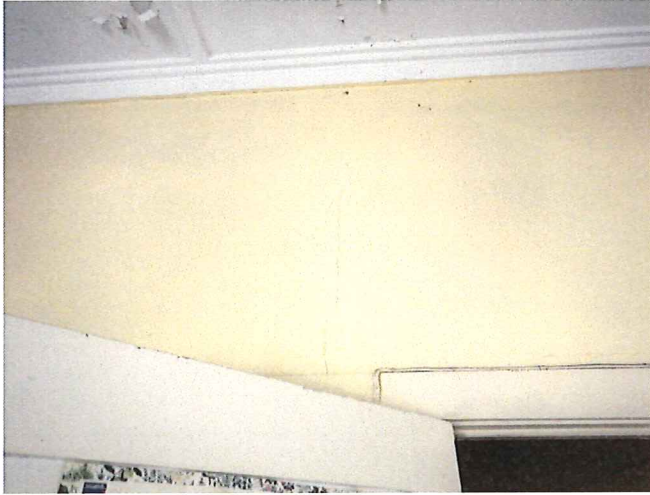
Walls to the upper level apartments were in better condition than the walls to the lower level apartments. The upper level walls over the retail tenancies had some cracks evident. These cracks varied from slight to moderate. Examples of the cracking observed can be seen in attached photographs 25 through 31.

Photo 25 - Evidence of cracking to the internal walls of the upper level apartments

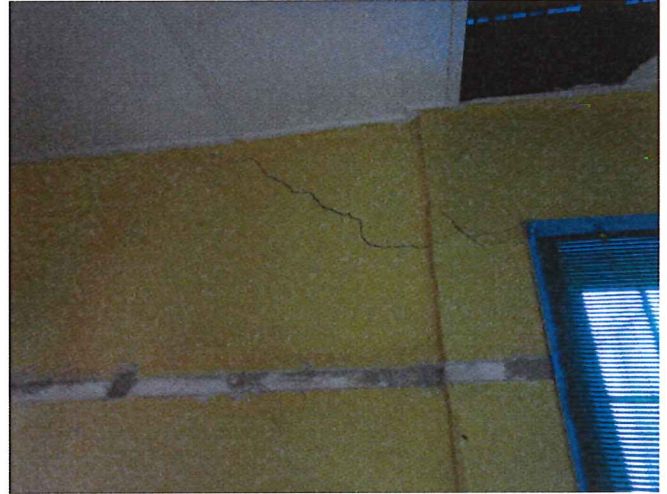
Photo 26 - Evidence of cracking to the internal walls of the upper level apartments

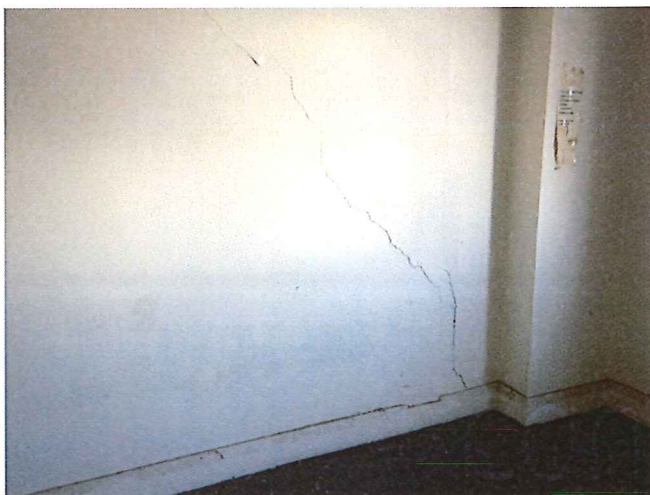
Photo 27 - Evidence of cracking to the internal walls of the upper level apartments

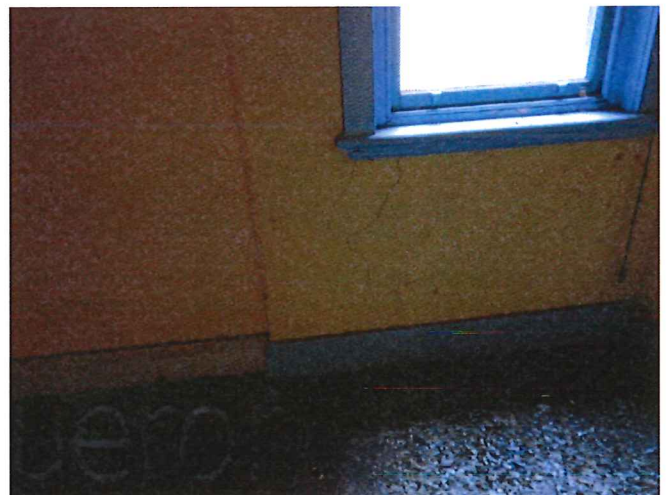
Photo 28 - Evidence of cracking to the internal walls of the upper level apartments

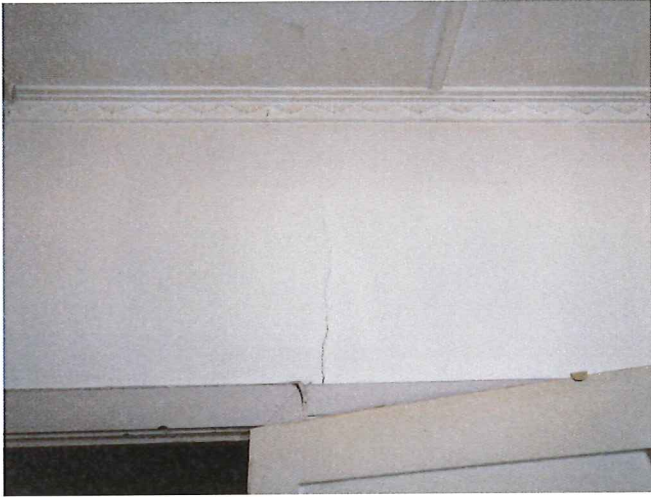
Photo 29 - Evidence of cracking to the internal walls of the upper level apartments

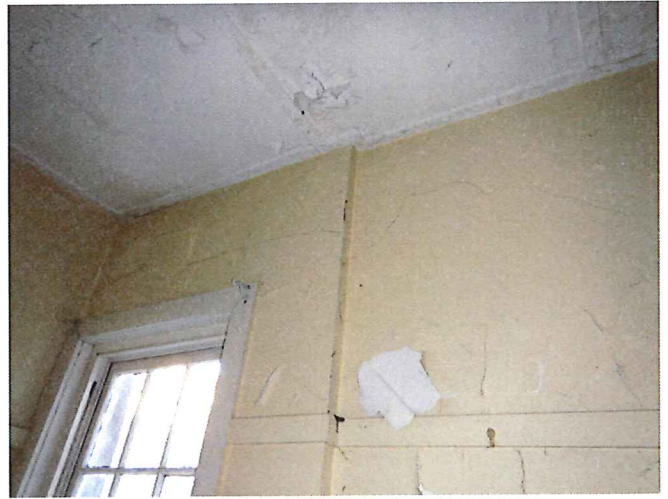
Photo 30 - Evidence of cracking to the internal walls of the upper level apartments

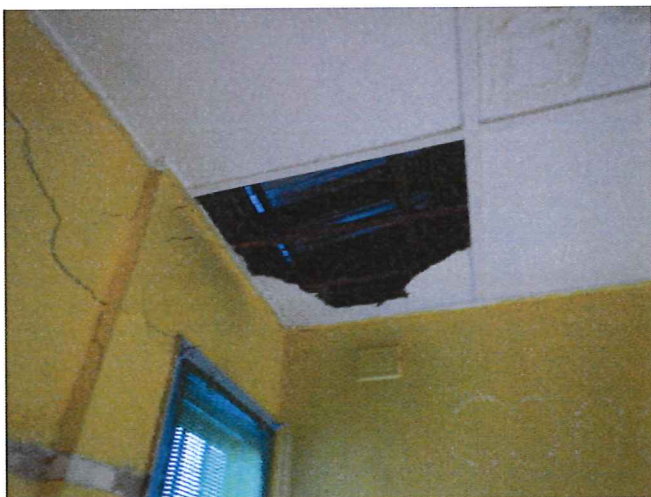
Photo 31 - Damage to roof of upper level apartment

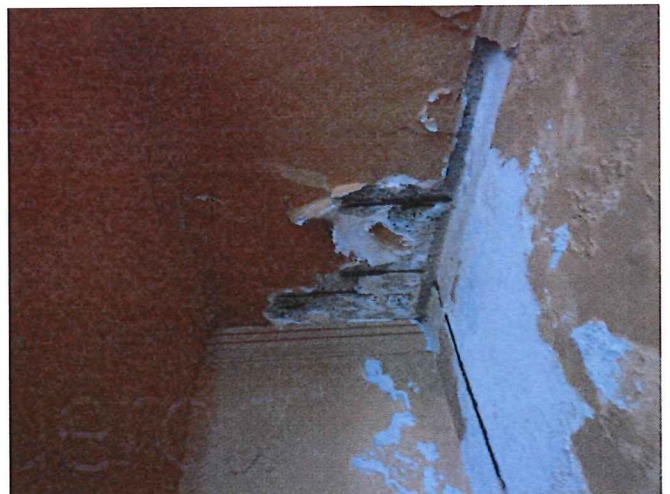
Photo 32 - Damage to roof of upper level apartment

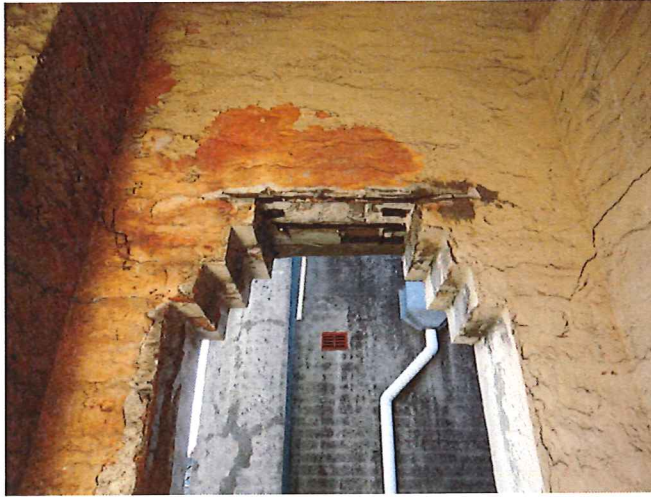
Photo 33 - Evidence of corrosion of lintels embedded within masonry. This is a consistent issue throughout the structure

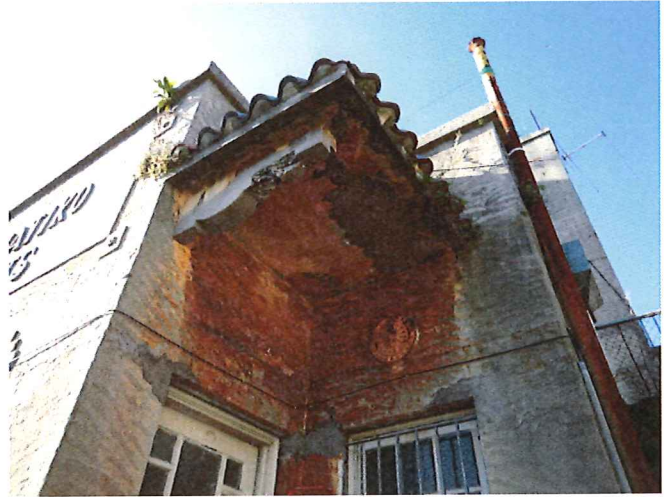
There was evidence of significant spalling to the reinforced concrete decorative elements around the building, an example of which can be seen in attached photograph 34.

Photo 34 - Concrete cancer to exposed slab details. This is a consistent issue throughout the building

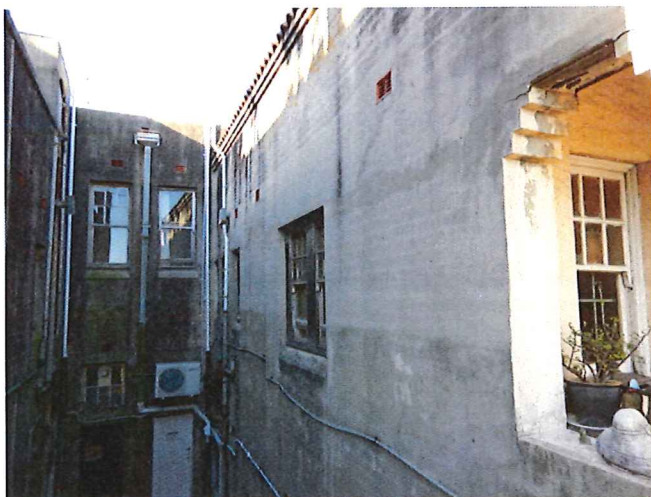
Photo 33 - Facade to internal courtyard. There is evidence of previous repairs to the walls

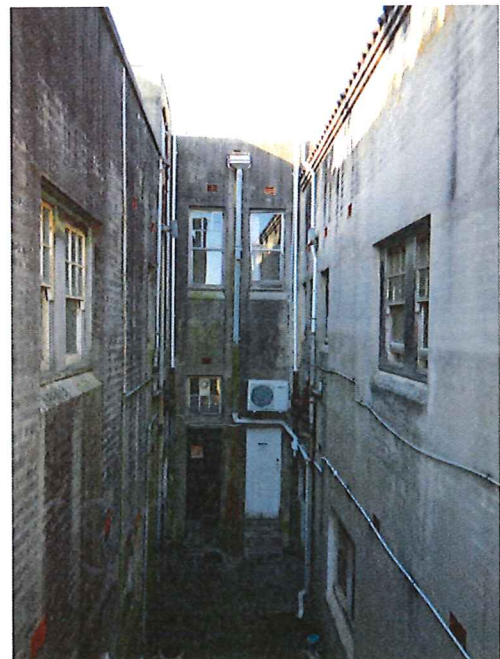
Photo 36 - Facade to internal courtyard. There is evidence of previous repairs to the walls

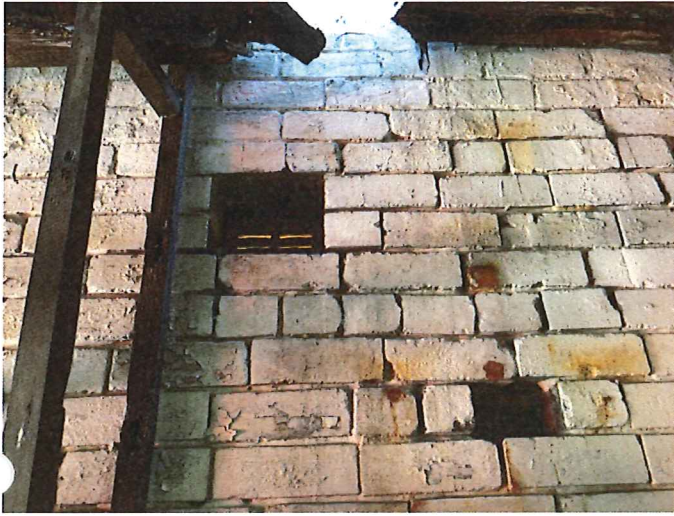
- Based on the information available, it appears that the structure is approximately 80 years old.
- The walls to the building are constructed of masonry with lime mortar. There is significant evidence of deterioration of the lime mortar, as can be seen in attached photographs 5 through 16. In some locations you can simply extract bricks from the wall by pulling on the brick.

Photo 5 - Internal wall. The walls are typically in poor condition and display significant dilapidation of the lime mortar joints

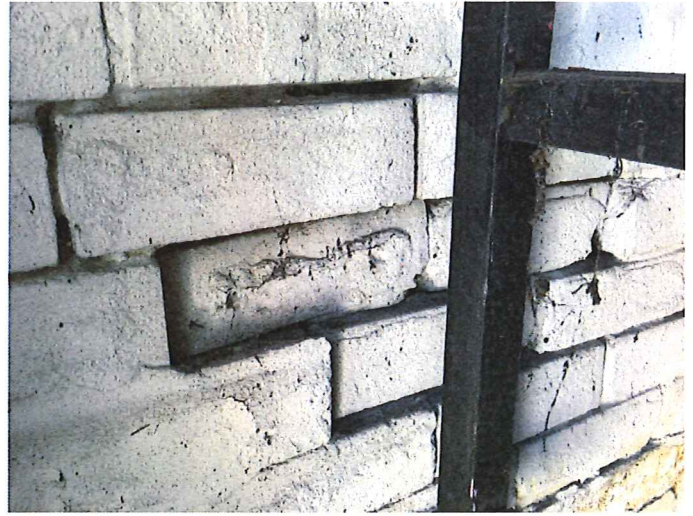
Photo 6 - Deteriorated section of internal wall

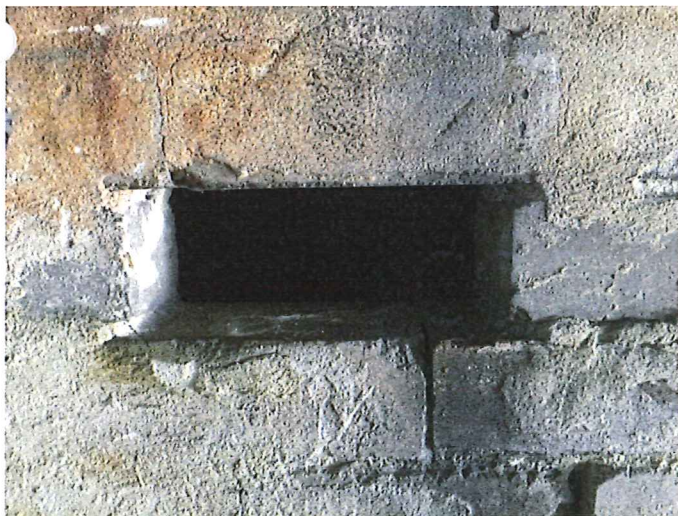
Photo 7 - Deteriorated section of internal wall

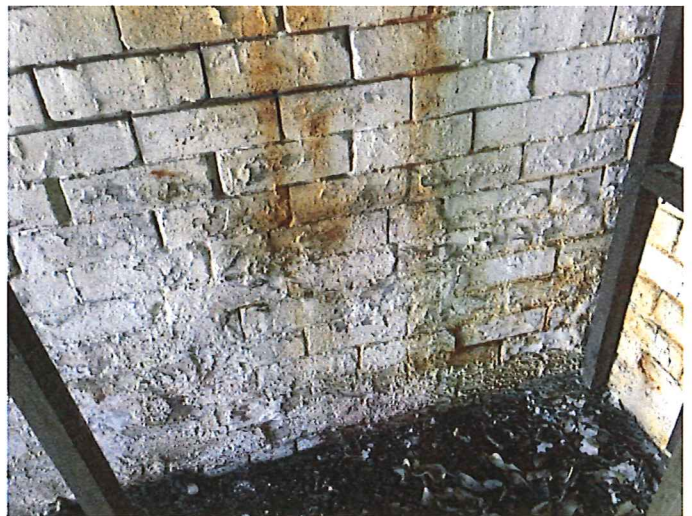
Photo 8 - Deteriorated section of internal wall

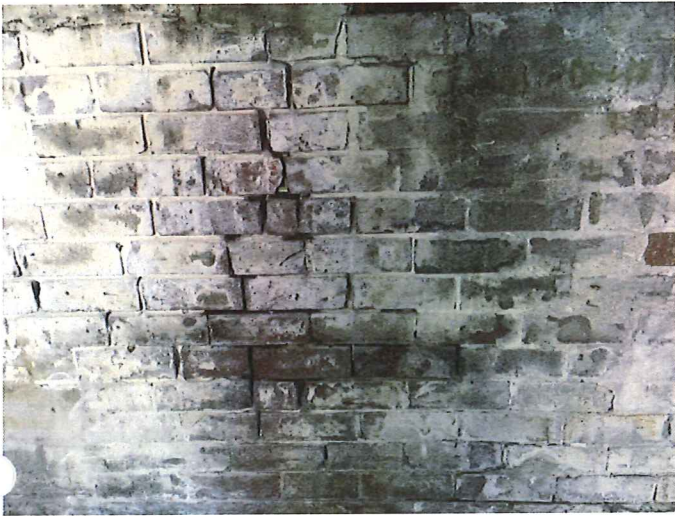
Photo 9 - Deteriorated section of internal wall

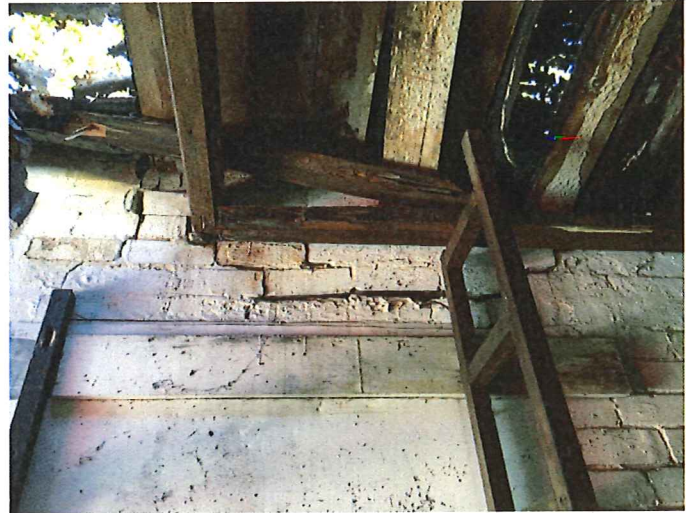
- There was significant damage observed above the window in the northern wall of the building, as can be seen by the exterior in attached photograph 11 and the interior in attached photograph 10. This is a result of significant corrosion in the steel lintel.

Photo 10 - Damage over window as a result of corroded lintel

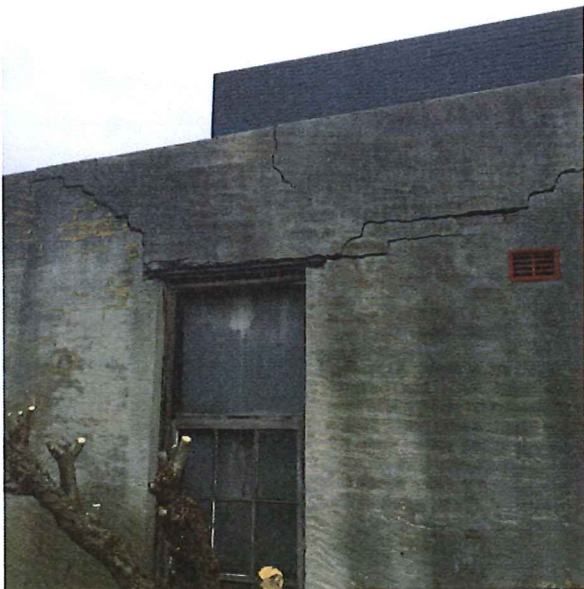
Photo 11 - Damage over window as a result of corroded lintel

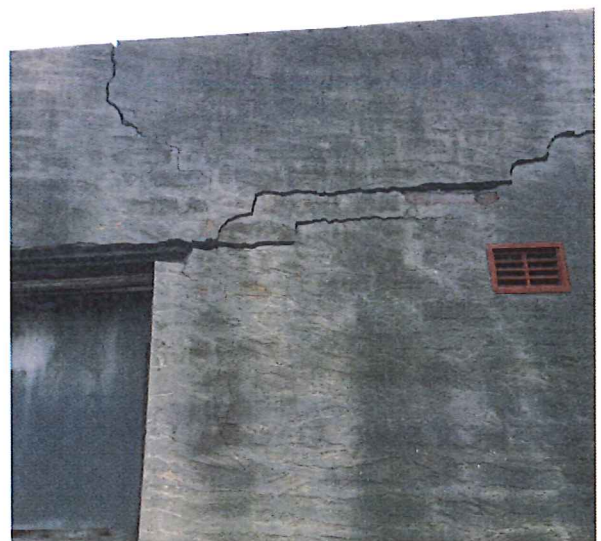
Photo 12 - Damage over window as a result of corroded lintel

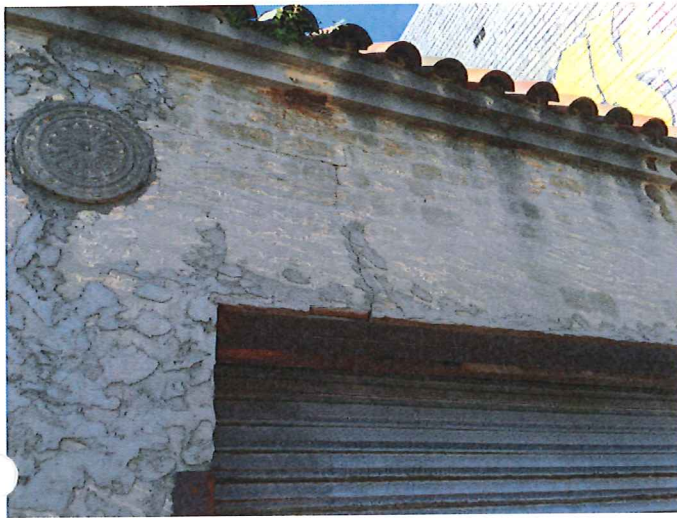
- There is evidence that there has been corrosion in the lintels above the garage doors in the past. These lintels have been replaced some time ago with what appear to be gal angles.

Photo 13 - Damage over garage door opening. Note repairs to previous damage as a result of corroded lintel.

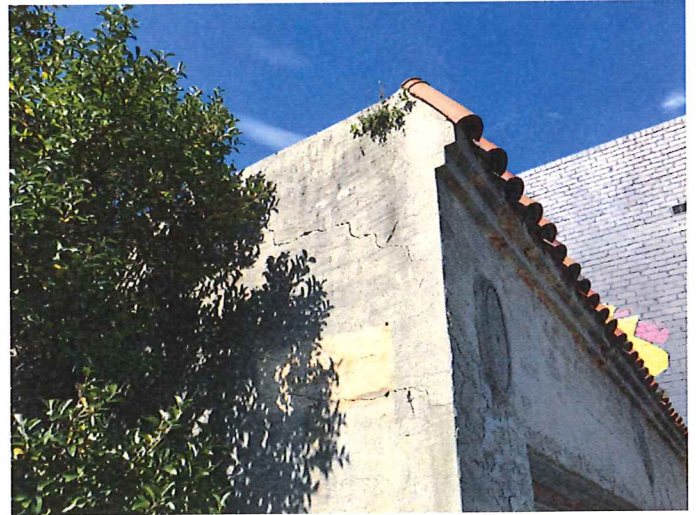
Photo 14 - Cracking to external corner of masonry wall

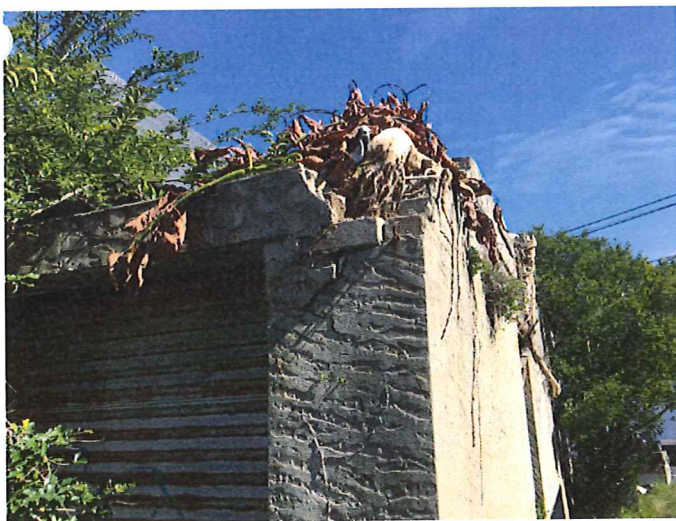
- There are several trees that have attached themselves to the structure, with the growth of the trunks impacting the masonry, as can be seen in attached photographs 15 and 16. It is noted that there are several trees quite close to the structure, which will most likely be impacting the foundations to the structure, as can be seen in attached photograph 17.

Photo 15 - Tree trunk growing within wall. Significant damage to wall and it would be anticipated that there significant damage to the floor and footings

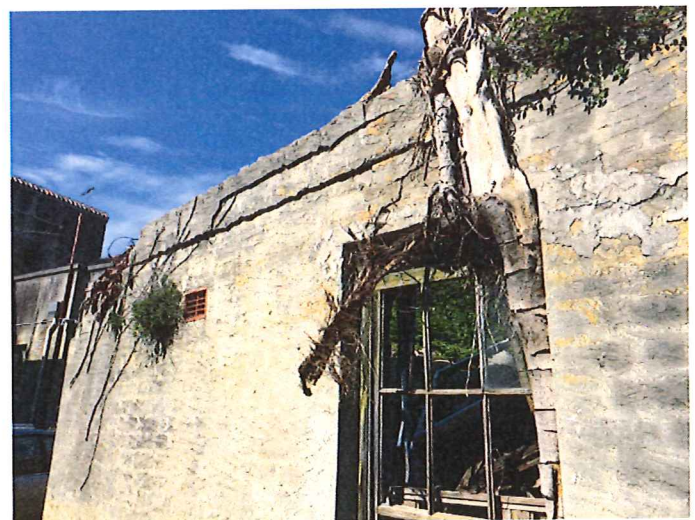
Photo 16 - Tree trunk growing within wall. Significant damage to wall and it would be anticipated that there significant damage to the floor and footings

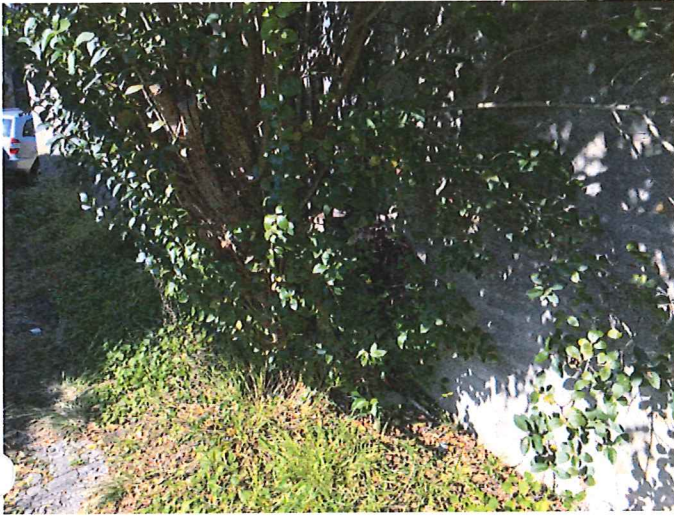
Photo 17 - Tree adjacent building footings

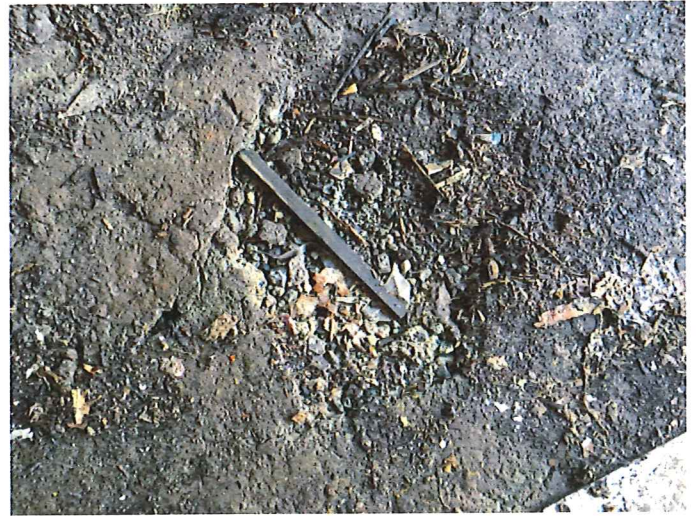
Photo 18 - Damage to ground floor slab

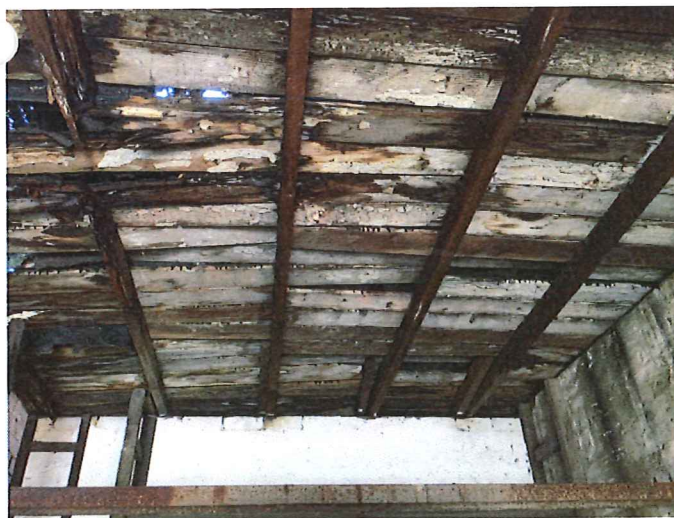
- There is a significant amount of stepped cracking evident within the masonry.
- The roofs of the structures are completely dilapidated, as can be seen in attached photograph 19.

Photo 19 - Significant damage to roof
