WAVERLEY COUNCIL HAZARDOUS BUILDING MATERIALS SURVEY

WAVERLEY COUNCIL CHAMBERS CORNER OF PAUL ST AND BONDI RD, BONDI JUNCTION NSW 2022

REFERENCE No. S10345-R01

JULY 2018

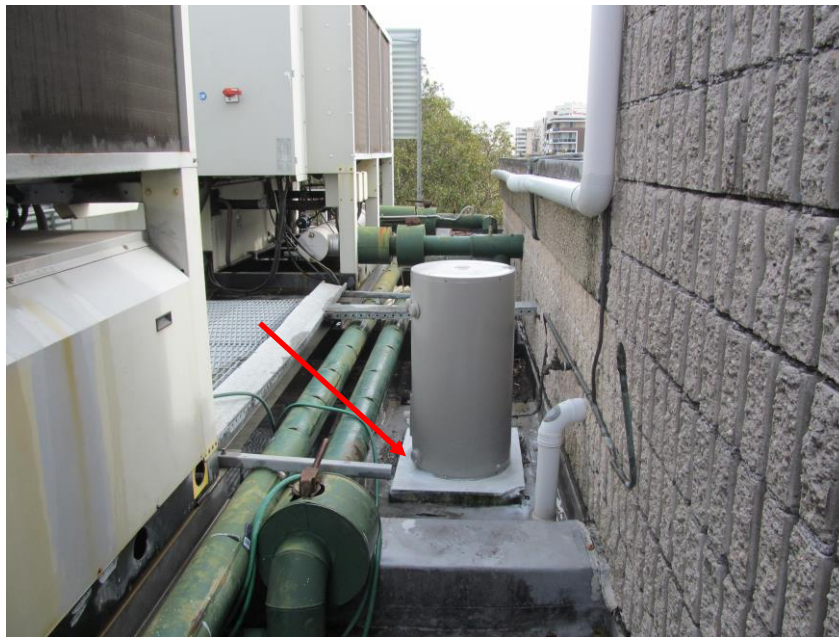
Description: The red arrow points to thick compressed asbestos cement sheet.

Recommendation: Leave and maintain in good condition

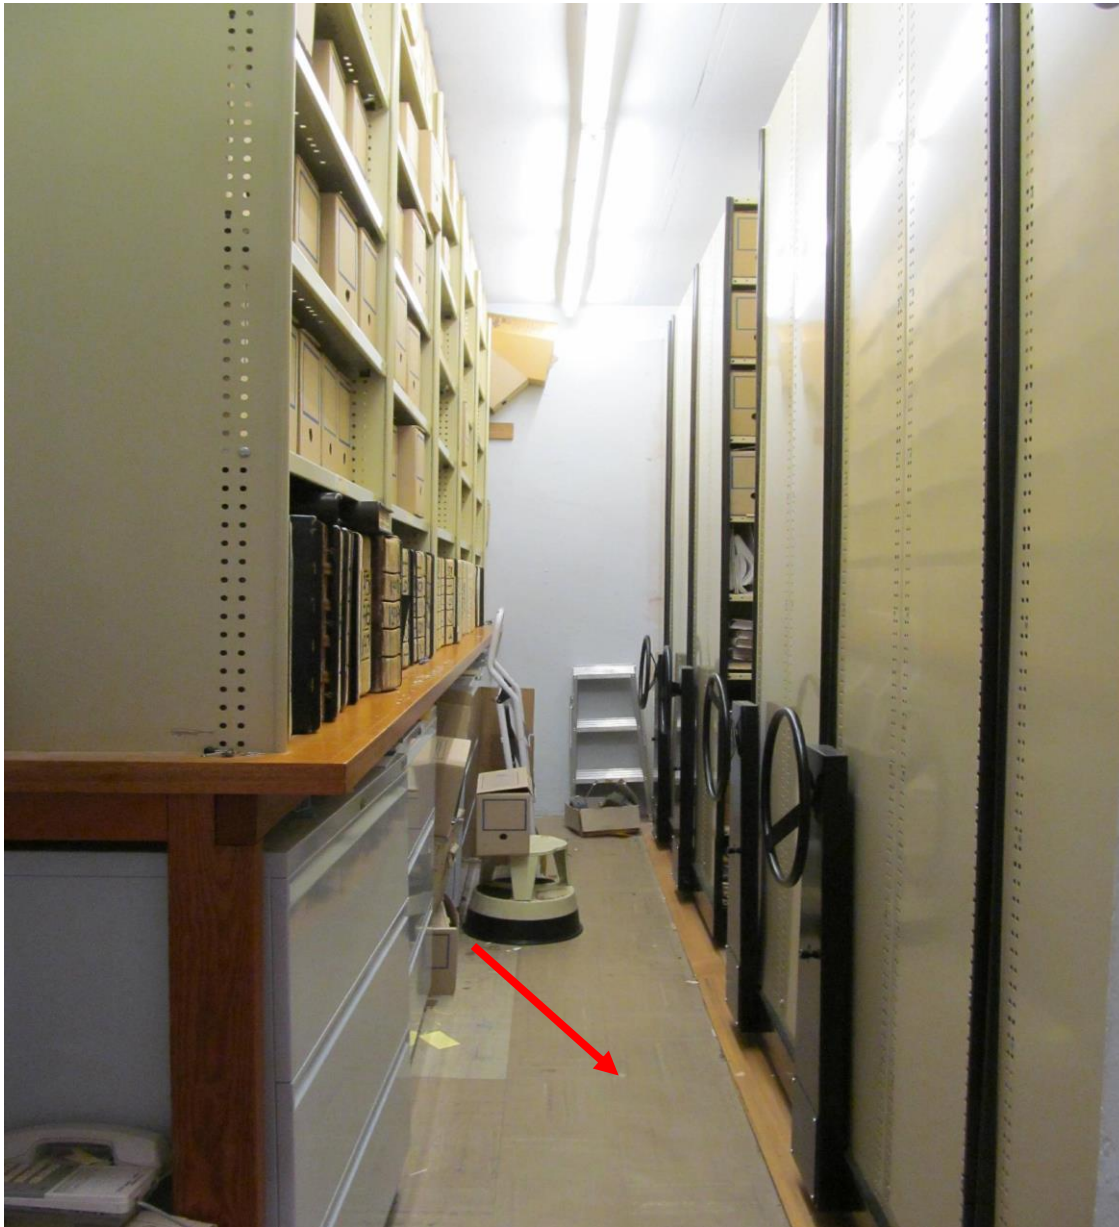
Photograph A02

Description: The red arrow points to vinyl floor tiles.

Recommendation: Leave and maintain in good condition.

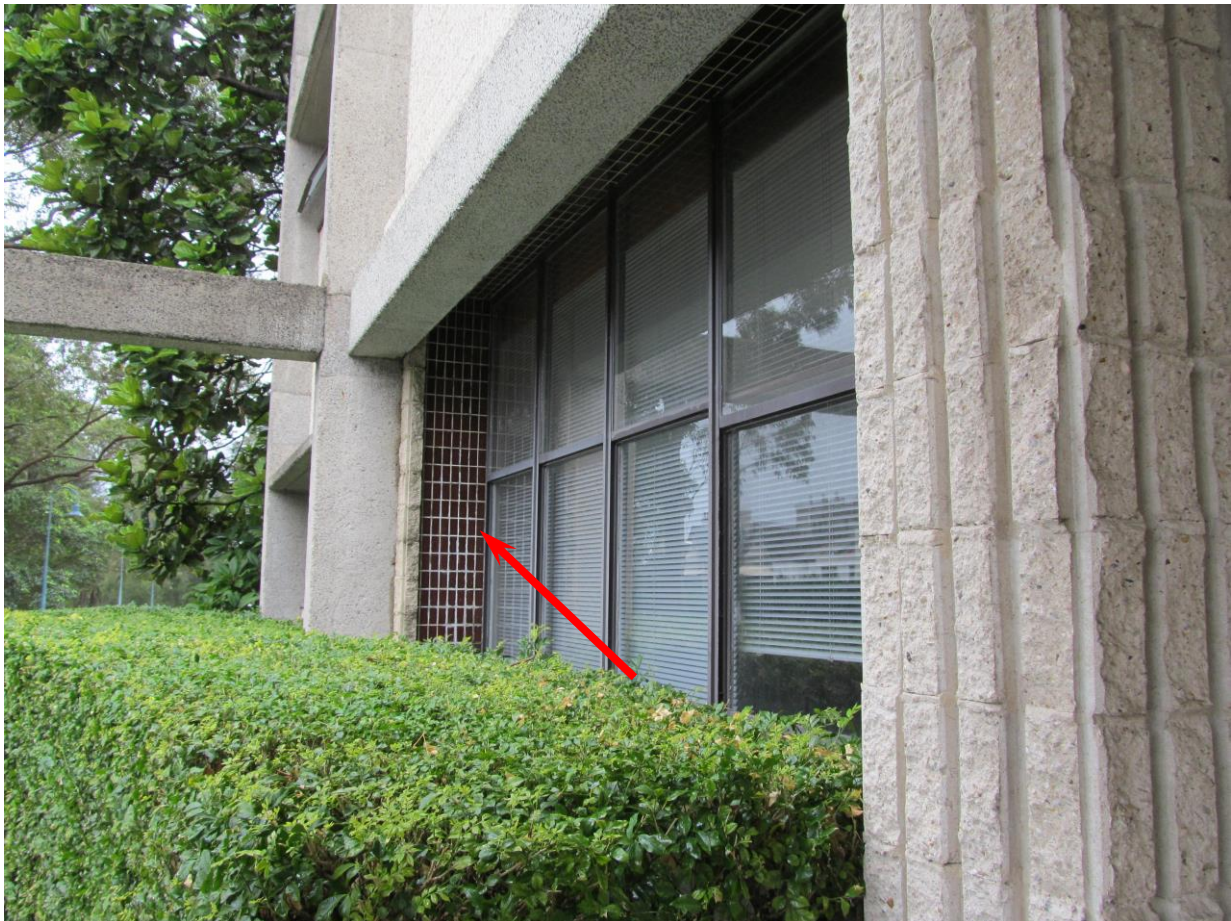
Photograph A03

Description: The red arrow points to where cement sheeting (which may contain asbestos), may be present.

Recommendation: Leave and maintain in good condition. Confirm asbestos status prior to refurbishment or demolition

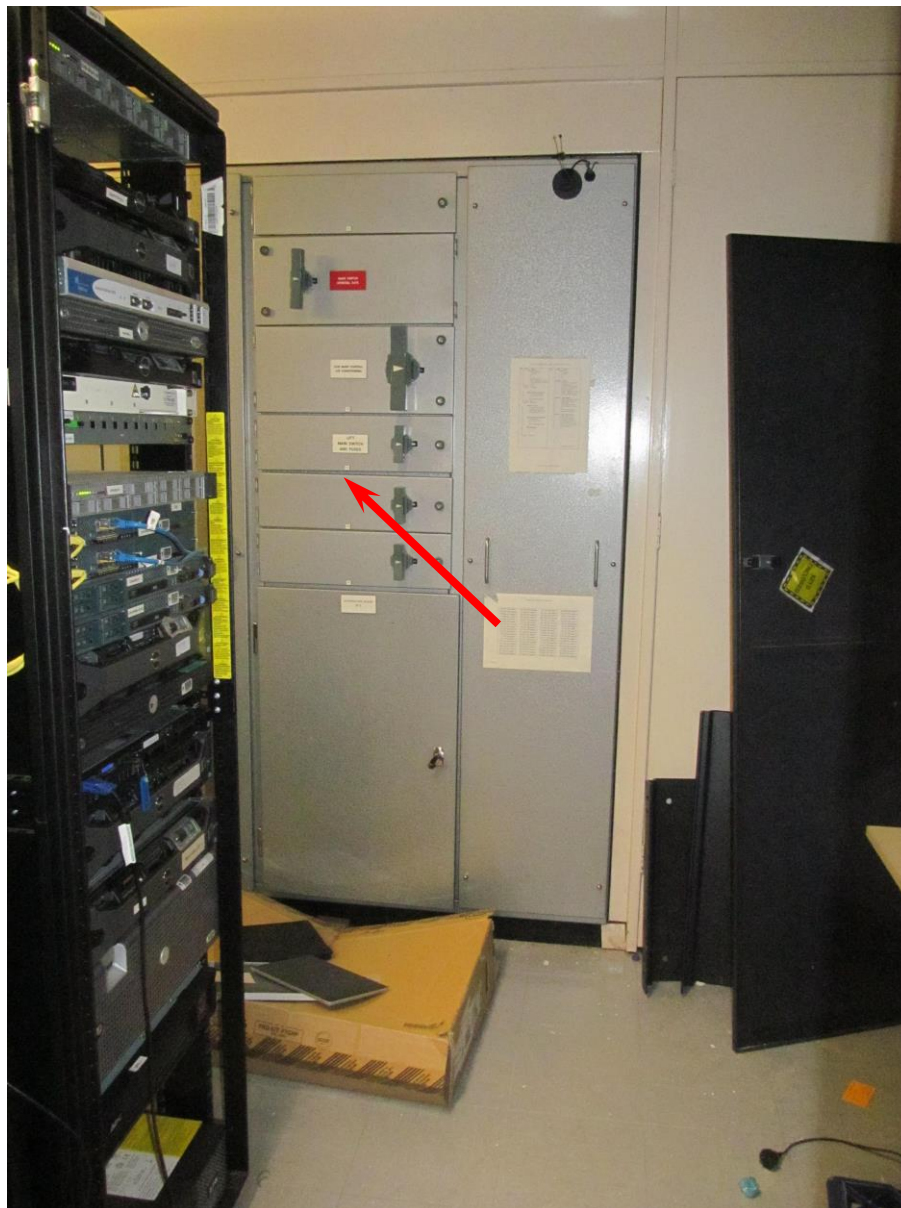
Photograph A04

Description: The red arrow points to electrical equipment.

Recommendation: Leave and maintain in good condition. Confirm asbestos status prior to refurbishment or demolition

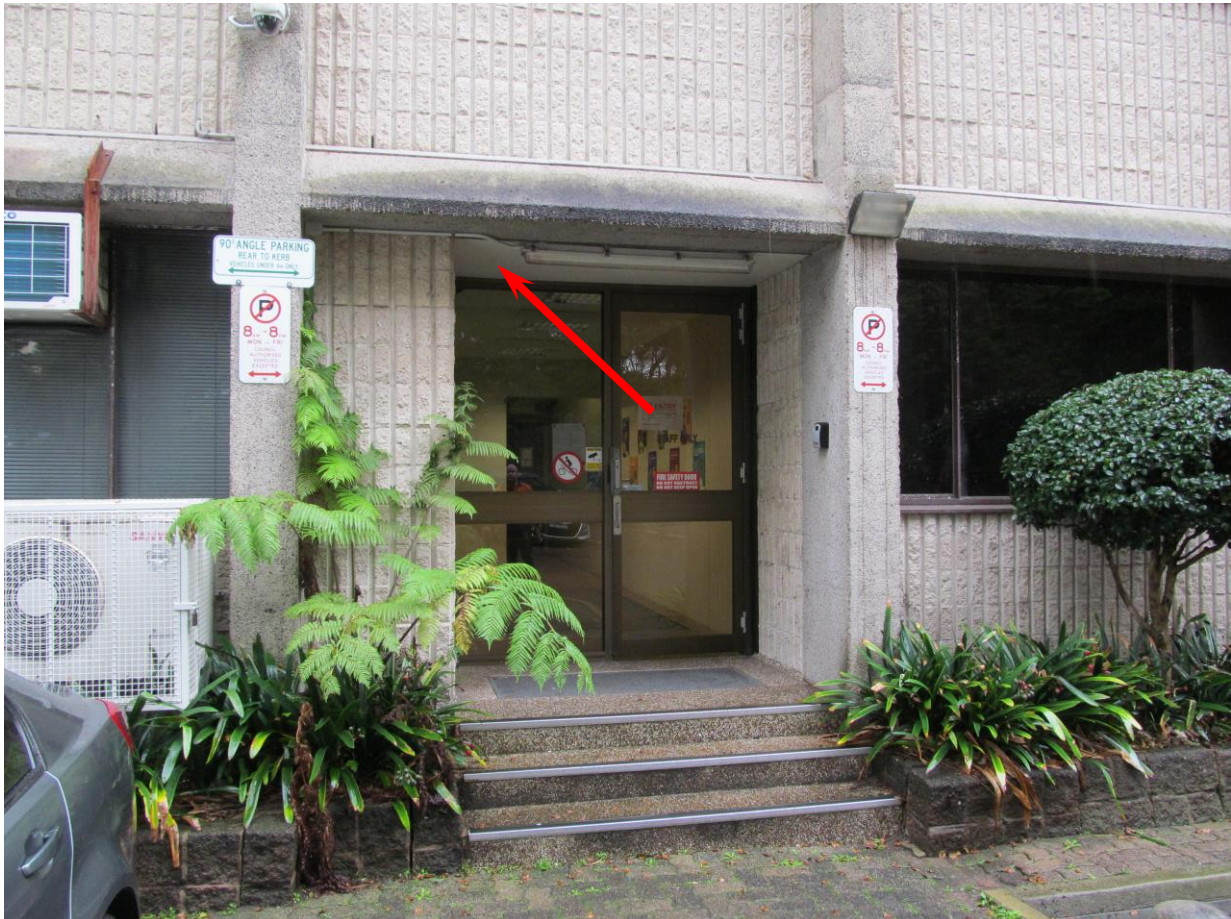
Photograph A05

Description: The red arrow points to ceiling lining.

Recommendation: Leave and maintain in good condition.

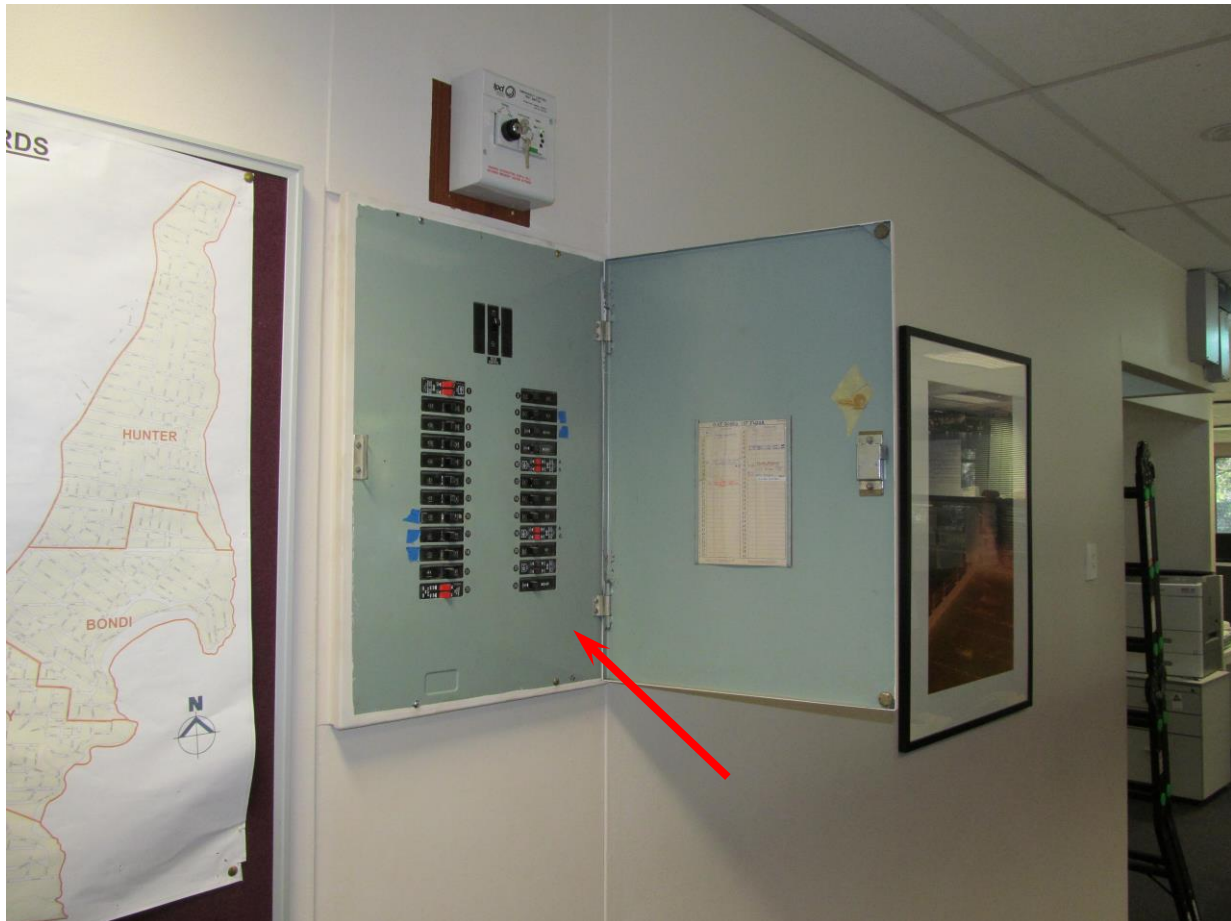
Photograph A06

Description: The red arrow points to electrical equipment.

Recommendation: Leave and maintain in good condition. Confirm asbestos status prior to refurbishment or demolition

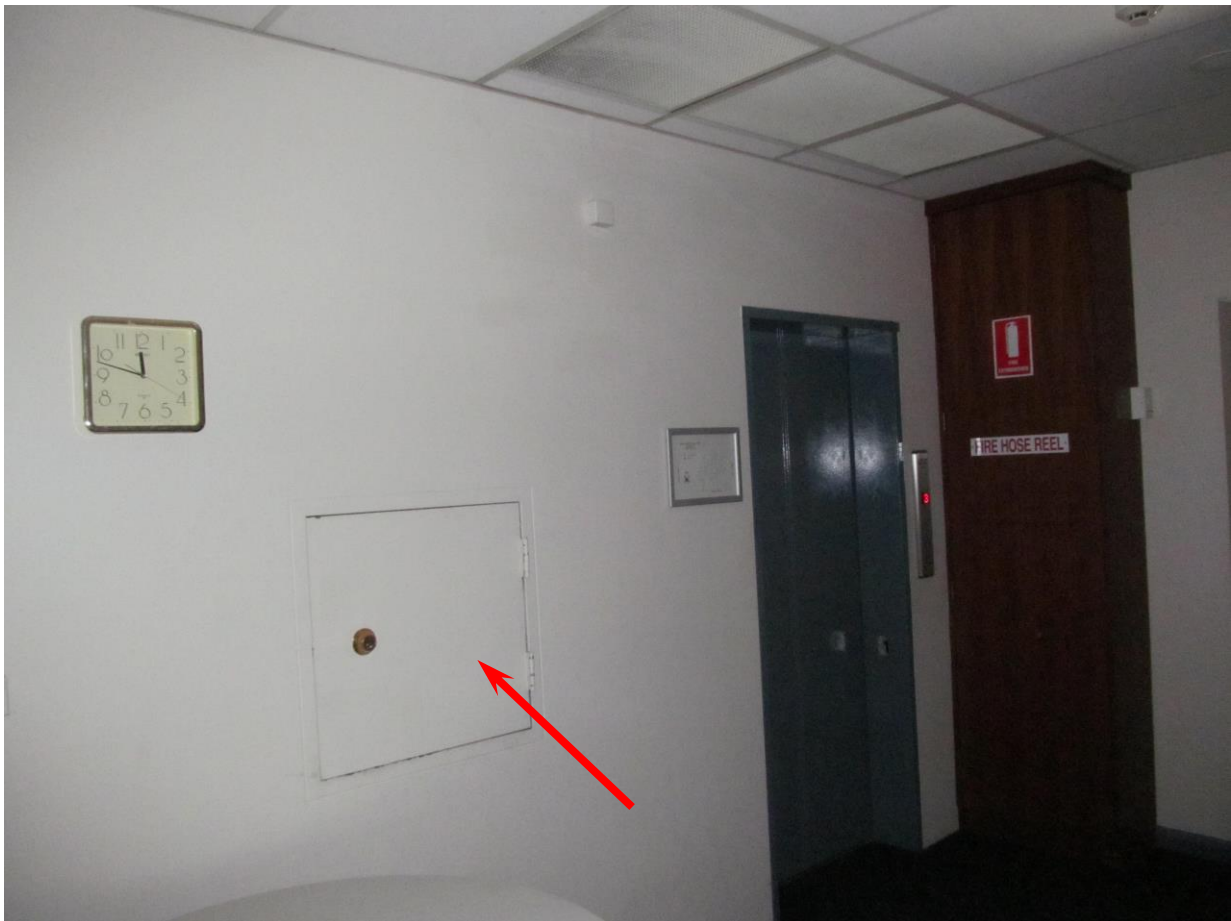
Photograph A07

Description: The red arrow points to a fire door.

Recommendation: Leave and maintain in good condition.

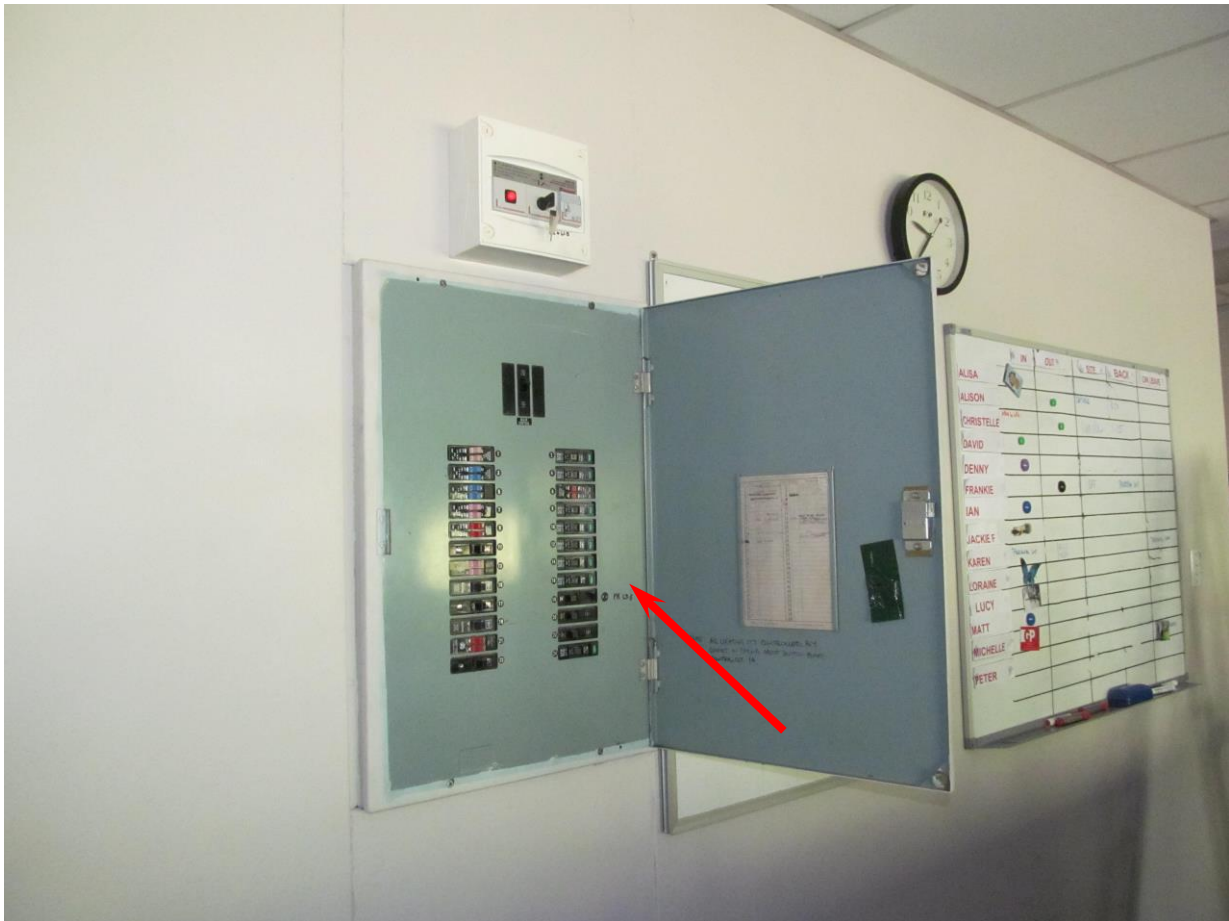
Photograph A08

- Site: Waverley Council Chambers.
- Location: Level 2, electrical cabinet in the south office, south of the central firestairs.
- Description: The red arrow points to electrical equipment.
- Recommendation: Leave and maintain in good condition. Confirm asbestos status prior to refurbishment or demolition

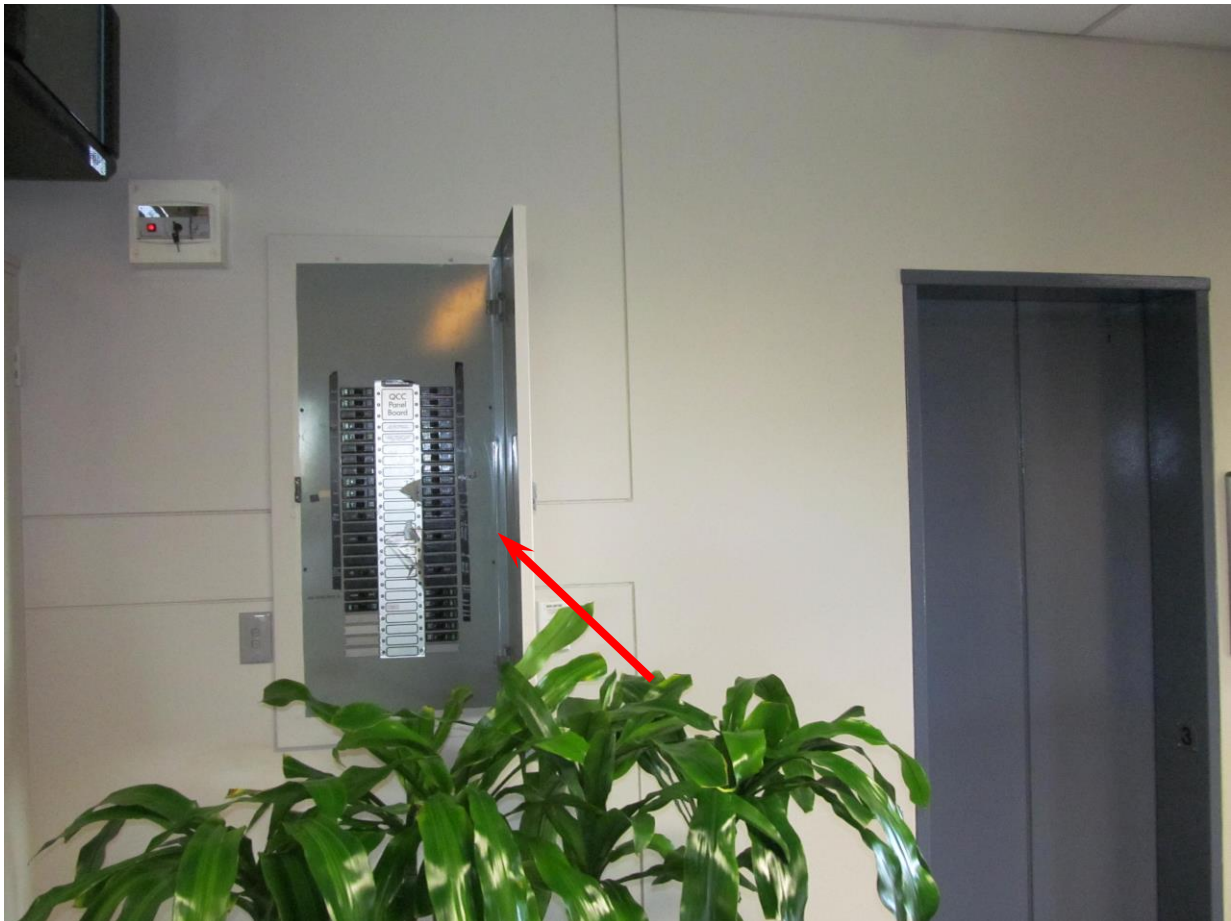
Photograph A09

Description: The red arrow points to electrical equipment.

Recommendation: Leave and maintain in good condition. Confirm asbestos status prior to refurbishment or demolition

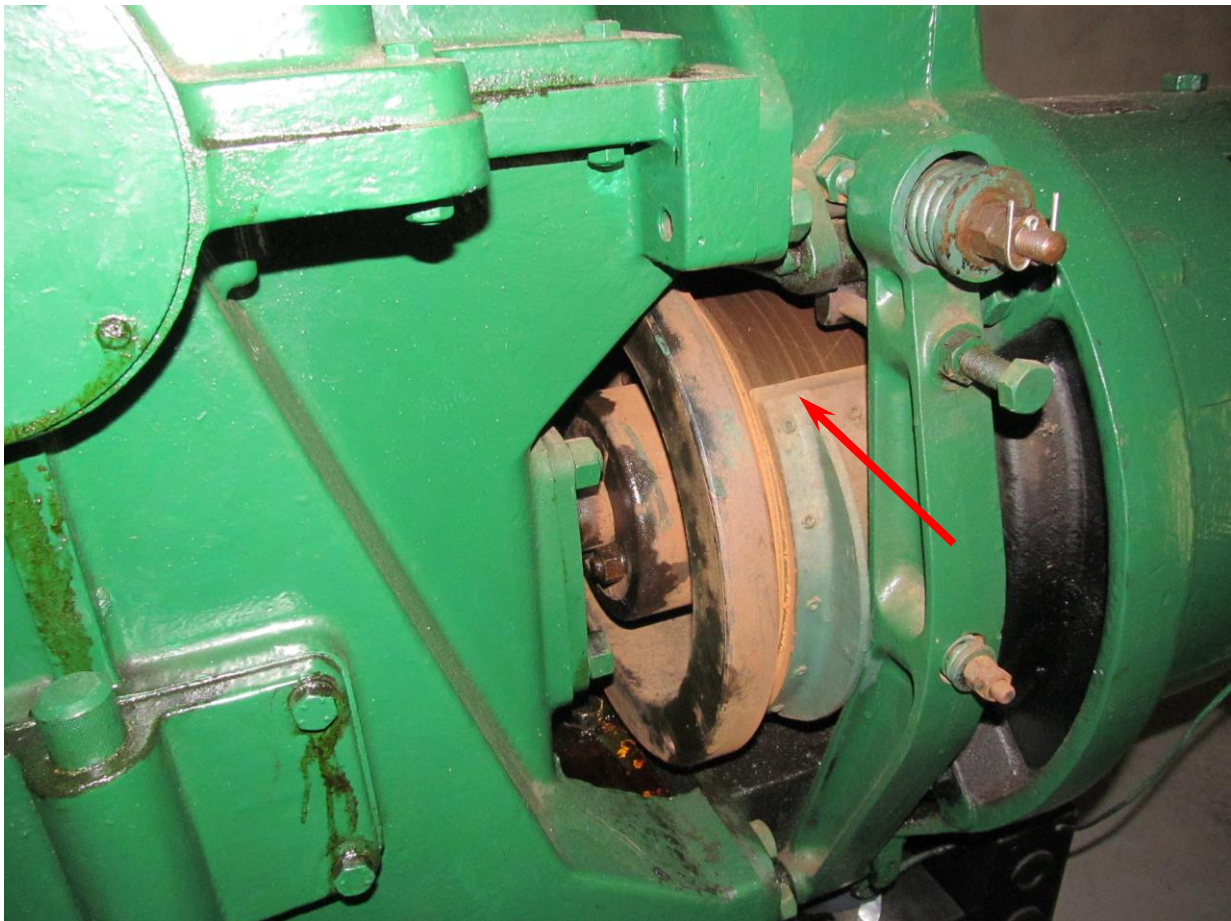
Photograph A10

Description: The red arrow points to brake shoe.

Recommendation: Leave and maintain in good condition.

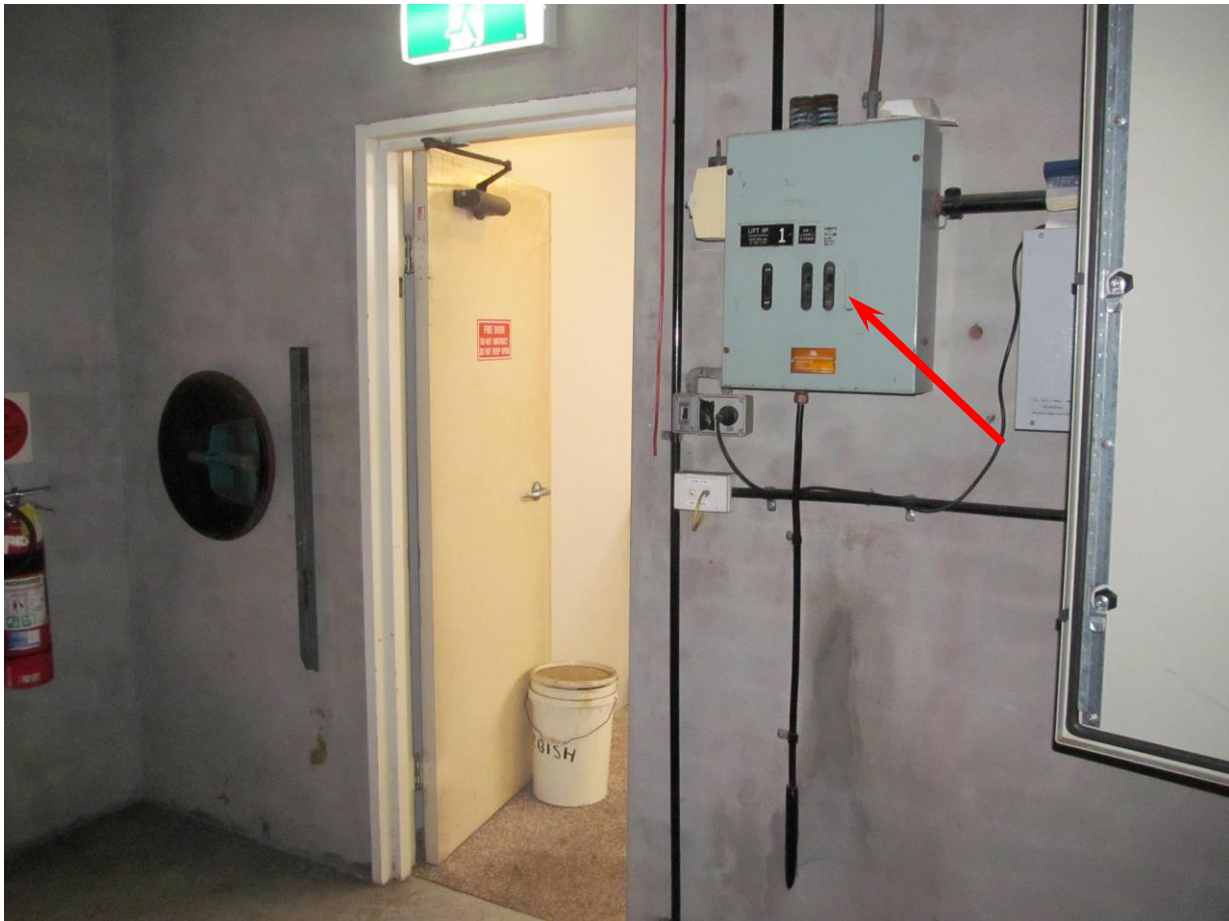
Photograph A12

Description: The red arrow points to electrical equipment.

Recommendation: Leave and maintain in good condition. Confirm asbestos status prior to refurbishment or demolition

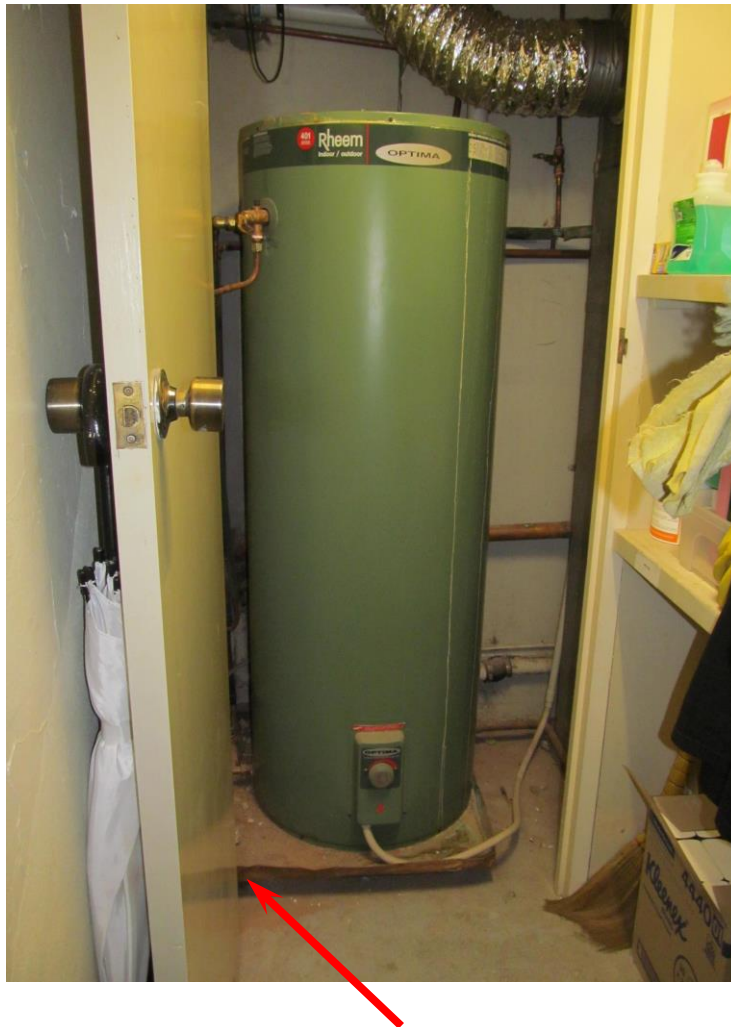
Photograph A13

Description: The red arrow points to flat asbestos cement sheet.

Recommendation: Leave and maintain in good condition.

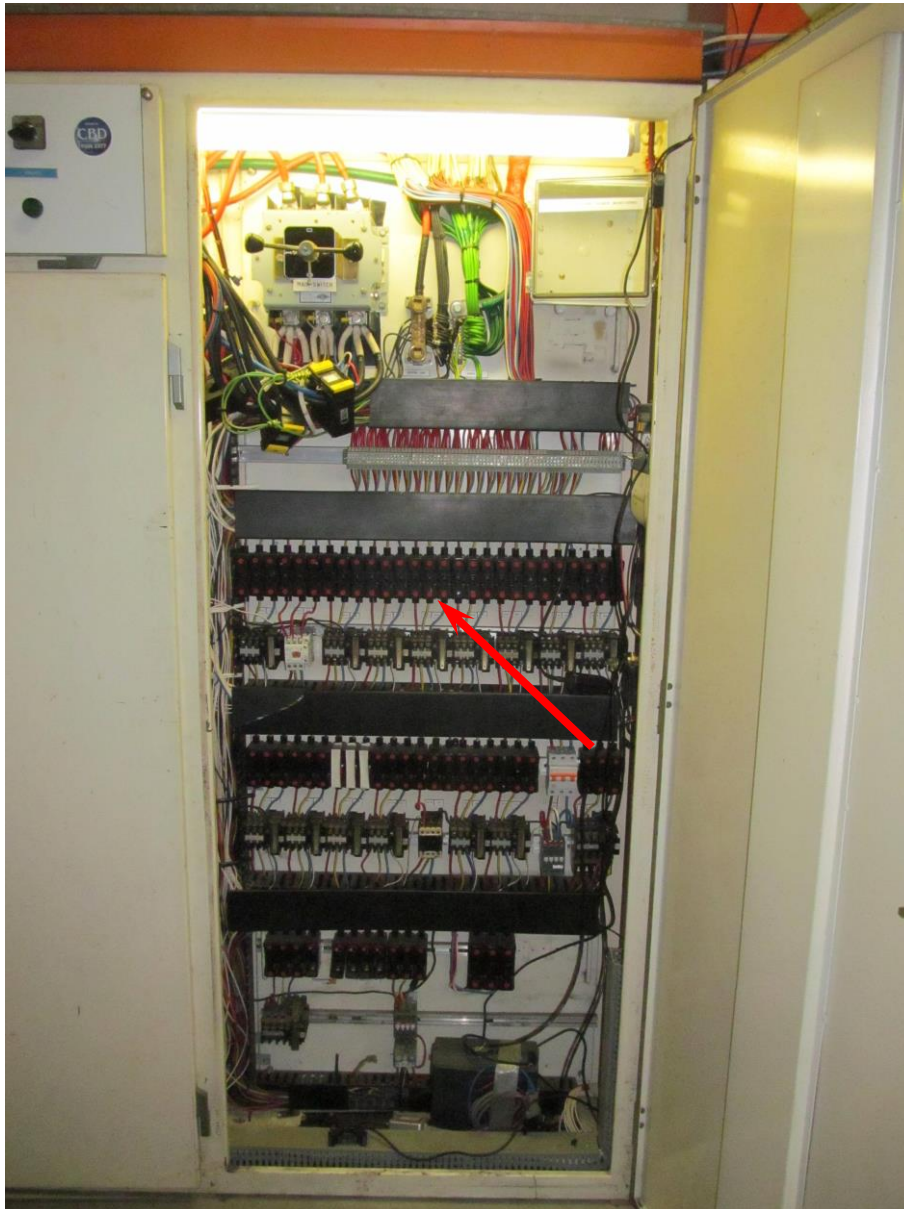
Photograph A14

Description: The red arrow points to electrical equipment.

Recommendation: Leave and maintain in good condition.

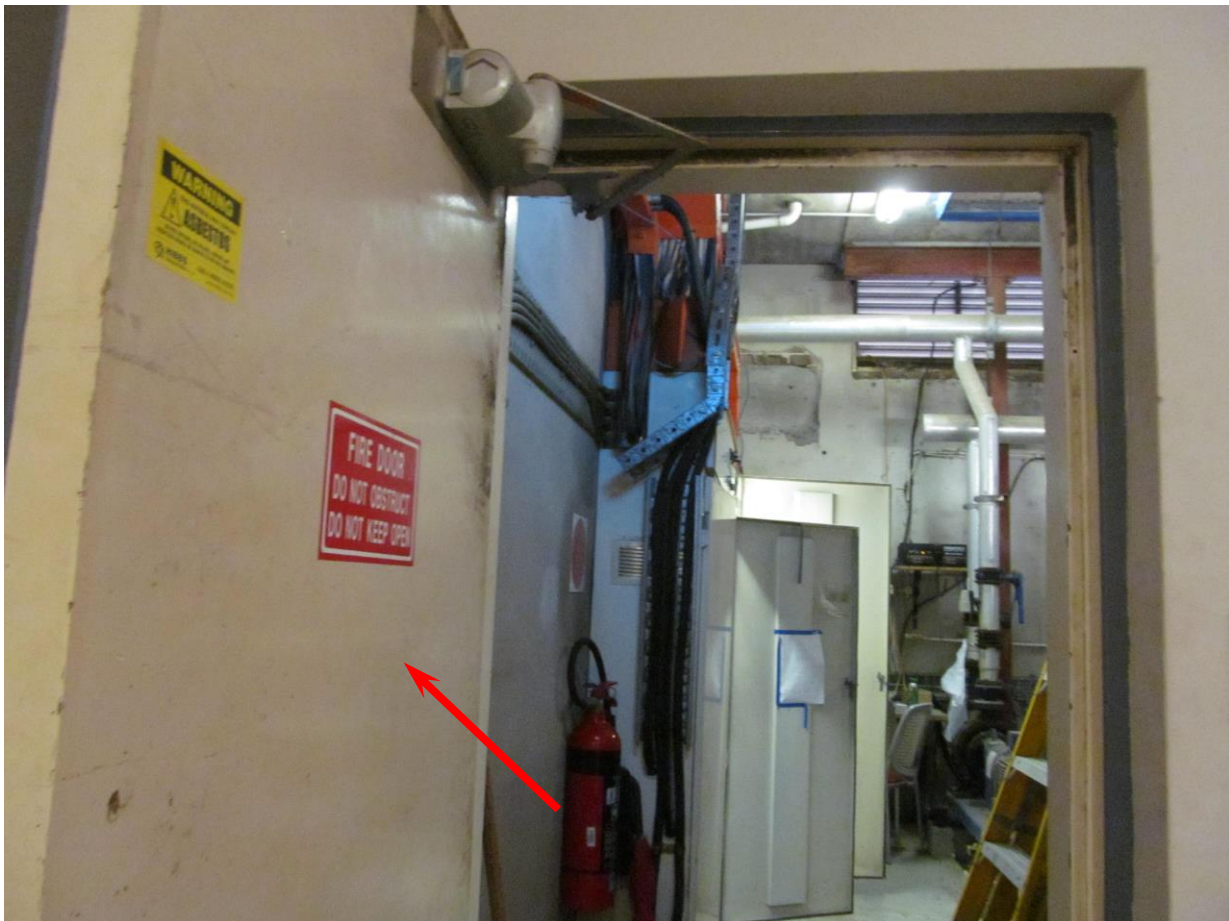
Photograph A15

Description: The red arrow points to a fire door.

Recommendation: Leave and maintain in good condition.

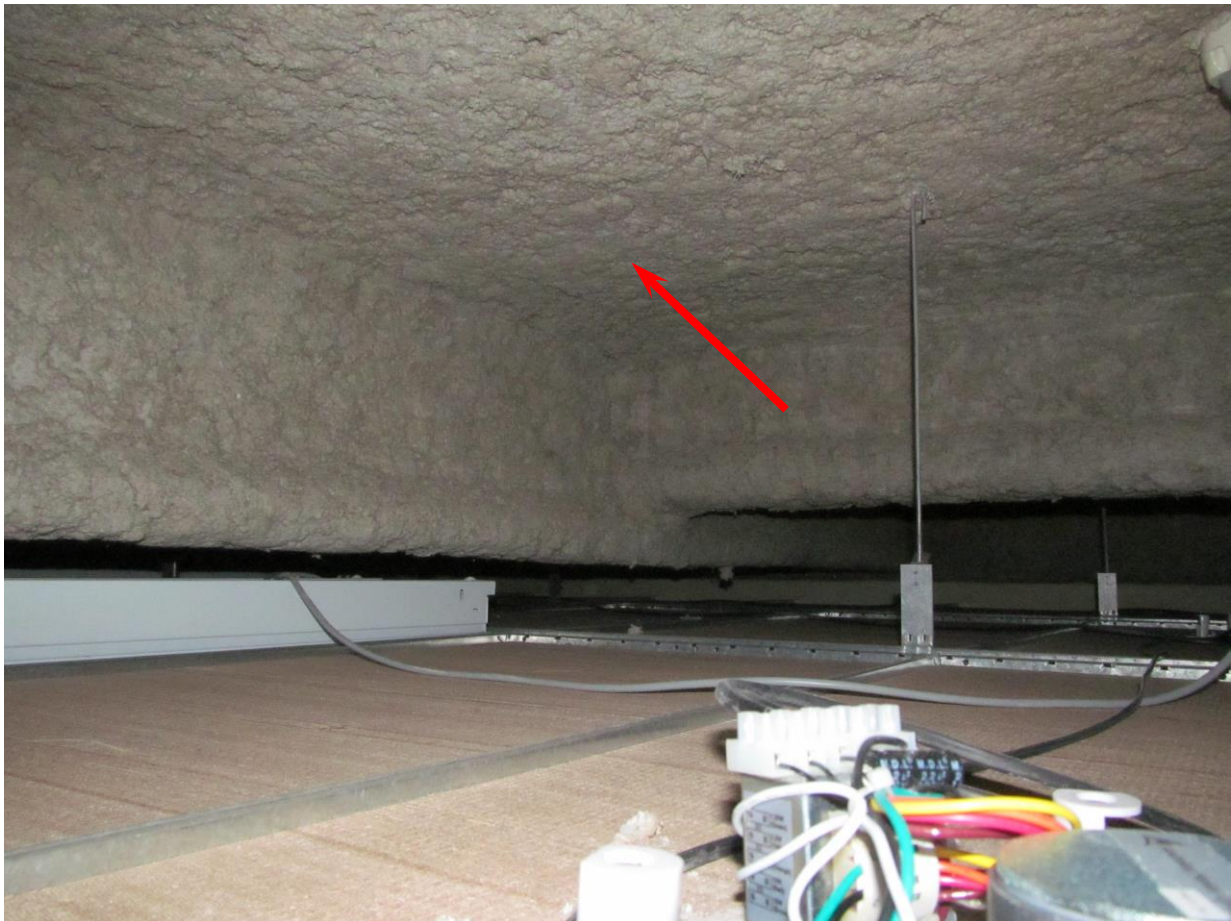
Photograph S01

Description: The red arrow points to unbonded synthetic mineral fibre material.

Recommendation: Leave and maintain in good condition.

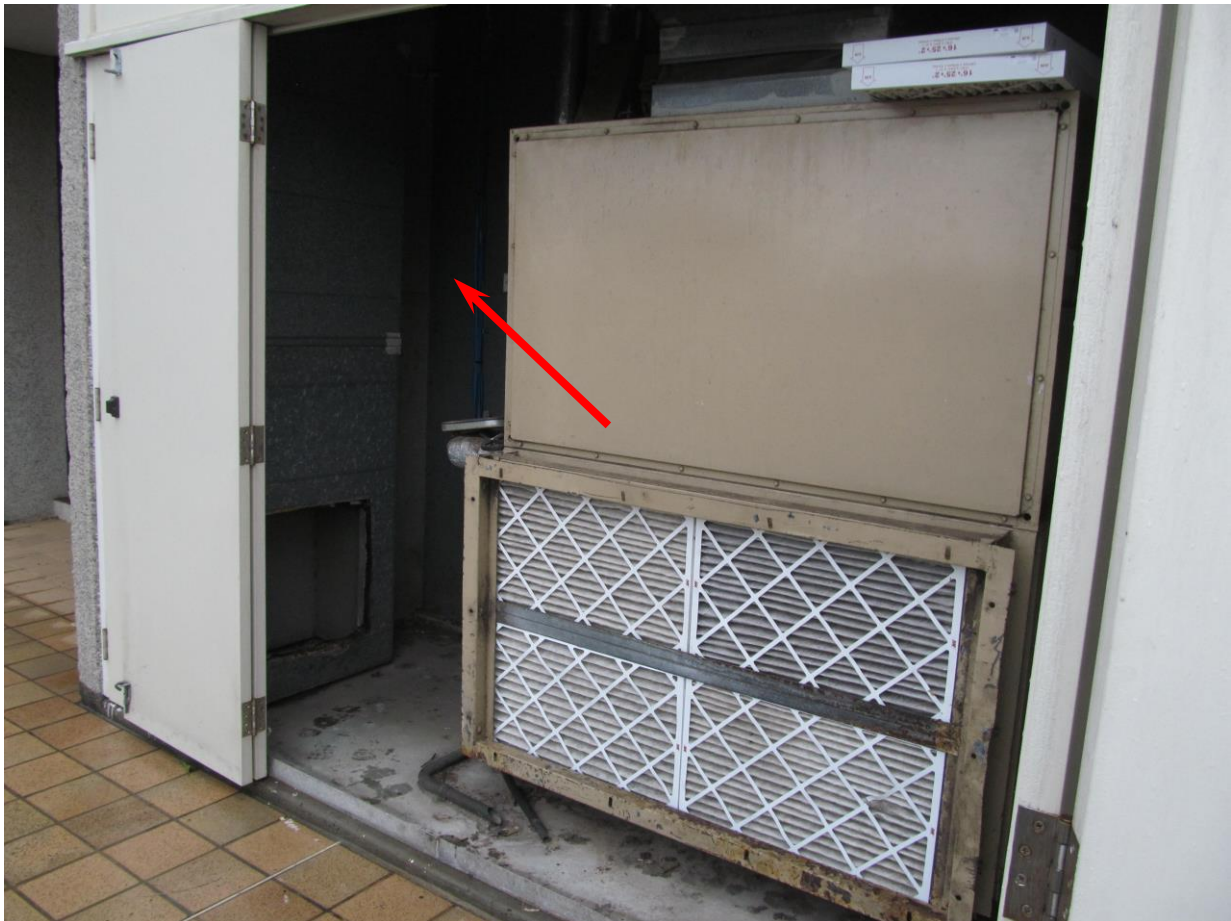
Photograph S02

Description: The red arrow points to bonded synthetic mineral fibre material.

Recommendation: Leave and maintain in good condition. Confirm asbestos status prior to refurbishment or demolition

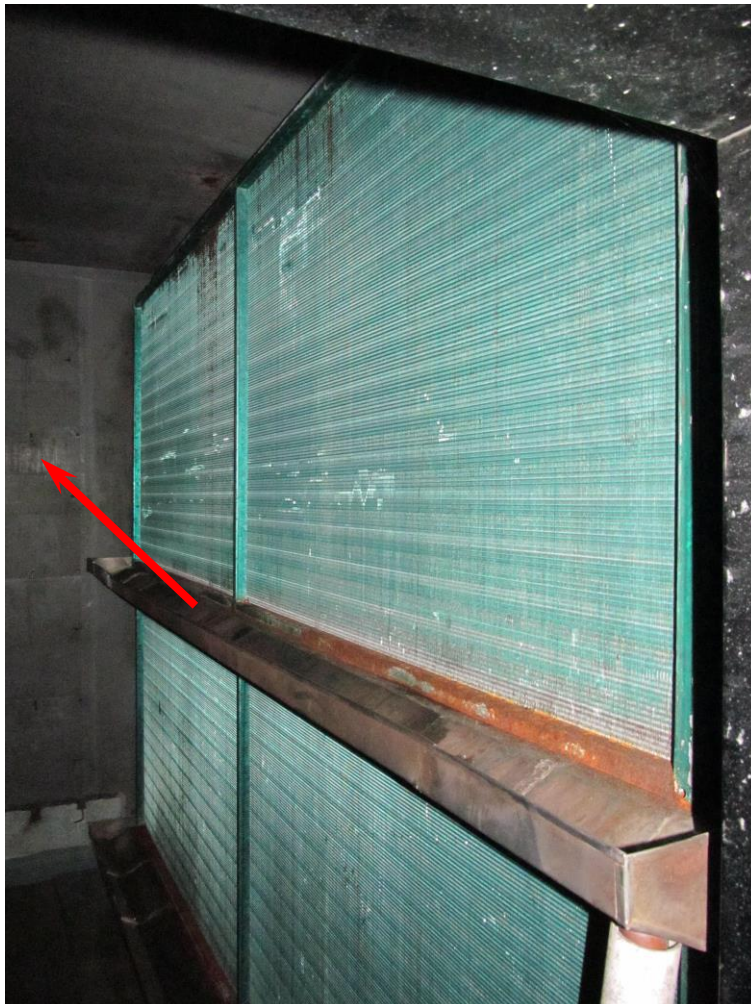
Photograph S03

- Site: Waverley Council Chambers.
- Location: Plant room, AHU fan room, wall and ceiling insulation behind perforated metal sheeting.
- Description: The red arrow points to bonded synthetic mineral fibre material.
- Recommendation: Leave and maintain in good condition. Confirm asbestos status prior to refurbishment or demolition

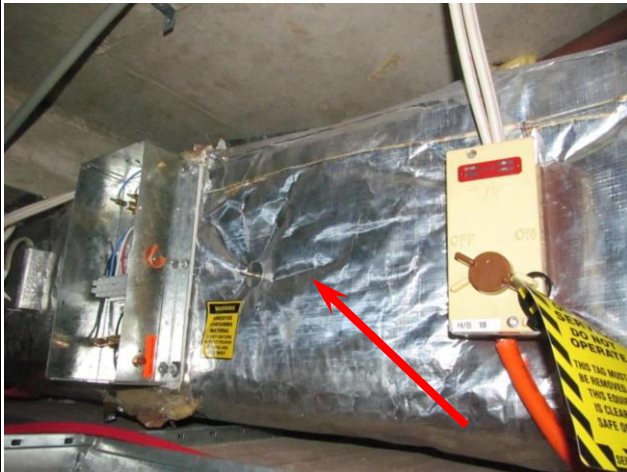
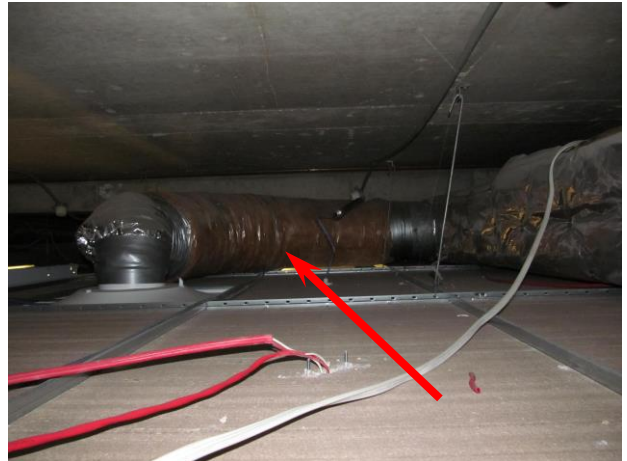
Photograph S04

Description: The red arrow points to insulation on fixed and flexible ductwork.

Recommendation: Leave and maintain in good condition. Confirm asbestos status prior to refurbishment or demolition

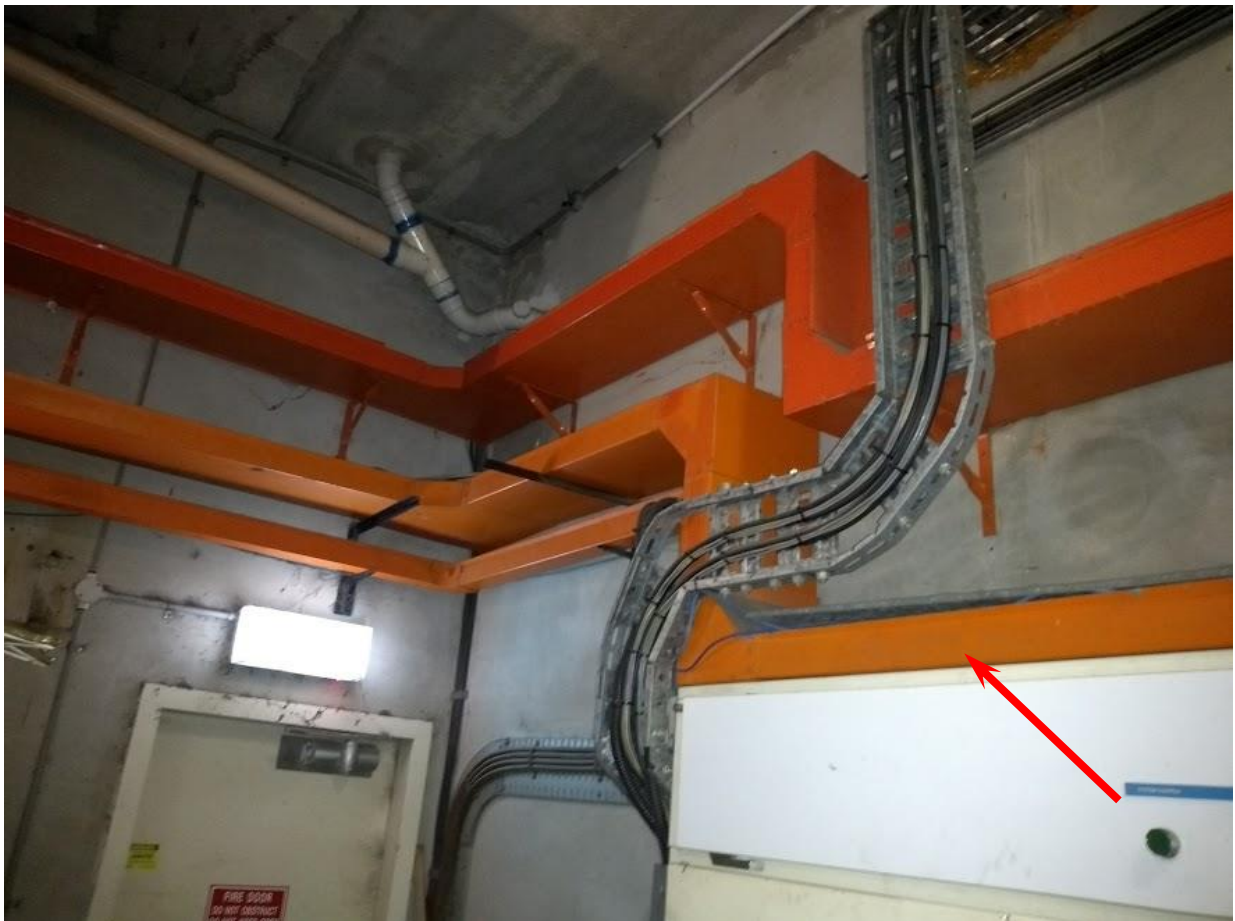
Photograph Pb01

Description: The red arrow points to orange coloured lead based paint system.

Recommendation: No Remedial Action Required

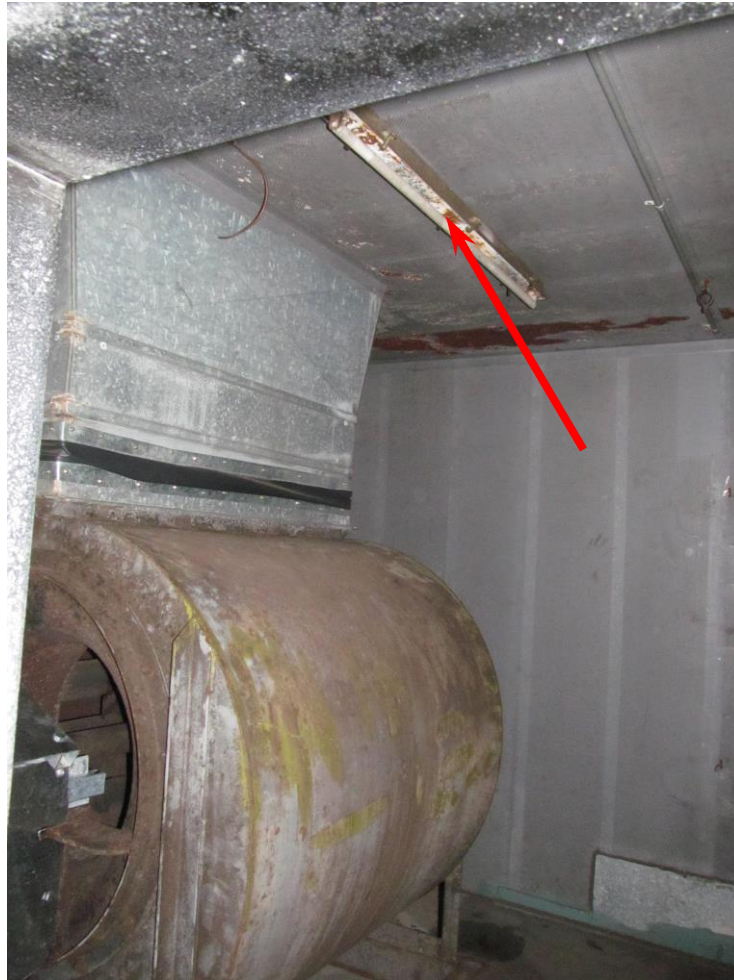
Photograph PCB01

A fluorescent light fitting in the AHU fan room within the plant room could not be accessed due to the disintegration of the light fitting with rust. This light fitting may contain PCBs. No visual evidence of PCB oil leakage was noted.

Description: The red arrow points to single tube surface mounted fluorescent light fitting - unknown - may contain PCBs - rusted shut.

Recommendation: Leave and maintain in good condition.
