# Curlew Street Streetscape Upgrade

## Pre-Construction Detailed Design Road Safety Audit

# Curlewis Street Streetscape Upgrade – Old South Head Road to Campbell Parade

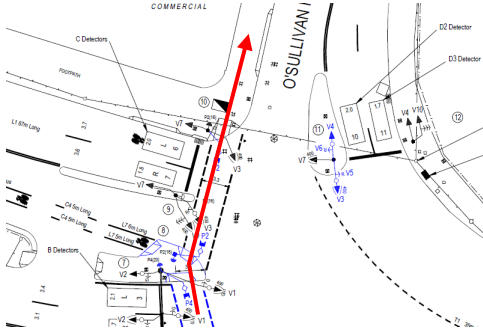
| Item No. | Location | Descriptions of Findings | Design/ Photo | Likelihood | Severity | Risk Rating | Designer Response |
|---|---|---|---|---|---|---|---|
| 1 | West side of O'Sullivan Road | <p>The cycleway design does not integrate with O'Sullivan Road in the northbound direction north of Old South Head Road. There is no shared use path on the west side of O'Sullivan Road north of Old Sullivan Road. Further, there is no bike ramp to enable a connection with O'Sullivan Road.</p> <p>This may result in cyclists continue cycling on the footpath, which would increase the likelihood of pedestrian/cyclist conflict. Alternatively, cyclists may rejoin O'Sullivan Road, however there is no delineation to inform northbound O'Sullivan Road motorists.</p> <p>It is noted that using a property driveway to connect with the roadway is considered unsafe due to the conflict with vehicles travelling into and out of the driveway.</p> | | Unlikely | Moderate | Medium | |

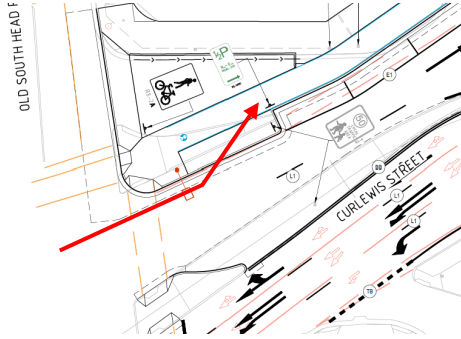
| Item No. | Location | Descriptions of Findings | Design/ Photo | Likelihood | Severity | Risk Rating | Designer Response |
|---|---|---|---|---|---|---|---|
| 2 | Various locations in Curlewis Street | <p>Confident cyclists cycling eastbound on Curlewis Street may avoid crossing points east of Old South Head Road, however they may want to connect with the shared path after the intersection.</p> <p>There is no provision of a bike ramp at the identified locations for on-road cyclists to access the shared path.</p> | | | | Note only | |

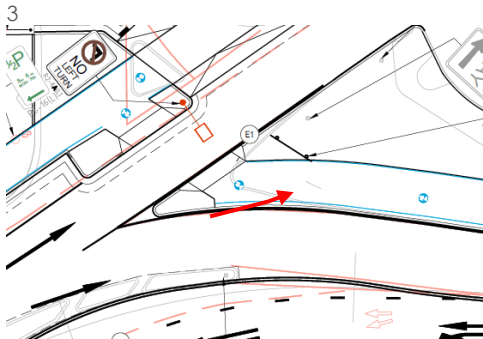
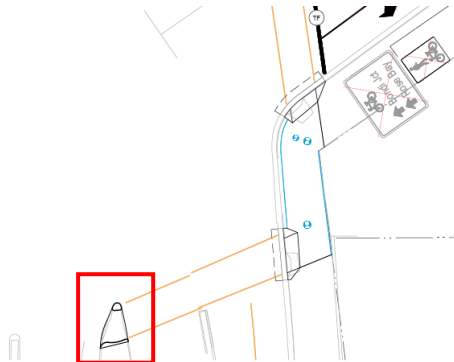
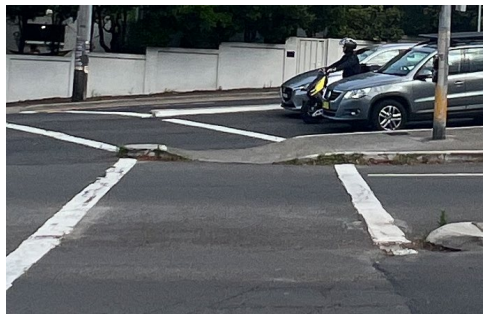
| Item No. | Location | Descriptions of Findings | Design/ Photo | Likelihood | Severity | Risk Rating | Designer Response |
|---|---|---|---|---|---|---|---|
| 3 | Old South Head Road | <p>The central median is about 2.2m wide but narrows at the tip, which is insufficient to fully accommodate more than one bicycle (or pedestrian with a pram) at a time waiting to across Old South Head Road (south leg).</p> <p>Cyclists may be caught in the central median towards the end of the walk clearance time. If the central median cannot contain the cyclist or pedestrian with a pram, this would expose them to passing traffic, and hence increase the risk of an incident.</p> | | Rare | Moderate | Low | |

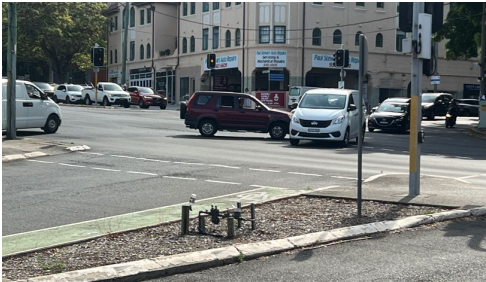
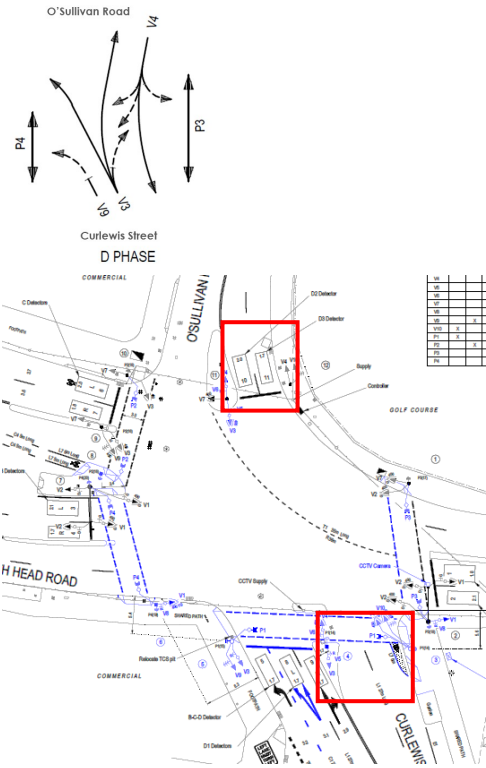
| Item No. | Location | Descriptions of Findings | Design/ Photo | Likelihood | Severity | Risk Rating | Designer Response |
|---|---|---|---|---|---|---|---|
| 4 | Old South Head Road, Curlewis Street, O'Sullivan Road and Birriga Road intersection | <p>The intersection of Old South Head Road, Curlewis Street, O'Sullivan Road and Birriga Road intersection is complicated as a five-way intersection.</p> <p>A near miss involving a right turning vehicle from Curlewis Street running into a vehicle from O'Sullivan Road was observed whilst on-site.</p> <p>Furthermore, it appears there are two departure lanes in Curlewis Street. In conjunction with the undefined lane discipline in O'Sullivan Road, this may result in vehicles travelling straight through the intersection from O'Sullivan Road towards the two departure lanes in Curlewis Street.</p> <p>This would make the filtered right turn movement more difficult to make against two lanes of through traffic, as opposed to one through lane under the existing condition. This may increase the likelihood of through/right collisions.</p> | <br> | Unlikely | Minor | Low | |

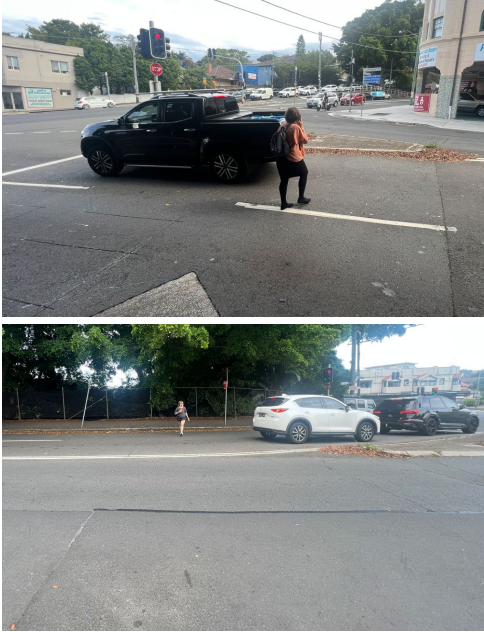
| Item No. | Location | Descriptions of Findings | Design/ Photo | Likelihood | Severity | Risk Rating | Designer Response |
|---|---|---|---|---|---|---|---|
| 5 | O'Sullivan Road | <p>There is no provision of a signalised pedestrian crossing in O'Sullivan Road to accommodate the pedestrian desire line in the north-south direction.</p> <p>This may result in pedestrians mixing with traffic when crossing the road, which may lead to vehicle-pedestrian collisions.</p> | | Unlikely | Moderate | Medium | |

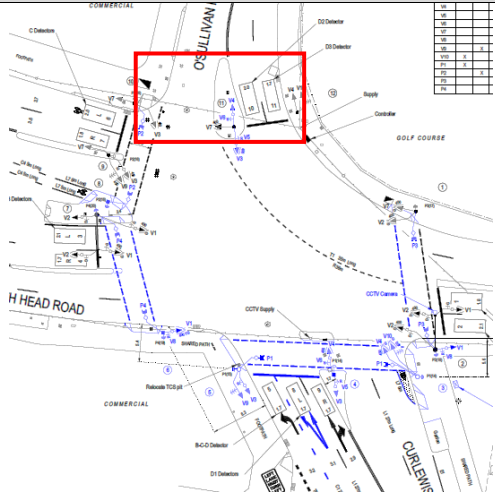
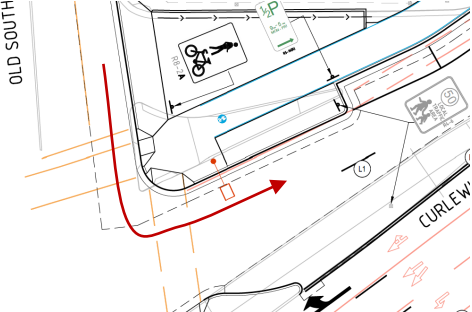
| Item No. | Location | Descriptions of Findings | Design/ Photo | Likelihood | Severity | Risk Rating | Designer Response |
|---|---|---|---|---|---|---|---|
| 6 | Old South Head Road, Curlew Street, O'Sullivan Road and Birriga Road intersection | <p>The swept path assessment does not include the left turn movement from Old South Head Road to Curlew Street.</p> <p>It is not clear whether sufficient clearance is available to accommodate the left turn movement as a result of removing the left turn slip lane.</p> | | - | - | Note only | |

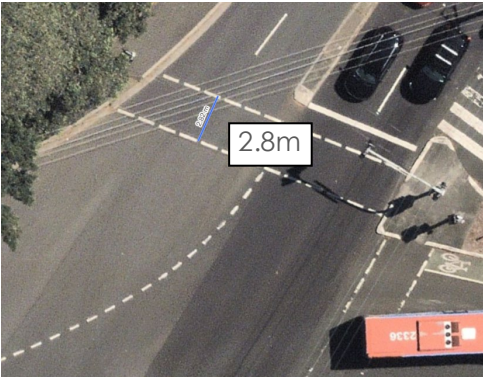
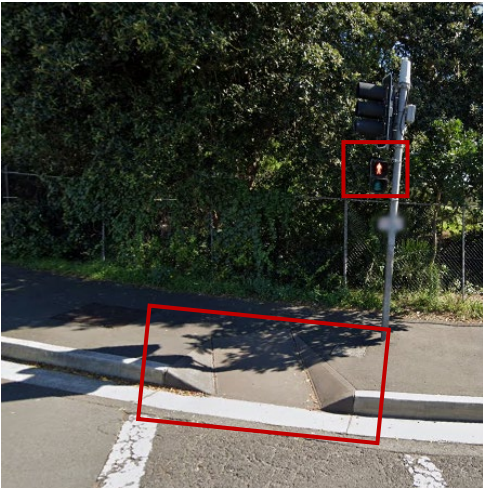
| Item No. | Location | Descriptions of Findings | Design/ Photo | Likelihood | Severity | Risk Rating | Designer Response |
|---|---|---|---|---|---|---|---|
| 7 | Old South Road, Curlewis Street and O'Sullivan Road intersection | <p>The design does not include an upgrade of the marked footpath crossing in Old South Road to enable a safe connection between the proposed shared use path on Curlewis Street and the existing one on O'Sullivan Road:</p> <ul style="list-style-type: none"> <li>The existing marked footpath crossing is 2.8m wide, which is less than the minimum requirement of 3.6m based on the TfNSW Delineation Guide.</li> <li>The existing kerb ramp at the north-western corner of the intersection is too narrow to accommodate both pedestrians and cyclists across Old South Head Road.</li> </ul> <p>Consequently, this may increase the likelihood of conflicts between cyclists and pedestrians using the crossing. Users may also travel outside the marked foot crossing which may lead to potential conflicts with passing vehicles.</p> | <br> | Unlikely | Minor | Low | |

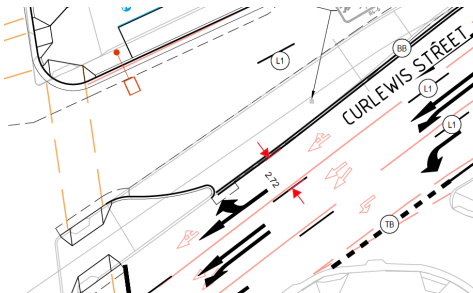
| Item No. | Location | Descriptions of Findings | Design/ Photo | Likelihood | Severity | Risk Rating | Designer Response |
|---|---|---|---|---|---|---|---|
| 8 | Old South Road and Curlewis Street intersection | <p>The shared through and right turn lane on Curlewis Street westbound is 2.7m wide, and may not be sufficient to accommodate the design vehicle along the curve towards the intersection, noting that the existing central median will be replaced by a double barrier line.</p> <p>Vehicles not staying within the lane may result in a side-swipe incident with vehicles in the adjacent lane.</p> | | Unlikely | Minor | Low | |

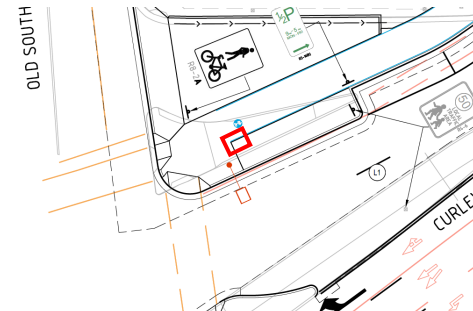
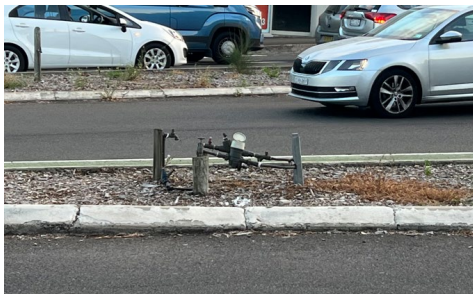
| Item No. | Location | Descriptions of Findings | Design/ Photo | Likelihood | Severity | Risk Rating | Designer Response |
|---|---|---|---|---|---|---|---|
| 9 | Curlewis Street west of Old South Head Road | <p>Utilities located within the future shared path area, if retained, will become hazardous to pedestrians and cyclists.</p> | | Unlikely | Minor | Low | |

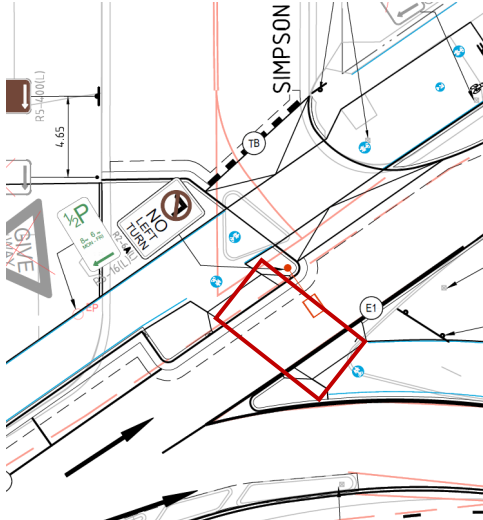
| Item No. | Location | Descriptions of Findings | Design/ Photo | Likelihood | Severity | Risk Rating | Designer Response |
|---|---|---|---|---|---|---|---|
| 10 | Curlewis Street and Blair Street intersection | <p>The design does not provide a crossing facility nor priority for shared path users at the crossing point in Blair Street.</p> <p>This crossing is located immediately following a diverge point.</p> <p>This may increase the risk of collisions with shared path users.</p> | | Unlikely | Minor | Low | |

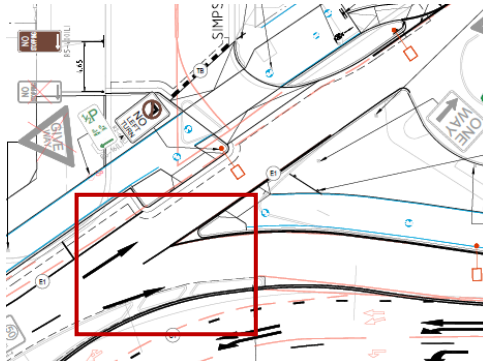
| Item No. | Location | Descriptions of Findings | Design/ Photo | Likelihood | Severity | Risk Rating | Designer Response |
|---|---|---|---|---|---|---|---|
| 11 | Diverge Point to Blair Street on Curlewis Street | <p>Drivers may not be aware of the diverge point on Curlewis Street as a result of the following issues:</p> <ul style="list-style-type: none"> <li>Pavement arrows give late notice of the split in traffic, road users not familiar with the area may make a late lane change to avoid taking the wrong turn.</li> <li>The gore area is not well delineated with insufficient line marking and signage to emphasise its presence.</li> </ul> <p>Late lane change may cause turbulence in the traffic stream, which may increase the risk in side-swipe and rear-end collisions.</p> | | Unlikely | Moderate | Medium | |

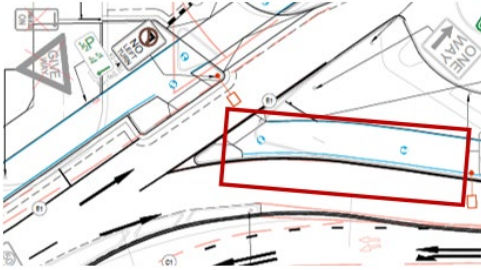
| Item No. | Location | Descriptions of Findings | Design/ Photo | Likelihood | Severity | Risk Rating | Designer Response |
|---|---|---|---|---|---|---|---|
| 12 | Curlewis Street east of Blair Street | <p>The proposed shared path is located directly behind the kerbline along the curve in Curlewis Street with no buffer / offset from passing traffic.</p> <p>There is a risk of errant vehicles traversing the shared path, which may result in conflicts with pedestrians and cyclists.</p> | | Unlikely | Moderate | Medium | |

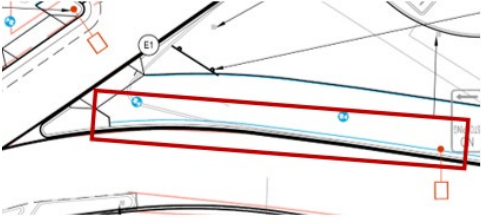
| Item No. | Location | Descriptions of Findings | Design/ Photo | Likelihood | Severity | Risk Rating | Designer Response |
|---|---|---|---|---|---|---|---|
| 13 | Curlewis Street east of Blair Street | <p>There is no provision of physical separation from the travel lane along the outside of the curve. This would leave pedestrians and cyclists unprotected on the shared use path.</p> <p>This would increase the likelihood of conflicts between an errant vehicle and shared path users.</p> | | Rare | Moderate | Low | |

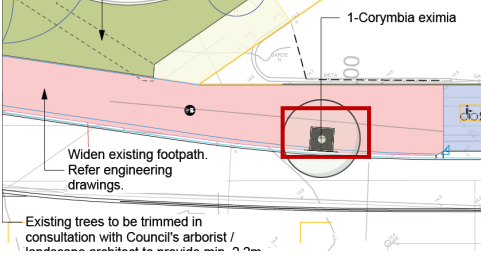
| Item No. | Location | Descriptions of Findings | Design/ Photo | Likelihood | Severity | Risk Rating | Designer Response |
|---|---|---|---|---|---|---|---|
| 14 | Curlewis Street, east of Blair Street | <p>The proposed new tree (Corymbia eximia) is located within the shared path which could obstruct visibility towards approaching shared path users.</p> <p>The tree and the pit would also reduce the effective width of the shared path and impede the travel path of a cyclist.</p> <p>This may increase the likelihood of cyclist-pedestrian conflicts.</p> | <br> | Unlikely | Minor | Low | |

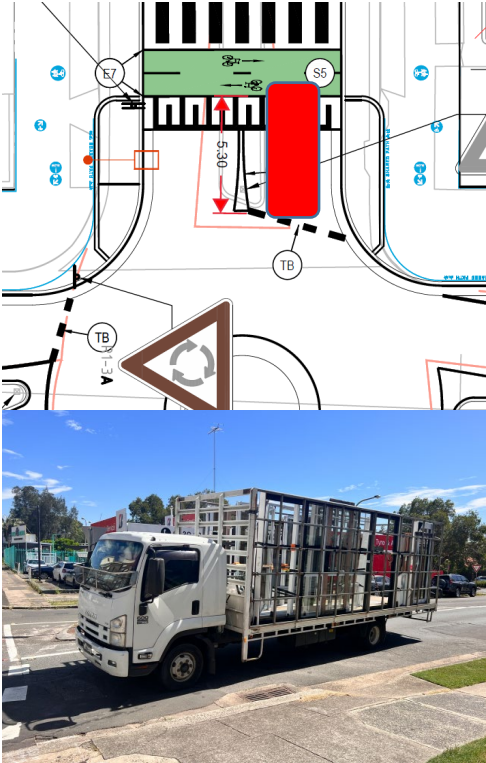
| Item No. | Location | Descriptions of Findings | Design/ Photo | Likelihood | Severity | Risk Rating | Designer Response |
|---|---|---|---|---|---|---|---|
| 16 | Wellington Street – Pedestrian Crossing | There does not appear to be 6m between the give way line marking on the Wellington Street north approach and the cycleway crossing. Consequently, vehicles may encroach the cycleway crossing which may lead to conflict with cyclists. This safety concern is exacerbated when a large vehicle waits at the give way line. | | Rare | Moderate | Low | |

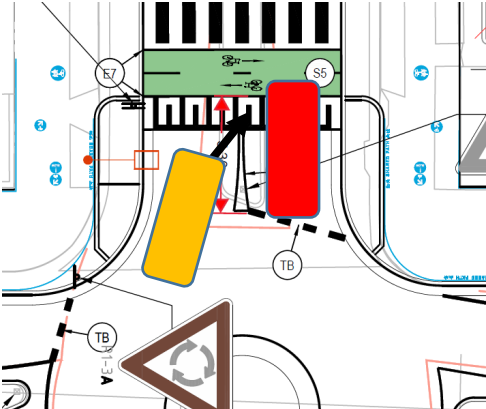
| Item No. | Location | Descriptions of Findings | Design/ Photo | Likelihood | Severity | Risk Rating | Designer Response |
|---|---|---|---|---|---|---|---|
| 17 | Wellington Street – Pedestrian Crossing | <p>Motorists waiting on the Wellington Street north approach to the roundabout may restrict the visibility of motorists traveling northbound on Wellington Street towards cyclists and pedestrians crossing Wellington Street.</p> <p>This would increase the likelihood of conflicts with cycleway and pedestrian crossing users at this location.</p> <p>If the pedestrian and cycle crossing is busy, the roundabout operation may become gridlocked which may lead to driver frustration and illogical driver behaviour.</p> | | Unlikely | Moderate | Medium | |

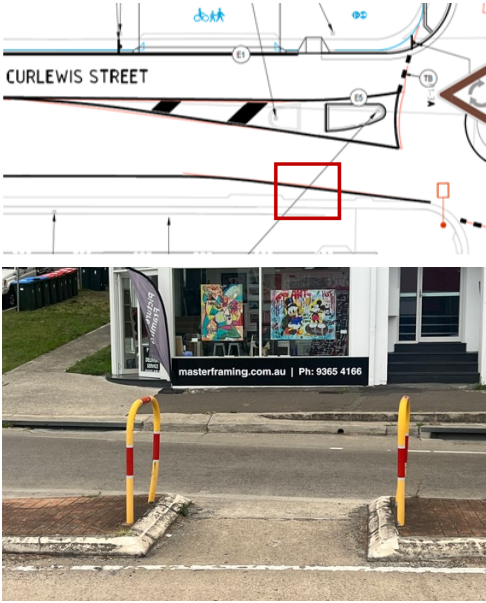
| Item No. | Location | Descriptions of Findings | Design/ Photo | Likelihood | Severity | Risk Rating | Designer Response |
|---|---|---|---|---|---|---|---|
| 18. | Wellington Street, Curlewis Street roundabout | <p>No kerb ramp has been provided on the south side of the west leg of the Wellington Street and Curlewis Street roundabout.</p> <p>Absence of the kerb ramp would not provide a smooth transition between the roadway and footpath for pedestrians with prams and in wheelchairs. They may walk in the roadway and cause conflicts with passing vehicles.</p> | | Rare | Moderate | Low | |

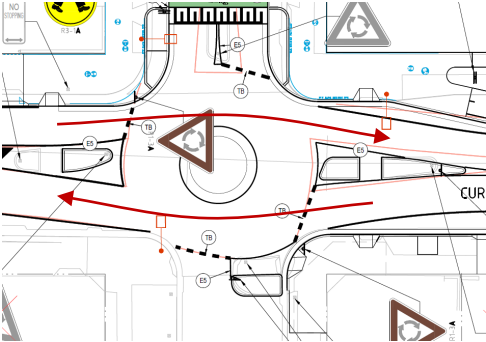
| Item No. | Location | Descriptions of Findings | Design/ Photo | Likelihood | Severity | Risk Rating | Designer Response |
|---|---|---|---|---|---|---|---|
| 19 | Wellington Street, Curlewis Street roundabout | <p>Kerb build-outs on both Curlewis Street approaches to Wellington Street provide little deflection for motorists heading westbound and eastbound on Curlewis Street.</p> <p>Vehicle speeds may remain high when travelling through the roundabout, and increase the likelihood of collisions with other road users.</p> | | Rare | Moderate | Low | |

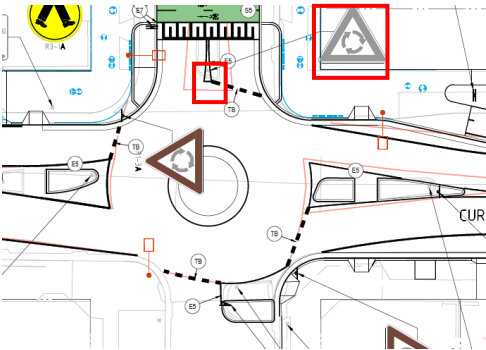
| Item No. | Location | Descriptions of Findings | Design/ Photo | Likelihood | Severity | Risk Rating | Designer Response |
|---|---|---|---|---|---|---|---|
| 20 | Wellington Street, Curlewis Street roundabout | <p>An existing 'Roundabout Give Way' sign would be located within a small painted median island on the north leg of the roundabout.</p> <p>The signpost could be knocked down by turning vehicles in the absence of a raised median island, as shown in the swept path diagram. This could cause damage to other vehicles.</p> <p>Subsequently, this could also result in vehicles not noticing the signage and stopping after the give way line marking which could result in an incident.</p> | | Unlikely | Moderate | Medium | |

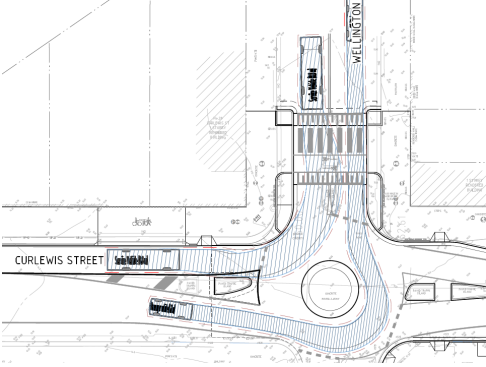
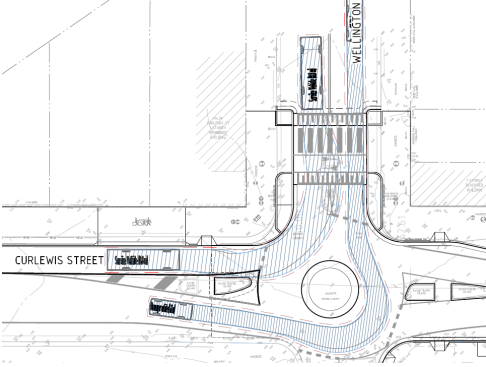
| Item No. | Location | Descriptions of Findings | Design/ Photo | Likelihood | Severity | Risk Rating | Designer Response |
|---|---|---|---|---|---|---|---|
| 21 | Wellington Street, Curlewis Street roundabout | <p>The swept path of the Curlewis Street to Wellington Street left turn movement encroaches the centreline and painted island in Wellington Street, which would be impeded by a southbound vehicle if it sits in the middle of the travel lane, as opposed to the swept path diagram that shows the southbound vehicle hugging the kerbline.</p> <p>As a result, this may increase the likelihood of side-swipe conflicts.</p> | <br> | Unlikely | Moderate | Medium | |

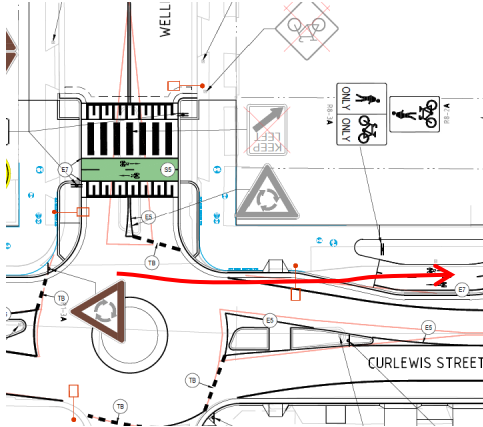
| Item No. | Location | Descriptions of Findings | Design/ Photo | Likelihood | Severity | Risk Rating | Designer Response |
|---|---|---|---|---|---|---|---|
| 22 | Wellington Street, Curlewis Street roundabout | <p>Confident cyclists cycling eastbound on Curlewis Street may avoid the shared path facility west of Wellington Street, however they may want to connect with the cycleway when it transitions to a bi-directional cycleway.</p> <p>There is a lack of a bike ramp to enable the connection to the cycleway.</p> | | - | - | Note only | |

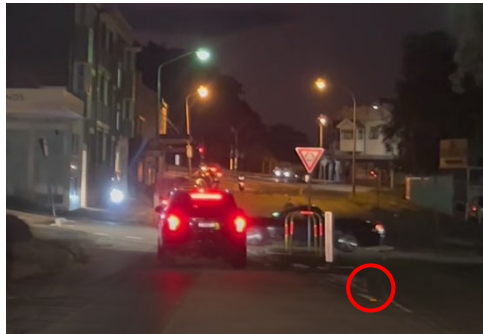
| Item No. | Location | Descriptions of Findings | Design/ Photo | Likelihood | Severity | Risk Rating | Designer Response |
|---|---|---|---|---|---|---|---|
| 23 | Wellington Street, Curlewis Street roundabout | <p>The design plan does not indicate whether the existing Raised Retro-Reflective Pavement Markers (RRPM) would be replaced to delineate the shifted centreline in Curlewis Street, on approach to the Wellington Street roundabout.</p> | | | | Note only | |

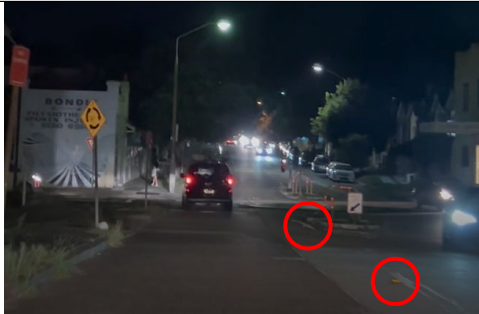
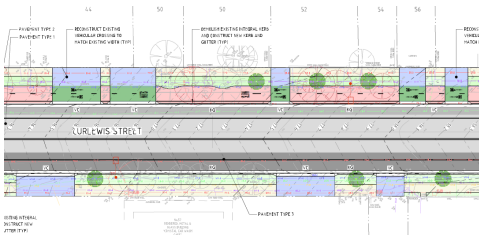
| Item No. | Location | Descriptions of Findings | Design/ Photo | Likelihood | Severity | Risk Rating | Designer Response |
|---|---|---|---|---|---|---|---|
| 24 | General finding | <p>There are several driveways along the route where motorists will be required to reverse across the proposed cycleway as there is insufficient area on-site to enter and exit in a forward direction.</p> <p>Inter-visibility between a cyclist and a driver turning into the driveway from Curlewis Street may be obstructed by vehicles parked in the parking lane.</p> <p>A motorist may not have full visibility of oncoming cyclists when reversing which may lead to them reversing into cyclists.</p> <p>Furthermore, vehicles awaiting a gap in traffic at a driveway may impede both directions of the cycleway. Likewise, vehicles entering a driveway from Curlewis Street may also impede the cycleway when they yield to pedestrians in the footpath.</p> <p>There is a potential risk to cyclists if motorists failed to cross the cycleway at an appropriate and safe time.</p> | | Unlikely | Moderate | Medium | |

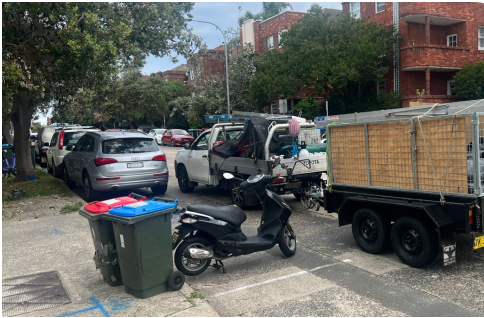
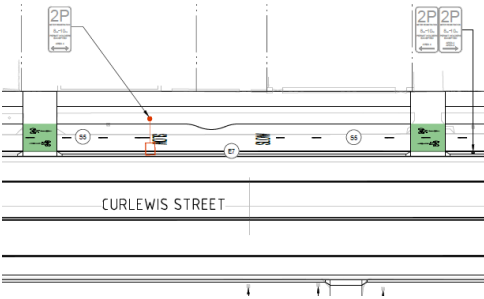
| Item No. | Location | Descriptions of Findings | Design/ Photo | Likelihood | Severity | Risk Rating | Designer Response |
|---|---|---|---|---|---|---|---|
| 25 | General finding | <p>It was observed on many occasions that delivery vehicles double park within the travel lane when kerbside parking is not available.</p> <p>Under the existing condition, vehicles would overtake the stationary vehicle by partially encroaching into the travel lane in the opposite direction, in the absence of a centreline.</p> <p>The proposed scheme would narrow the travel lanes with provision of a double barrier centreline. Motorists are not legally allowed to encroach the centreline to overtake the stationary delivery vehicles.</p> <p>However, it is likely that some motorists may breach the road rule by crossing over the double barrier line. This would increase the likelihood of a side-swipe collision due to the reduced buffer in the narrowed travel lanes.</p> | <br> | Unlikely | Moderate | Medium | |

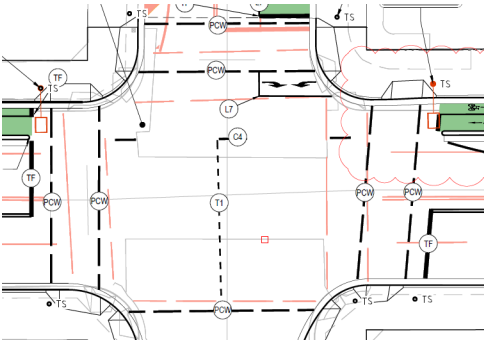
| Item No. | Location | Descriptions of Findings | Design/ Photo | Likelihood | Severity | Risk Rating | Designer Response |
|---|---|---|---|---|---|---|---|
| 26 | Glenayr Avenue and Curlewis Street intersection | <p>The hook turn bay is 4 to 5.2m long to accommodate eastbound cyclists waiting to turn right, and westbound cyclists waiting to turn left towards Glenayr Avenue southbound.</p> <p>Considering Austroads require 3m for the hook turn bay (one direction), the proposed bay is too short to accommodate two bicycles in opposite directions. This may result in conflicts between cyclists, or cyclists storing outside the hook turn bay.</p> <p>Furthermore, the hook turn bay has no bicycle line marking (i.e. green paint and</p> | | Unlikely | Minor | Low | |

| Item No. | Location | Descriptions of Findings | Design/ Photo | Likelihood | Severity | Risk Rating | Designer Response |
|---|---|---|---|---|---|---|---|
| | | <p>bike symbol) and therefore may not be used correctly. Cyclists may ignore this and will use a conventional right-turn which has a greater risk of collision with vehicles.</p> <p>Of note, hook turns can be used as an alternative to a conventional right-turn from the centre of the road under the <i>Australian Road Rules (National Transport Commission 2012)</i>, however, there is no mention of left turn hook turns within the Austroads Guide.</p> <p>Lastly, consideration should be given to providing a hook turn for the Glenayr Avenue to Curlewis Street right turn movement.</p> | | | | | |

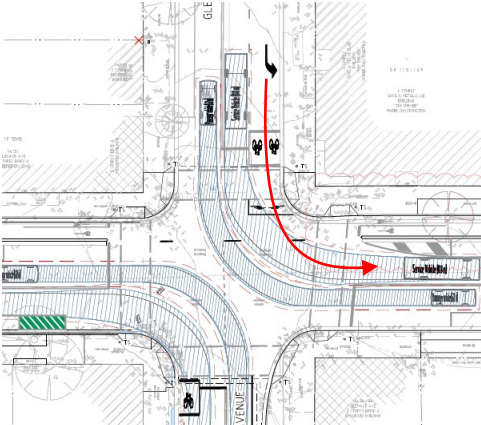
| Item No. | Location | Descriptions of Findings | Design/ Photo | Likelihood | Severity | Risk Rating | Designer Response |
|---|---|---|---|---|---|---|---|
| 27 | Glenayr Avenue and Curlewis Street intersection | <p>The swept path assessment shows the left turn movement being made from the second lane (median lane) on Glenayr Avenue onto Curlewis Street rather than straddling both lanes. Consequently, motorists turning left from the kerbside lane may conflict with motorists turning left from the median lane.</p> | | Unlikely | Moderate | Medium | |

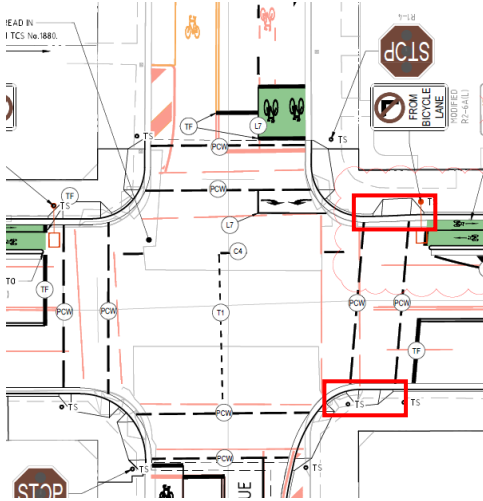
| Item No. | Location | Descriptions of Findings | Design/ Photo | Likelihood | Severity | Risk Rating | Designer Response |
|---|---|---|---|---|---|---|---|
| 28 | Curlewis Street, east leg at the Glenayr Avenue intersection | <p>The proposed kerb ramps are 2.3m wide in Curlewis Street and do not extend the full width of the marked foot crossings which are about 3.6m wide on Curlewis Street.</p> <p>RMS Guide to Traffic Signals Appendix D suggests kerb ramps should ideally be the full width of the crossing.</p> | | | | Note only | |

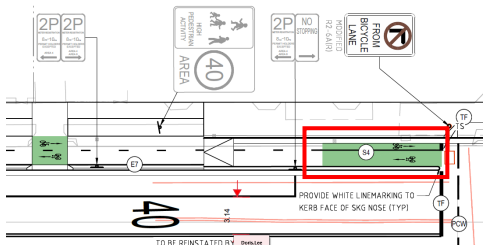
| Item No. | Location | Descriptions of Findings | Design/ Photo | Likelihood | Severity | Risk Rating | Designer Response |
|---|---|---|---|---|---|---|---|
| 29 | Curlewis Street, west leg at the Glenayr Avenue intersection | <p>The width of the eastbound cycleway appears too narrow and is inconsistent with the width of the upstream cycleway. It could be a CAD error.</p> | | | | Note only | |

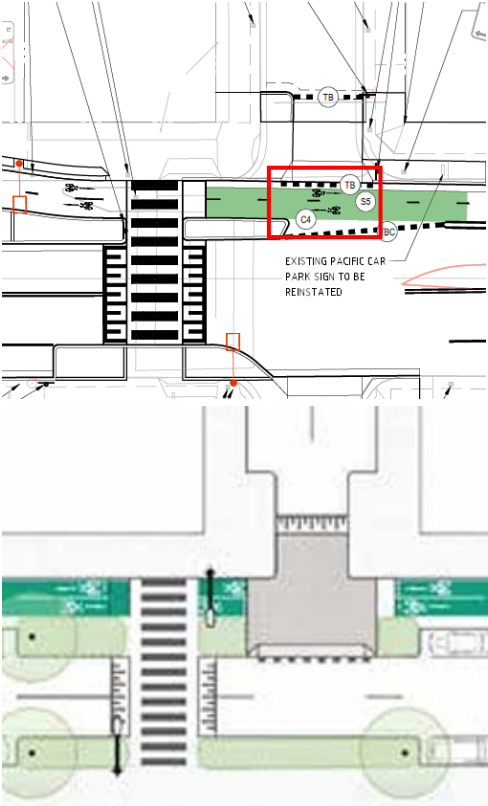
| Item No. | Location | Descriptions of Findings | Design/ Photo | Likelihood | Severity | Risk Rating | Designer Response |
|---|---|---|---|---|---|---|---|
| 30 | Gould Street – north approach | <p>The cycleway is not included in the raised continuous footpath treatment.</p> <p>An example design stipulated in TfNSW cycleway Toolbox involves an extension of the raised platform past the intersection.</p> | | Rare | Moderate | Low | |

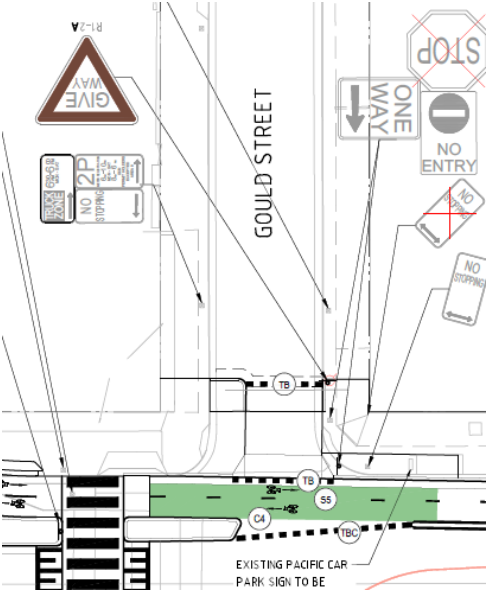
| Item No. | Location | Descriptions of Findings | Design/ Photo | Likelihood | Severity | Risk Rating | Designer Response |
|---|---|---|---|---|---|---|---|
| 31 | Gould Street – north approach | <p>No advance cycle crossing ahead signage is provided on the Gould Street north approach to Curlewis Street.</p> <p>Drivers may not be aware of the cycle crossing after the raised pedestrian facility and could collide with passing cyclists.</p> | | Rare | Moderate | Low | |

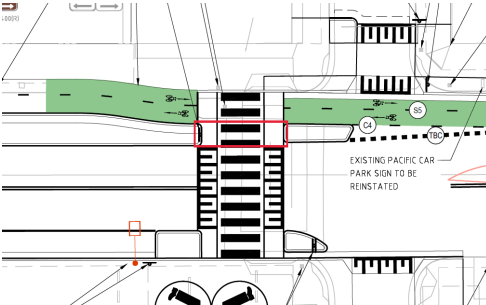
| Item No. | Location | Descriptions of Findings | Design/ Photo | Likelihood | Severity | Risk Rating | Designer Response |
|---|---|---|---|---|---|---|---|
| 32 | Pedestrian crossing on Curlewis Street west of Gould Street | <p>The storage area for pedestrians travelling south on the pedestrian crossing between the cycleway and road is small.</p> <p>Pedestrians may store outside the storage area which may result in conflicts with cyclists or passing vehicles.</p> <p>Further, given this area is a decision point for pedestrians, it should not be marked as a pedestrian crossing, as it would give pedestrians a false impression that the crossing is continuous without having to look out for traffic after crossing the cycleway or the roadway.</p> | | Rare | Moderate | Low | |

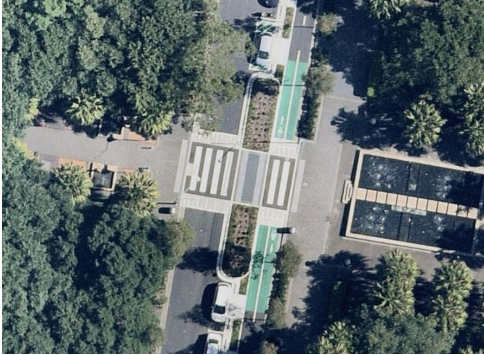
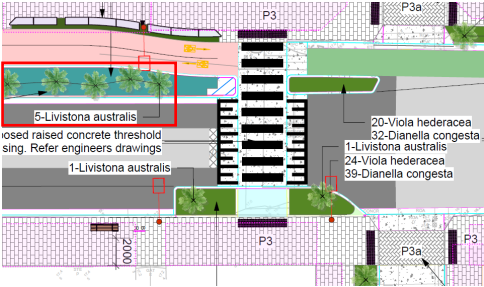
| Item No. | Location | Descriptions of Findings | Design/ Photo | Likelihood | Severity | Risk Rating | Designer Response |
|---|---|---|---|---|---|---|---|
| 33 | Pedestrian crossing on Curlewis Street west of Gould Street | <p>Pedestrians waiting on the footpath may have their sight distance impeded by landscaping.</p> <p>The landscaping design plans indicate that <i>livistona australis</i> palms will be installed within the kerb build outs. Mature palms can grow 10 to 25 metres, which may impact sight visibility between pedestrians and cyclists.</p> <p>Insufficient sight visibility at the pedestrian crossing and cycleway increases risks to pedestrians as cyclists may not see pedestrians crossing in the northbound direction. Similarly, pedestrians may not see oncoming vehicles in the other direction.</p> <p>Landscaping within the kerb buildout should not be higher than 1.0m to allow for reciprocal visibility as per design principles in the Cycleway Design Toolbox.</p> | | Rare | Moderate | Low | |

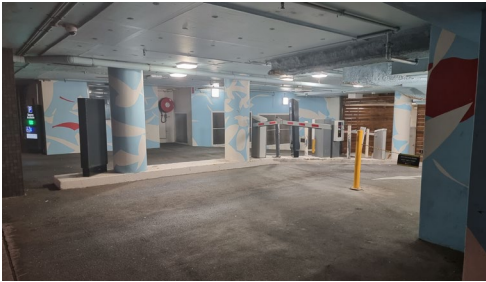
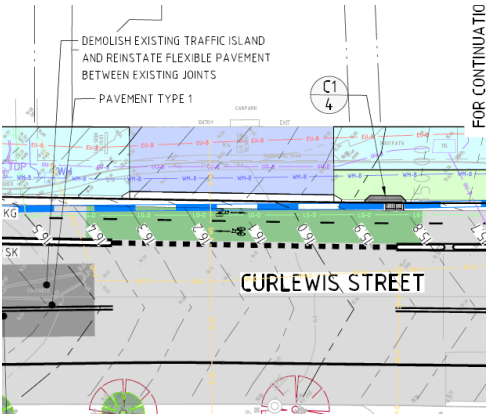
| Item No. | Location | Descriptions of Findings | Design/ Photo | Likelihood | Severity | Risk Rating | Designer Response |
|---|---|---|---|---|---|---|---|
| 34 | Pacific Car Park | <p>During busy periods, vehicles queueing for the boom gate when entering the car park may queue across the cycleway. This would increase the likelihood of an incident between cyclists and queued vehicles.</p> <p>Cyclists may also use the roadway or footpath to avoid vehicles queued across the cycle lane which increases the likelihood of incidents with vehicles or pedestrians.</p> | | Rare | Moderate | Low | |

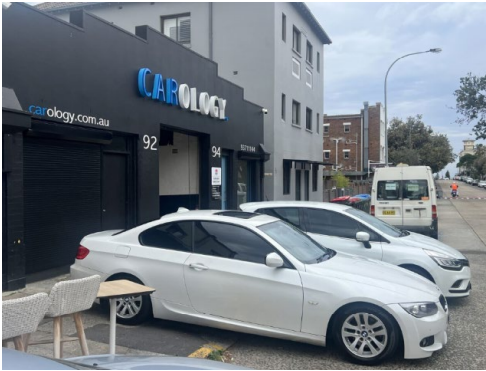
| Item No. | Location | Descriptions of Findings | Design/ Photo | Likelihood | Severity | Risk Rating | Designer Response |
|---|---|---|---|---|---|---|---|
| 35 | Carlogy, east of Glenayr Avenue | Outside Carlogy, motorists park perpendicular to the cycleway across the driveway. In the future, these cars may park across the cycleway, however for the purposes of this audit it is assumed motorists would not park in this location in the future. | | | | Note only | |

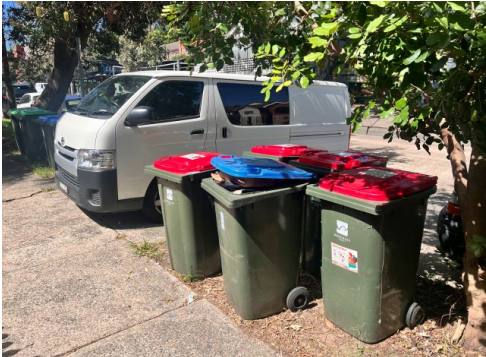
| Item No. | Location | Descriptions of Findings | Design/ Photo | Likelihood | Severity | Risk Rating | Designer Response |
|---|---|---|---|---|---|---|---|
| 36 | General comment | Similarly, delivery vehicles were observed parked across the driveway. In the future, these cars may park across the cycleway, however for the purposes of this audit it is assumed motorists would not park in this location in the future. | | | | Note only | |

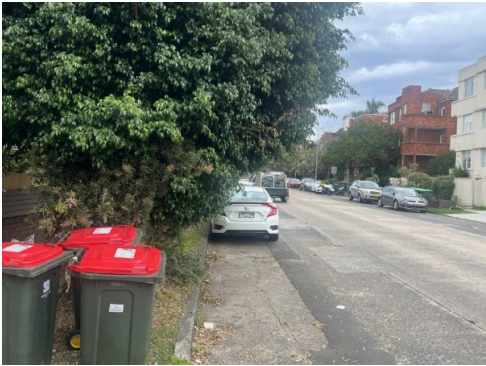
| Item No. | Location | Descriptions of Findings | Design/ Photo | Likelihood | Severity | Risk Rating | Designer Response |
|---|---|---|---|---|---|---|---|
| 37 | General comment | <p>A number of trees would be retained in the road verge on the north side of the cycleway.</p> <p>In some instances, vegetation overhanging into the proposed cycleway would intrude into the cyclist design envelope and become a potential head hazard.</p> <p>A 2.2m vertical clearance is required for the cyclist design envelope (plus another 0.3m for overhead clearance) in accordance with Austroads.</p> <p>Overhanging vegetation reduces visibility and could be a hazard to cyclists. Vegetation would need to be trimmed on a regular basis in the future.</p> <p>Trimming vegetation should be included in Council's maintenance program.</p> | | Unlikely | Minor | Low | |

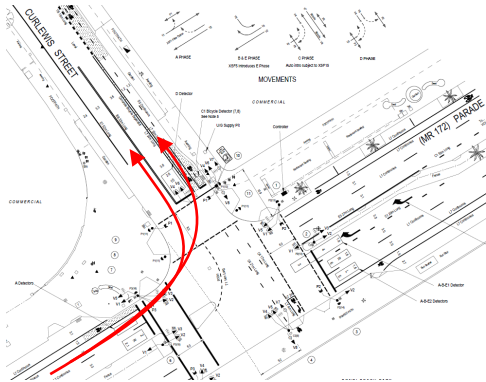
| Item No. | Location | Descriptions of Findings | Design/ Photo | Likelihood | Severity | Risk Rating | Designer Response |
|---|---|---|---|---|---|---|---|
| 38 | West leg approach side of Campbell parade | <p>The design does not indicate any connectivity or restriction for cyclist turning movements from the existing on-road cycleway on Campbell Parade (west approach) to Curlewis Street or Curlewis Street cycleway.</p> <p>This would potentially cause confusion for cyclists and motorists turning left from Campbell Parade into Curlewis which could result in an incident.</p> | | Unlikely | Moderate | Medium | |

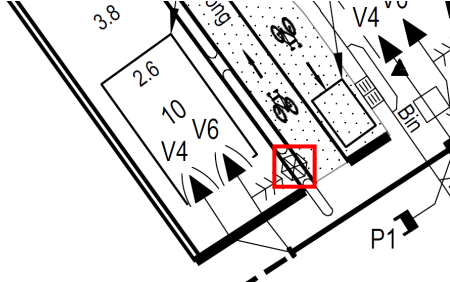
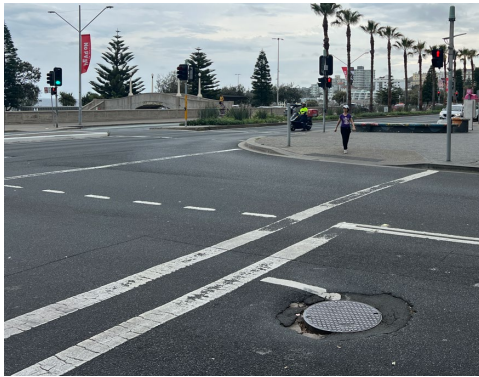
| Item No. | Location | Descriptions of Findings | Design/ Photo | Likelihood | Severity | Risk Rating | Designer Response |
|---|---|---|---|---|---|---|---|
| 39 | Curlewis Street approach to the Campbell Parade intersection | <p>The ridge between the pavement and utility pit exceeds the surface tolerance of 10mm specified in Austroads Guide to Road Design Part 6A.</p> <p>If not repaired, the change in level of the surface may unseat a cyclist.</p> | | Rare | Moderate | Low | |

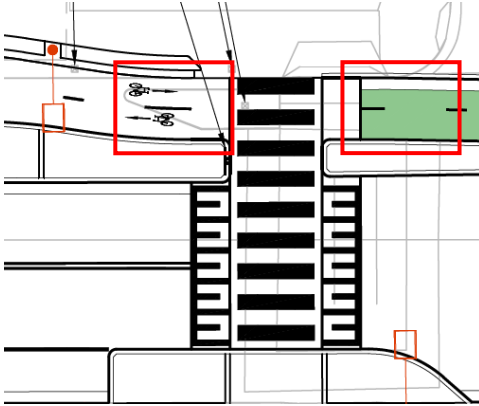
| Item No. | Location | Descriptions of Findings | Design/ Photo | Likelihood | Severity | Risk Rating | Designer Response |
|---|---|---|---|---|---|---|---|
| 41 | General | Markings for all cycleway entry points should be: Direction arrow + bicycle symbol + "ONLY" - in top to bottom order. No pavement markings on exit. | | | | Note only | |
