# ARBORICULTURAL IMPACT ASSESSMENT

# TREE PROTECTION SPECIFICATION

REF: L&Co2021051 | 04 April 2023 | v1.1 SITE ADDRESS | Curlewis Street, Bondi PREPARED FOR | Northrop Consulting Engineers c/-33parallel PREPARED BY | Dr Matthew Laurence Ms Allison Mertin BSc. (Hons) BSc. (Hons) PhD (Plant Pathology) Grad Cert (Arboriculture)

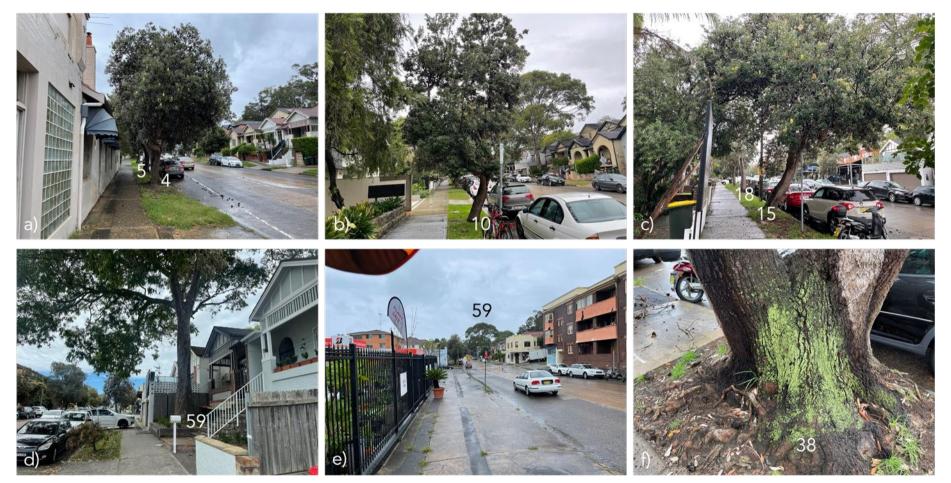
a) Showing Trees 4 and 5 with existing kerb and footpath in TPZ. b) Showing Tree 10. c) Showing Trees 15 & 18. d) Showing Tree 59 with existing vehicular crossovers in TPZ. e) Showing crown of Tree 59. f) Showing Tree 38 and the presence of wounds with early signs of decay.
