Project No: WAV/CHAM/21 Report No: WAV/CHAM/AIA/A

ARBORICULTURAL IMPACT ASSESSMENT TREE PROTECTION SPECIFICATION

Waverley Council Chambers Refurbishment Bondi Road Bondi Junction

Revision A
12th October 2021

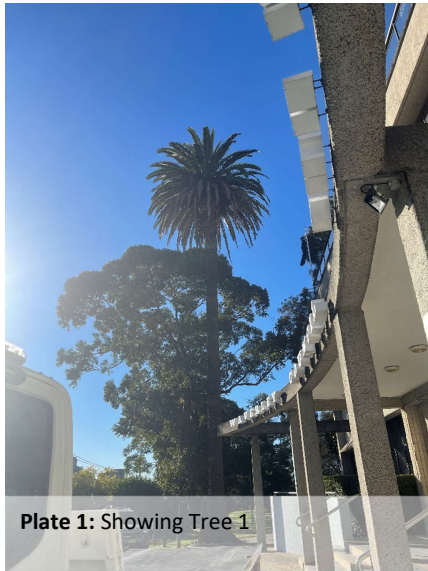
Plate 1: Showing Tree 1

- 3.1.1 Tree 1 was identified as *Phoenix canariensis* (Canary Island Date Palm) and is a late-mature specimen located on the Bondi Road frontage. The tree is in good health and structural condition. Tree 1 is of high Landscape Significance and has been allocated a Retention Value of *Priority for Retention*.

- 3.1.5 **Recommendations**
- Preliminary excavation and root pruning should be undertaken along the excavation line of the reconfigured forecourt/driveway access within the TPZ prior to the commencement of the bulk excavation works. No over-excavation, battering or benching should be undertaken.

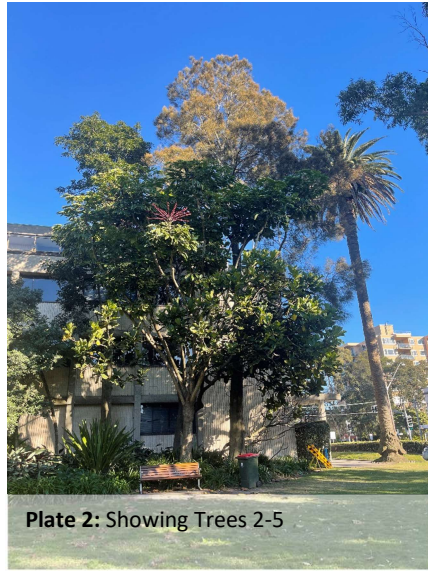
Plate 2: Showing Trees 2-5

- 3.2.1 Tree 2 was identified as *Casuarina glauca* (Swamp She-Oak) and is late-mature specimen located adjacent to the existing building. The tree is in fair health as evidenced by a reduced crown density and presence of deadwood within its crown. It has a short ULE (5-15 years), is of moderate Landscape Significance and has been allocated a Retention Value of *Consider for Retention*.
- 3.2.2 The supplied plans show that Tree 2 is to be retained with no works proposed within its TPZ.
- 3.2.3 **Recommendations**
- There is limited clearance between Tree 2 and the flagpole on the upper courtyard. The flagpole should be relocated as part of the works to avoid crown conflict with the tree.

- 3.3.1 Trees 3, 5 and 12 were identified as *Schefflera actinophylla* (Umbrella Tree), *Brachyciton acerifolious* (Illawarra Flame Tree) and *Buckinghamia celsissima* (Ivory Curl Tree) respectively and are mature rainforest-type species located adjacent to the existing building. The trees are in good health and structural condition. Trees 3, 5 and 12 are of moderate Landscape Significance and have been allocated a Retention Value of *Consider for Retention*.
- 3.3.2 The supplied plans show that Trees 3, 5 and 12 are to be retained with no works proposed within their TPZ areas.

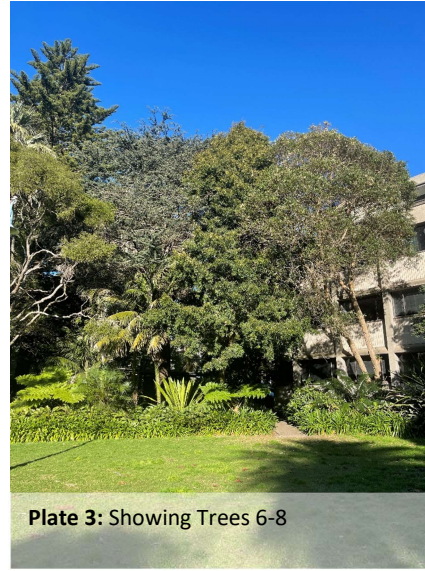
Plate 3: Showing Trees 6-8

- 3.5.1 Tree 6 was identified as *Tristaniaopsis laurina* (Water Gum) and is a mature specimen located adjacent to the existing building. The tree is in fair health as evidenced by a reduced crown density and the presence of high volumes of deadwood within its crown. The tree is of moderate Landscape Significance and has been allocated a Retention Value of *Consider for Retention*.
- 3.5.2 The supplied plans show that Tree 6 is to be retained with no works proposed within its TPZ.
- 3.5.3 **Recommendations**
There is limited clearance between Tree 6 and the building façade. Minor Reduction Pruning of branches less 50mm in diameter should be undertaken to provide a 500mm building clearance.

- 3.6.1 Tree 7 was identified as *Podocarpus elatus* (Brown Pine) and is a mature specimen located adjacent to the south-east of the building. The tree is in poor structural condition due to the presence of a major co-dominant inclusion which represents a significant structural defect. The loading on this defect will increase as the tree develops in crown size and sail area, particularly during severe weather events. Tree 7 has developed a moderate lean to the north-east, presumably as a phototropic response to suppression from adjacent trees. No evidence of root plate movement was observed at the time of assessment. The tree is of moderate Landscape Significance and has been allocated a Retention Value of *Consider for Retention*.
- 3.6.2 The supplied plans show that Tree 7 is to be retained with no works proposed within its TPZ.

- 3.7.1 Tree 8 was identified as *Cedrus deodara* (Himalayan Cedar) and is a late-mature specimen located adjacent to the south-east of the building. The tree is in fair health as evidenced by a reduced crown density and the presence of high volumes of deadwood within its crown. A concrete slab appears to have been recently constructed at the base of the tree. It is not known if any roots, and to what extent, may have been damaged or if these works are associated with the tree's declining health. The tree is of moderate Landscape Significance and has been allocated a Retention Value of *Consider for Retention*.
- 3.7.2 The supplied plans show that Tree 8 is to be retained with no works proposed within its TPZ.

- 4.1.9 Tree 7 *Podocarpus elatus* (Brown Pine) is a mature specimen located adjacent to the south-east of the building. The tree is in poor structural condition due to the presence of a major co-dominant inclusion which represents a significant structural defect. The loading on this defect will increase as the tree develops in crown size and sail area, particularly during severe weather events. Council's Tree Management Team should be notified of the defect.

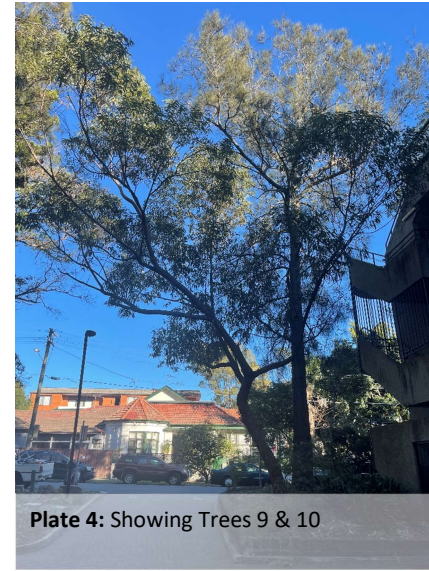
Plate 4: Showing Trees 9 & 10

- 3.8.1 Tree 9 was identified as *Eucalyptus botryoides* (Southern Mahogany) and is a mature specimen located near the entrance to the Paul Street carpark. The tree is in fair health as evidenced by a reduced crown density and the presence of high volumes of deadwood within its crown. Tree 9 is in fair structural condition due to a previous branch failure at crown break. The wound created by the failure has decayed and is starting to develop into a cavity. The tree is of moderate Landscape Significance and has been allocated a Retention Value of *Consider for Retention*.
- 3.8.2 The supplied plans show that Tree 9 is to be retained and no works are proposed within its TPZ.

- 3.9.3 Recommendations
- Preliminary excavation and root pruning should be undertaken along the excavation line of the grease arrestor footprint within the TPZ prior to the commencement of the bulk excavation works. No over-excavation, battering or benching should be undertaken beyond the arrestor footprint.

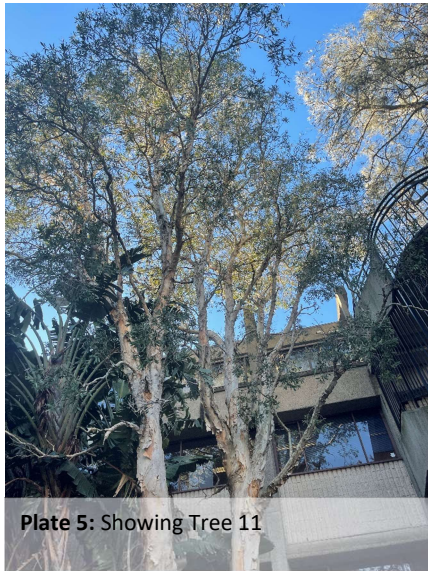
Plate 5: Showing Tree 11

- 3.10.1 Tree 11 was identified as *Melaleuca quinquenervia* (Broadleaf Paperbark) and is a mature specimen located adjacent to the existing building. The tree is in fair structural condition due to the presence of bark inclusions, typical of species. The tree is of moderate Landscape Significance and has been allocated a Retention Value of *Consider for Retention*.

- 3.10.3 The supplied plans also show a booster assembly area, water pump, fire hydrant pump enclosure and footpath replacement are proposed within its TPZ. The extent of works represents a *Major Encroachment* as defined by AS-4970.

- The removal and replacement of the existing footpath should retain existing sub-base layers. If sections of the sub-base layer require refurbishment/modification, the sub-base materials should be removed in thin (20mm) layers using an excavator (<3.5T) fitted with a flat bladed bucket. The excavator operator should be guided by a spotter to identify and expose tree roots which may be present in/under the sub-base layer. Roots (>25mmØ) should be exposed by localised hand excavation and protected from damage. Roots (>25mmØ) identified with sub-base layers should be retained, and surfaces and sub-base layers should be thinned/modified as required by the Project Arborist. Root pruning should be undertaken by the Project Arborist only.

- Pipes for the fire hydrant pump and grease arrester should be installed using tree sensitive excavation (hand/hydrovac/airspade etc) methods with the pipes located around/below roots (>25mmØ) as required by the Project Arborist. Excavation using compact machinery (<2T) fitted with a flat bladed bucket is permissible where approved by the Project Arborist. Excavation using compact machinery should be undertaken in small increments, guided by a spotter who is to look for and prevent damage to roots (>25mmØ).

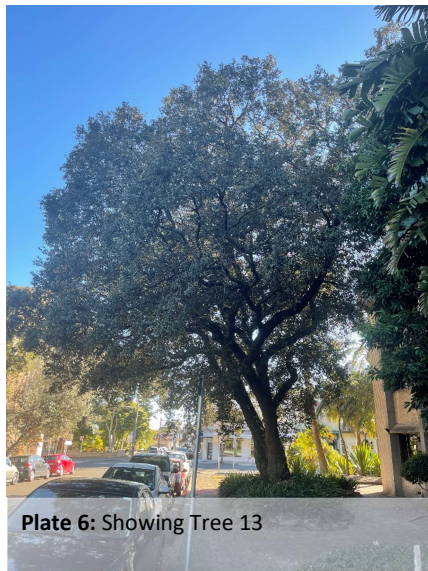
Plate 6: Showing Tree 13

- 3.11.1 Tree 13 was identified as a *Quercus ilex* (Holm Oak) and is a late-mature specimen located adjacent to the Paul Street frontage. The tree is in good health and structural condition. The tree is of high Landscape Significance and has been allocated a Retention Value of *Priority for Retention*.
- 3.11.2 The supplied plans show that Tree 13 is to be retained with a booster assembly area, water pump, fire hydrant pump enclosure, footpath replacement, bike rack and new pavement area proposed within its TPZ. The extent of works represent a *Major Encroachment* as defined by AS-4970. The following tree sensitive methods should be used within the TPZ to minimise adverse impacts.

3.11.4 It should be noted that Tree 13 is of a significant age and may be less tolerant of construction impacts or than younger, more vigorous trees. Whilst it is possible to undertake works within the TPZ with the use of tree sensitive design and construction methods as outlined above, the adherence of contractors to these methods and general tree protection requirements will ultimately determine whether the viability of the tree is maintained in the medium to long term.

- The slabs for the booster assembly, water pump and fire hydrant pump enclosure, footpath replacement and pipes for the fire hydrant pump and grease arrester should be installed as per Section 3.10.5 above.

- The area of new pavement should be installed above existing grade to minimise the potential for root damage. Levels may need to be locally raised, and surfaces and sub-base layers thinned/modified as required to enable the retention of roots (>25mmØ) as required by the Project Arborist.

3.11.5 Given the age and significance of Tree 13, it is recommended that an irrigation system is installed prior to the commencement of construction to promote new fibrous root development and maintain tree health.

- A soil wetting agent should be applied (in accordance with the manufacturer's instructions) to the irrigated areas to promote infiltration of irrigation through the soil profile.

- A seaweed-based soil conditioner should be applied (in accordance with the manufacturer's instructions) to the irrigated area to promote a healthy soil microbiome.

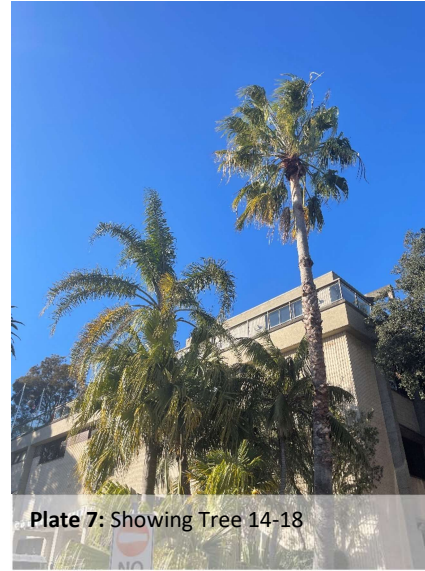
Plate 7: Showing Tree 14-18

3.12.1 Trees 14 and 18 were identified as *Butia capitata* (Jelly Palm) and *Livistona australis* (Cabbage Tree Palm) respectively and are located near the vehicular driveway on Bondi Road. The trees are in good health and structural condition. Trees 14 and 18 are of low Landscape Significance and have been allocated a Retention Value of *Consider for Removal*.

3.12.2 The supplied plans show that Trees 14 and 18 are to be removed as part of the proposed landscape treatment. New tree plantings using healthy, advanced-sized specimens could replace the loss of amenity from tree removal within a short timeframe.

3.13.1 Trees 15-17 are a group of palms including *Livistona australis* (Cabbage Tree Palm), *Howea forsteriana* (Kentia Palm) and *Syagrus romanzoffiana* (Cocos Palm), and are located near the vehicular driveway on Bondi Road. The trees are in good health and structural condition. Tree 15 is of moderate Landscape Significance and has been allocated a Retention Value of *Consider for Retention*. Tree 16 is of low Landscape Significance and has been allocated a Retention Value of *Consider for Removal*. Tree 17 is of low Landscape Significance and has been allocated a Retention Value of *Priority for Removal*.

- Tree 15 has developed a minor trunk sweep and above ground guying may be required as part of the transplanting works. In many circumstances, the planting of a new advanced-size palm of similar dimensions often is a more practical and less costly exercise than transplanting.
- Transplanting works should be undertaken by an experienced Tree Transplanting Contractor with a minimum qualification equivalent (using the Australian Qualifications Framework) of Level 3 or above, in Arboriculture or its recognised equivalent.
- Any transplanted trees which fail to establish or where transplanting is deemed unfeasible should be replaced with new trees of the same size and species.
- Tree 17 *Syagrus romanzoffiana* (Cocos Palm) should not be transplanted due to its weed status.

4.1.5 The supplied plans show Trees 15-17 are to be transplanted to a new garden bed on site. Tree 17 *Syagrus romanzoffiana* (Cocos Palm) should not be transplanted due to its weed status. Transplanting works should be undertaken by an experienced Tree Transplanting Contractor with a minimum qualification equivalent (using the Australian Qualifications Framework) of Level 3 or above, in Arboriculture or its recognised equivalent. Any transplanted trees which fail to establish or where transplanting is deemed unfeasible should be replaced with new trees of the same size and species.

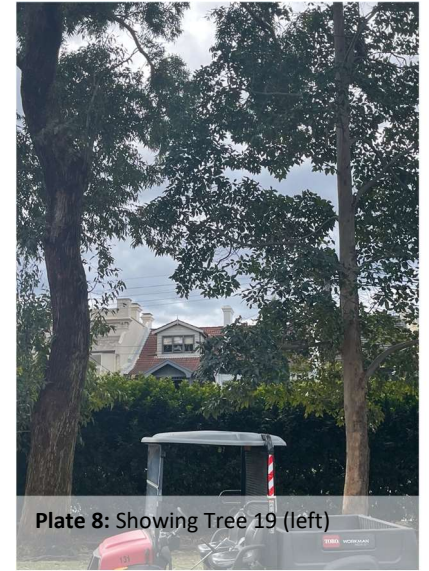
Plate 8: Showing Tree 19 (left)

3.14.1 Tree 19 was identified as *Eucalyptus botryiodes* (Southern Mahogany) and mature specimen located to the north-east of the building. The tree is in good health and structural condition. Tree 19 is of moderate Landscape Significance and has been allocated a Retention Value of *Consider for Retention*.
