MARKS PARK AND COASTWALK LANDSCAPE WORKS

PROPOSED FURNITURE SUITE

WAVERLEY COUNCIL FITNESS EQUIPMENT SUITE

Project Title: **MARKS PARK AND COAST WALK WORKS**

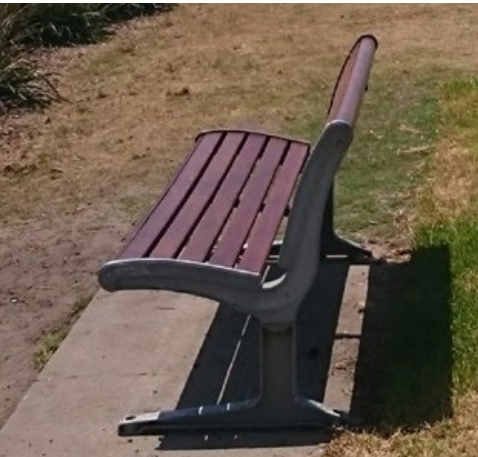
Timber Seat with back

Replacing all existing seats and new seats placed at 65-75m spacing.

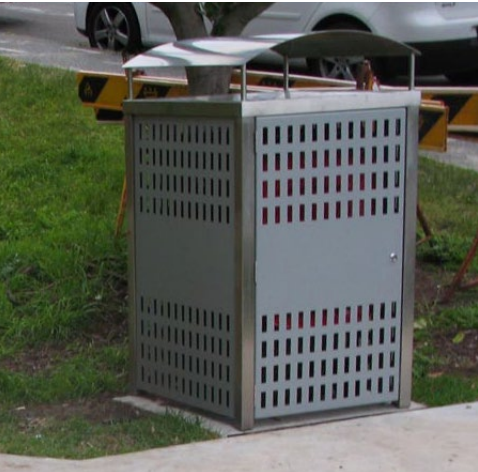
Standard WC 240l Bin Enclosure

Replacing all bin types, typically placed at entry path intersection with coast walk.

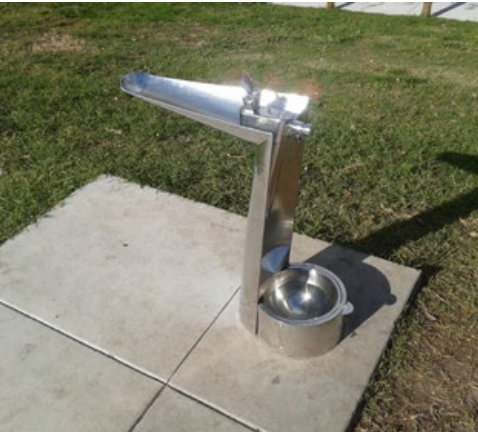
Drinking Fountain

New fountains placed typically every 250m if practicable.

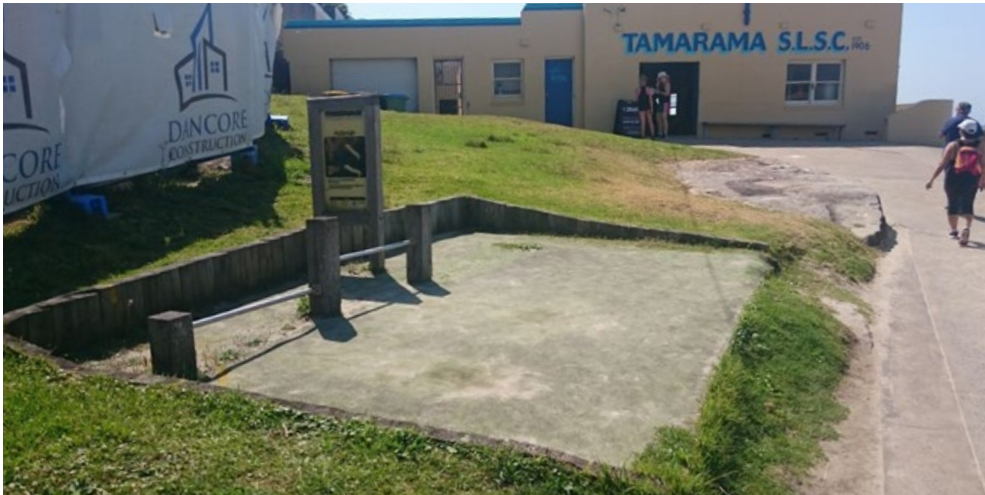
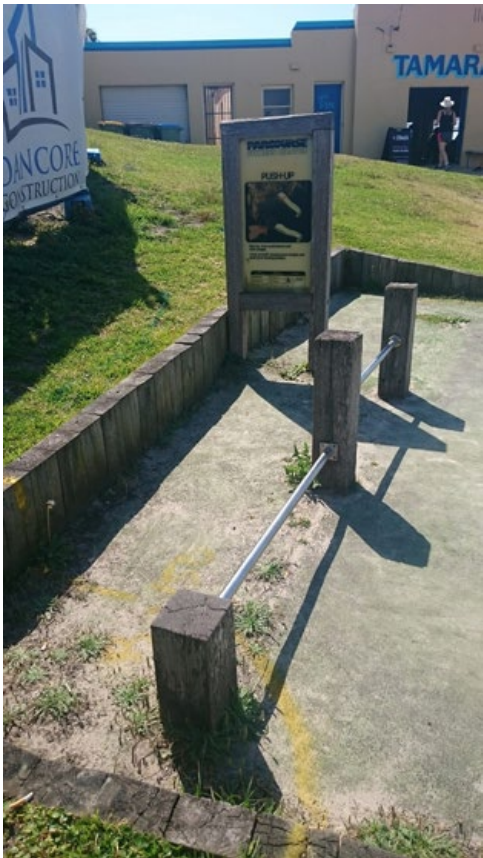
FITNESS STATION 1

F1 Tamara Beach Fitness station, consisting of two push up bars.
Level bench has been removed.
Activities: 1 (Previously 2)
Area: 18 sqm
Condition: Poor
Material: Hardwood timber edging, artificial turf surfacing, hardwood timber and stainless steel furniture.

PUSHUP BARS, EVIDENCE OF LEVEL BENCH BEHIND

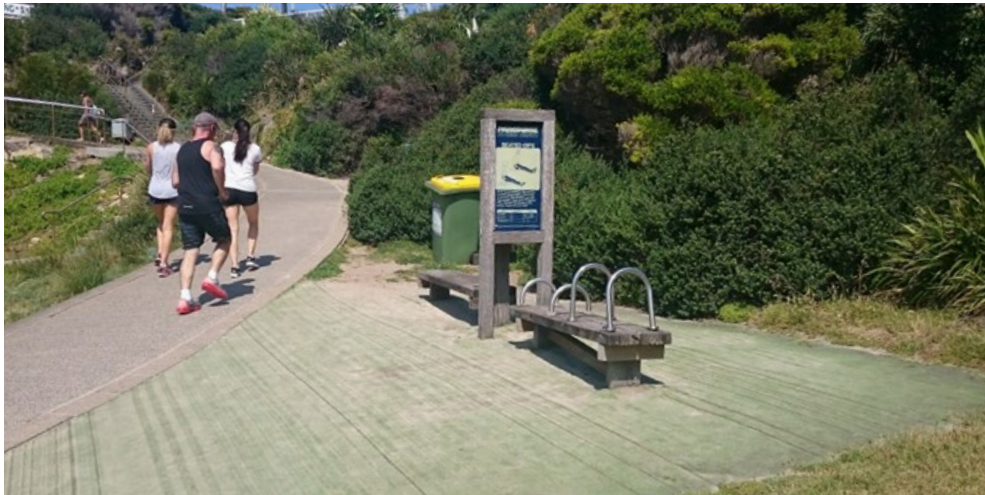
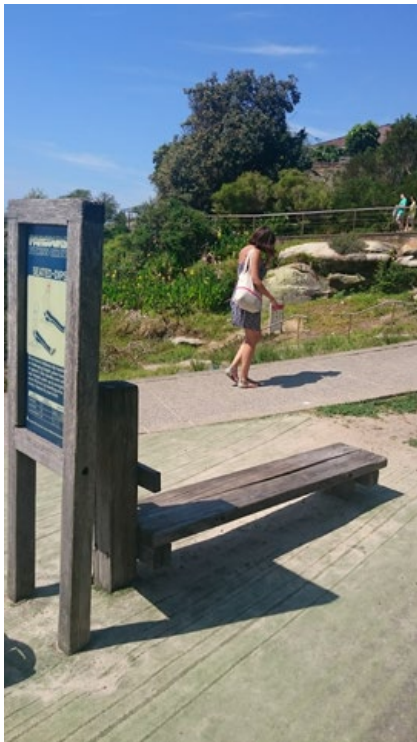
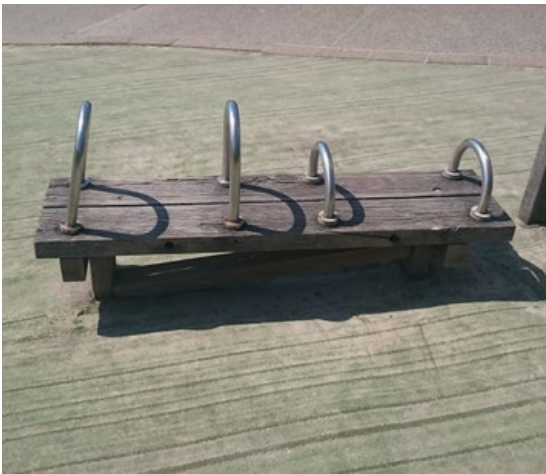
FITNESS STATION 2

F2 Gaerlock Ave Fitness station, consisting of bench curl and seated dips.
Activities: 2
Area: 28 sqm
Condition: Poor
Material: Hardwood timber edging, artificial turf surfacing, hardwood timber and stainless steel furniture.

BENCH CURL BENCH

SEATED DIPS BENCH

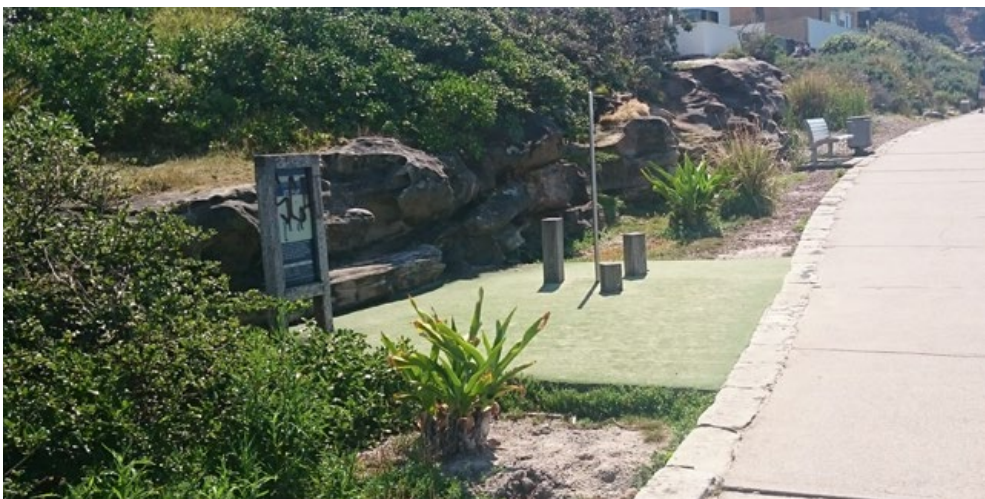
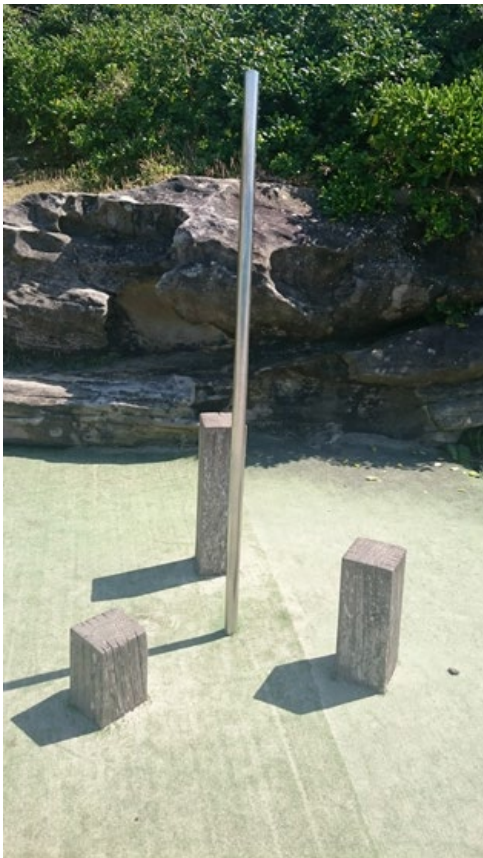
FITNESS STATION 3

F3 Fitness station between Gaerloch Ave and Marks Park. Consisting of 3no. step up steppers and central pole.

VARIABLE HEIGHT STEPPERS WITH BALANCE POLE

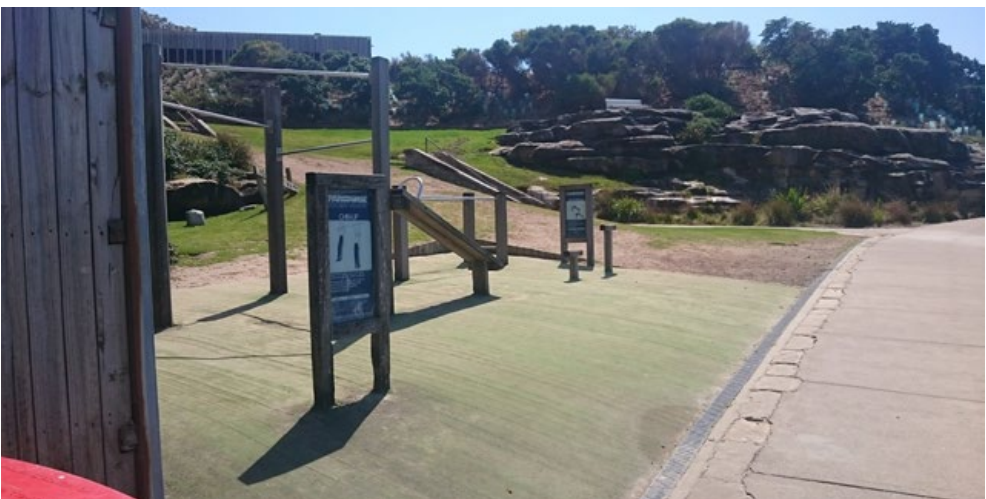
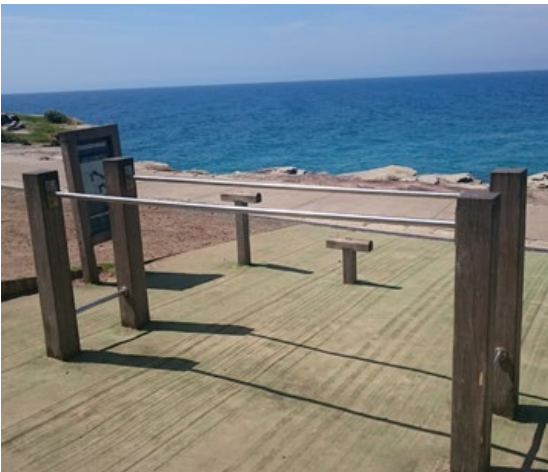
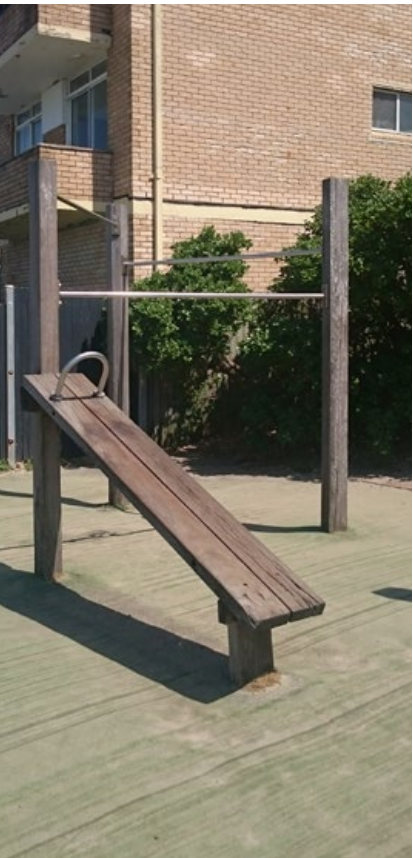
FITNESS STATION 4

F4 Marks Park Fitness station, consisting of 4no. activities. body curl, chin up, hand walk, and leg stretching.

PARALLEL BARS INFRONT, STRETCHING POSTS BEHIND

INCLINE BENCH INFRONT, PULL UP BAR BEHIND.

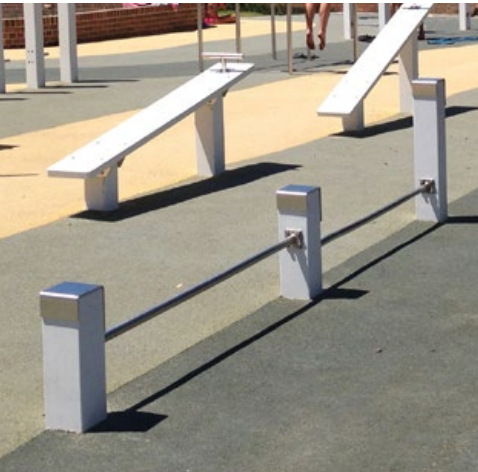
Push up bar
Upper body
Activities: Push ups
Varying degrees of difficulty provided by different heights of bars.

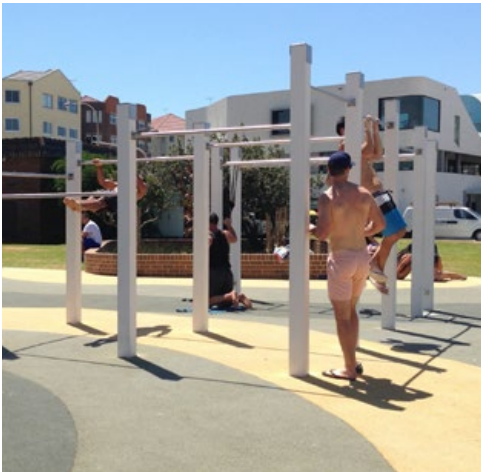
Pull up bars
Upper body
Activities: Pull ups

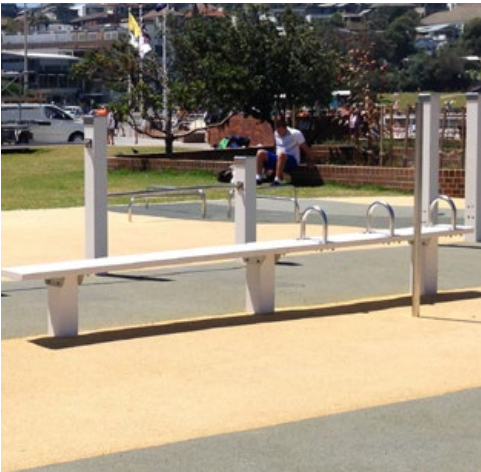
Level bench with post and bars
Upper body and Lower body
Activities: Push ups, Squats, Dips, Supermans, stretching

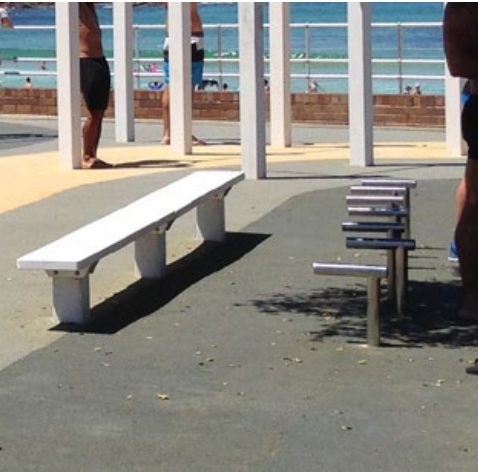
Level bench with push up bars
Upper body
Activities: Push ups, Dips, stretching
Varying degrees of difficulty provided by different distances from bench to bars.

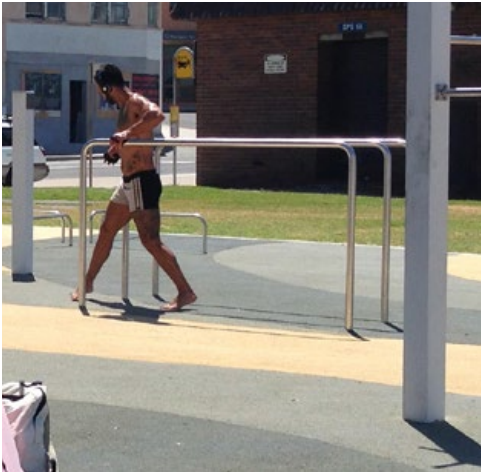
Triple dip bars
Upper body
Activities: Dips, Hand walk

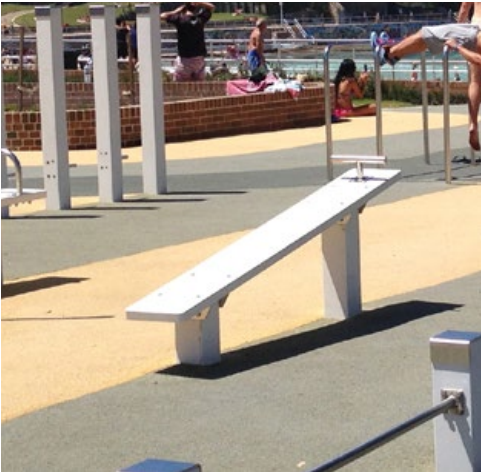
Incline bench
Lower body and Core
Activities: Sit ups, Back curls, Leg raises
Varying degrees of difficulty provided by different degrees of incline.

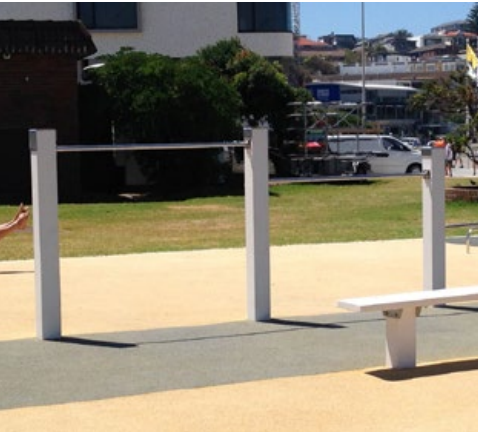
Chest height push up bars
Upper body
Activities: Push ups, Chin ups.

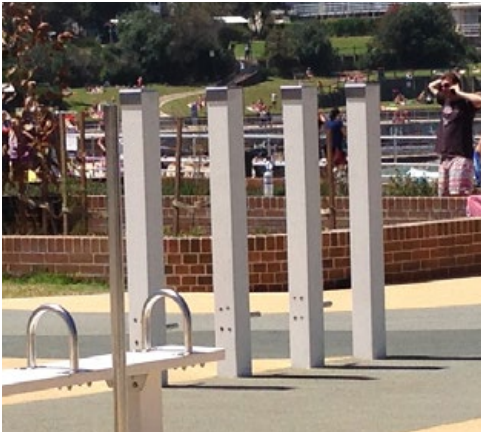
Post dips
Upper body
Activities: Dips

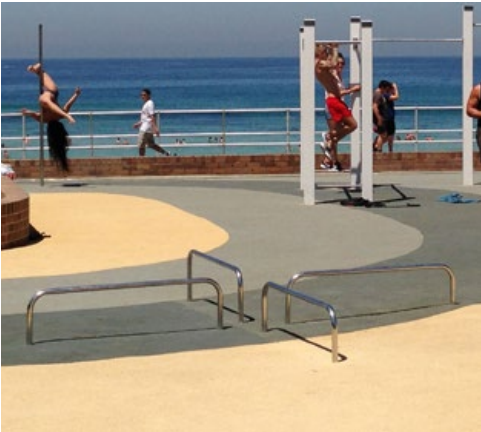
Hop bars
Compound exercise
Activities: Bar hopping

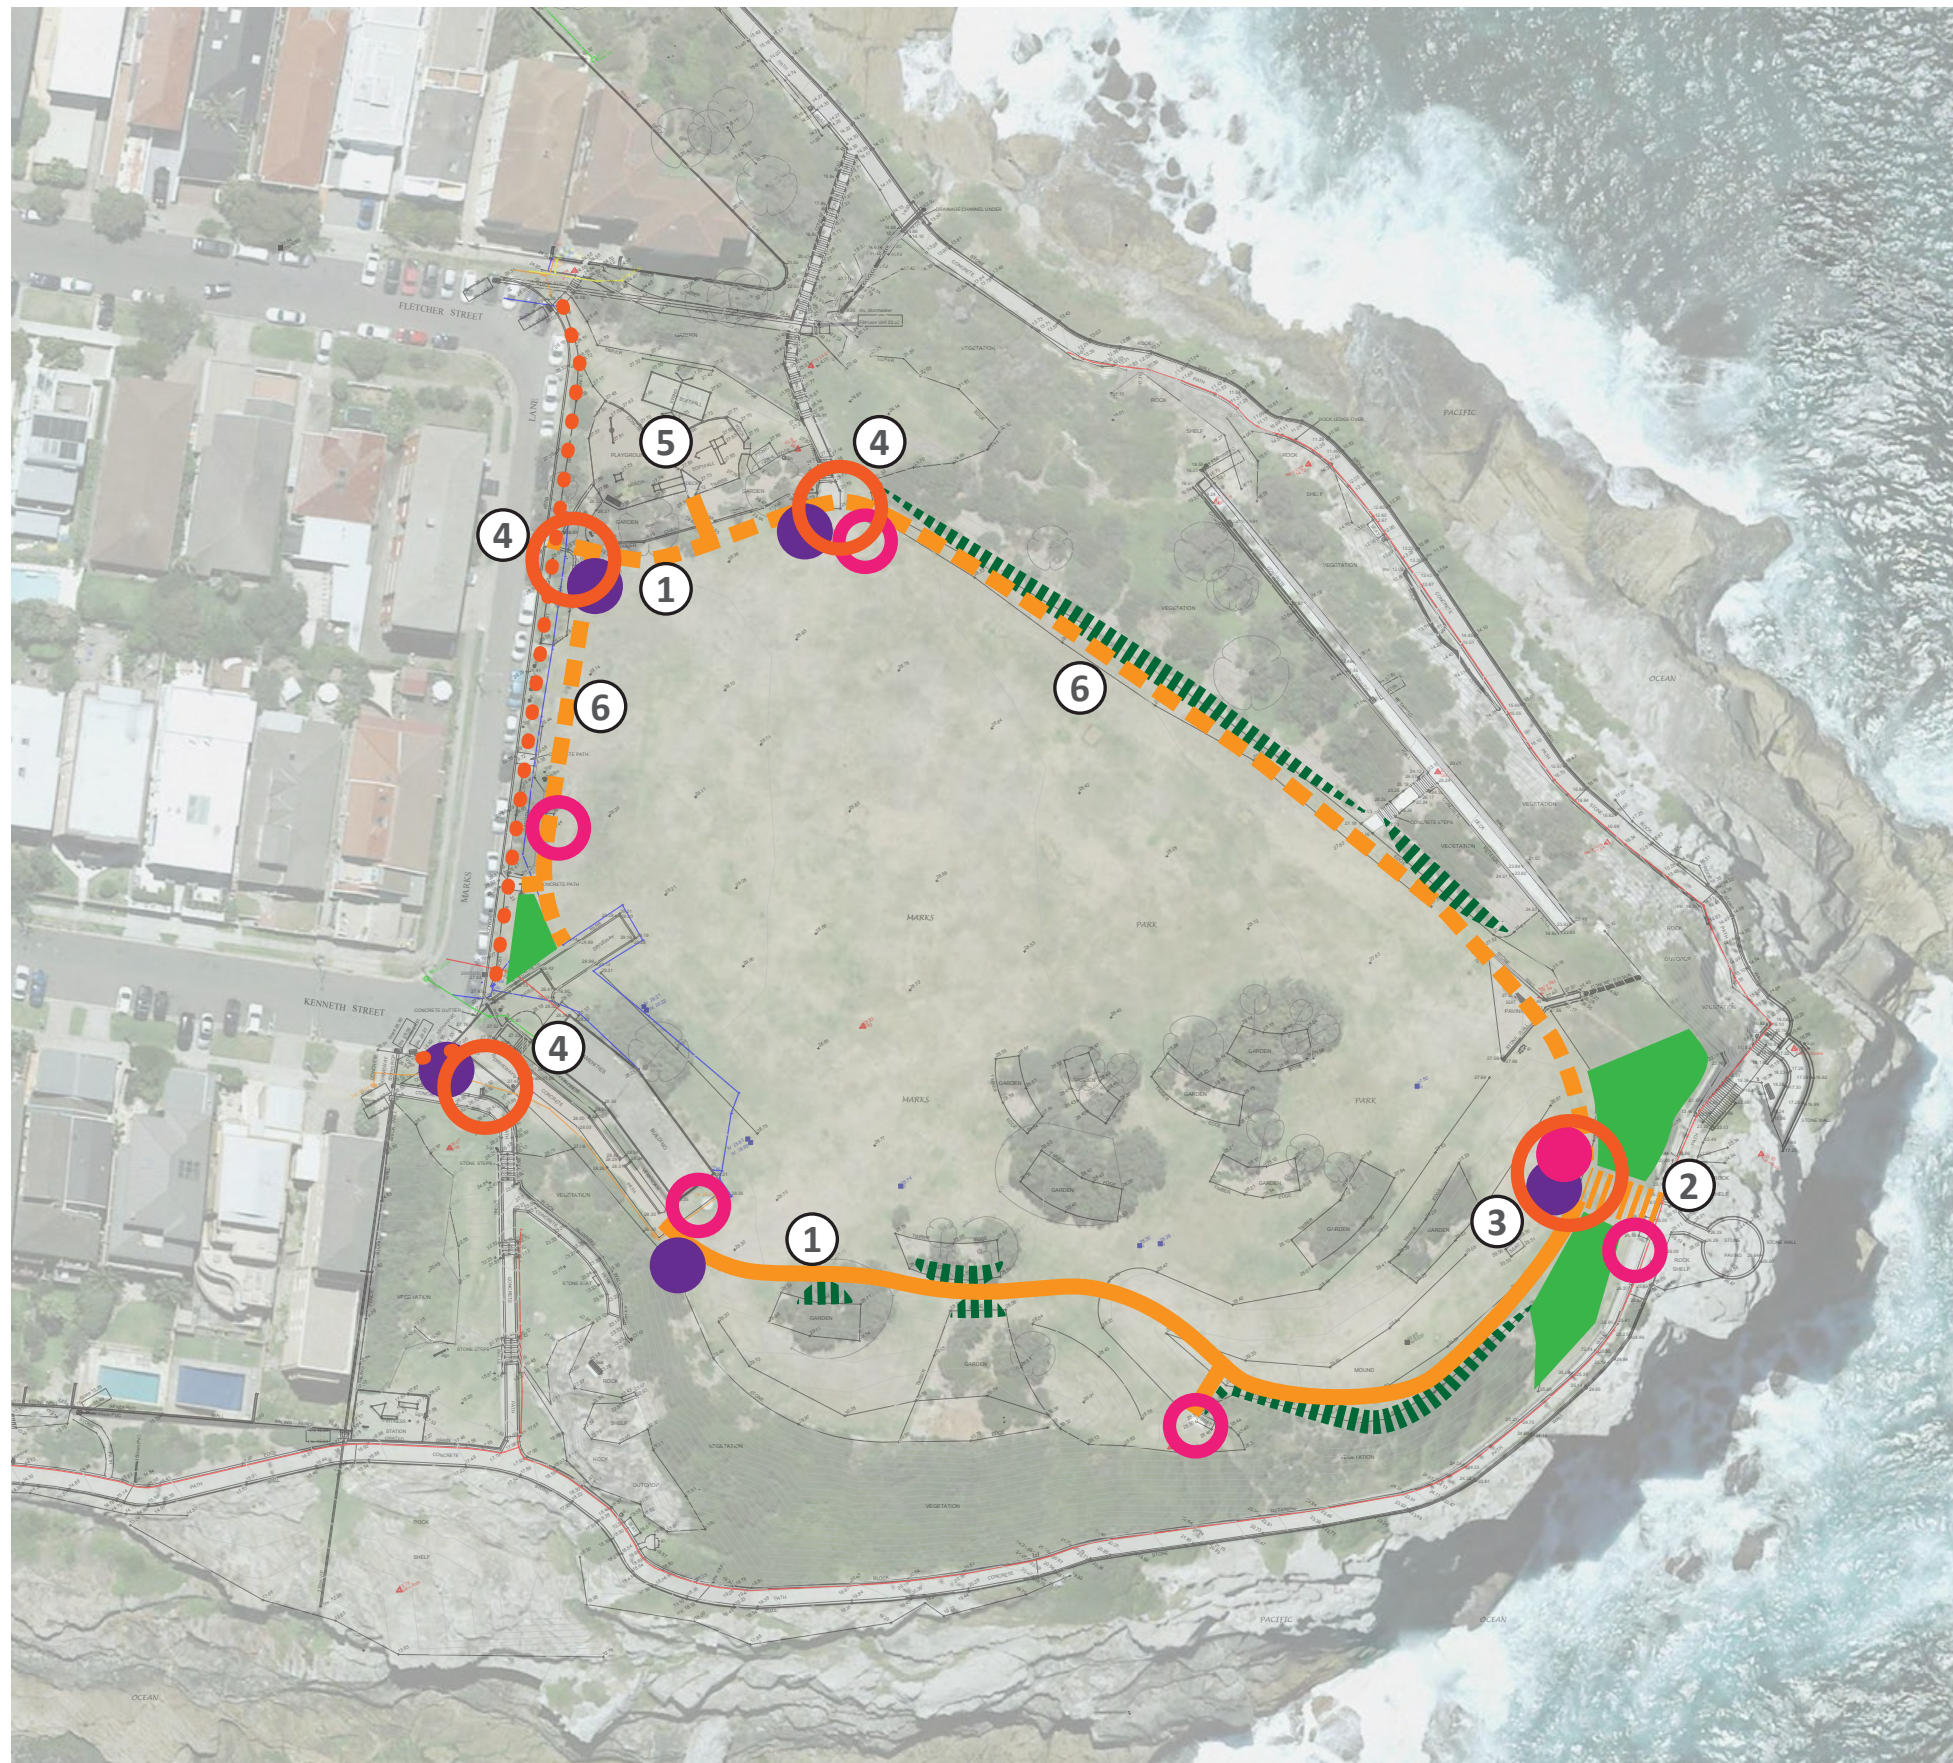
Drawing Name: **MARKS PARK CONCEPT DIAGRAM**

① New top park access path.

Create a formal hard paved footpath around the top park, providing a easily trafficable and durable surface.

② Improve access to Point Lookout

Create a formal access from the top park to the Coast walk and Point look out. Extending low native planting to assist in slope stabilisation.

③ New top park lookout.

Provide an accessible lookout providing a similar experience to the Point Lookout for all users of the park.

④ Entry Nodes.

Create formalised entry locations to the park and coagulate infrastructure (bins, bike racks, benches) at these nodes.

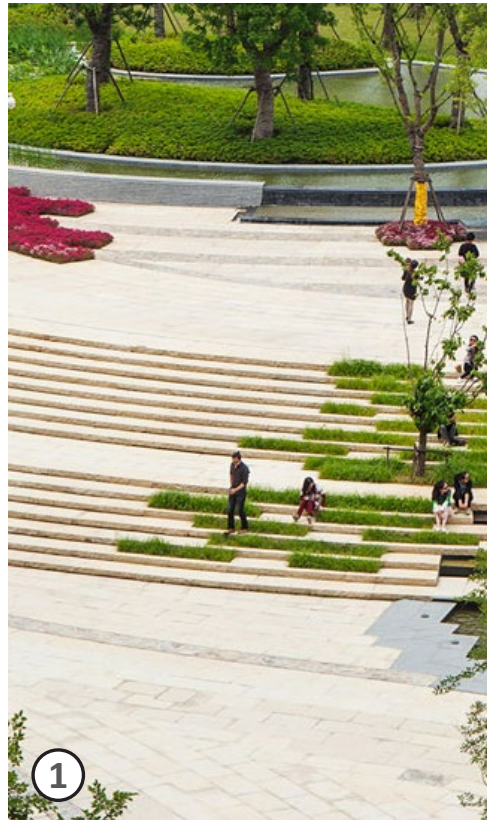
- 1 Standard stairs hardscaped stairs softened with planting in the stair treads.

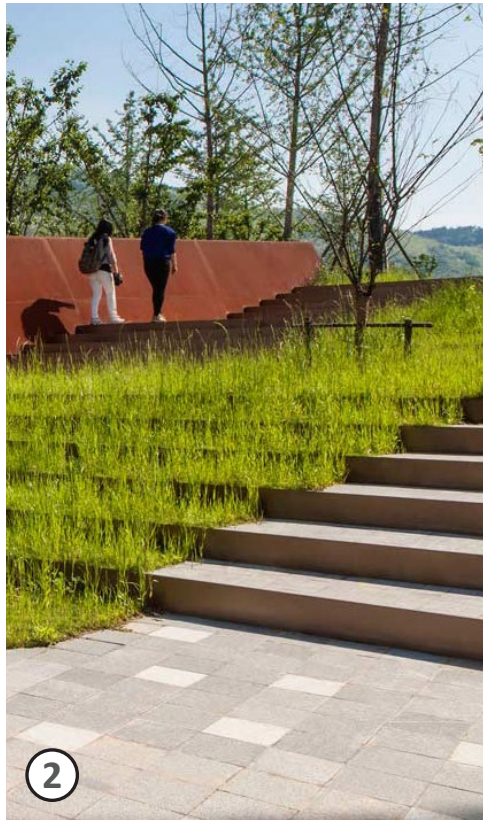
- 2 Standard stairs integrated with adjacent planting beds.

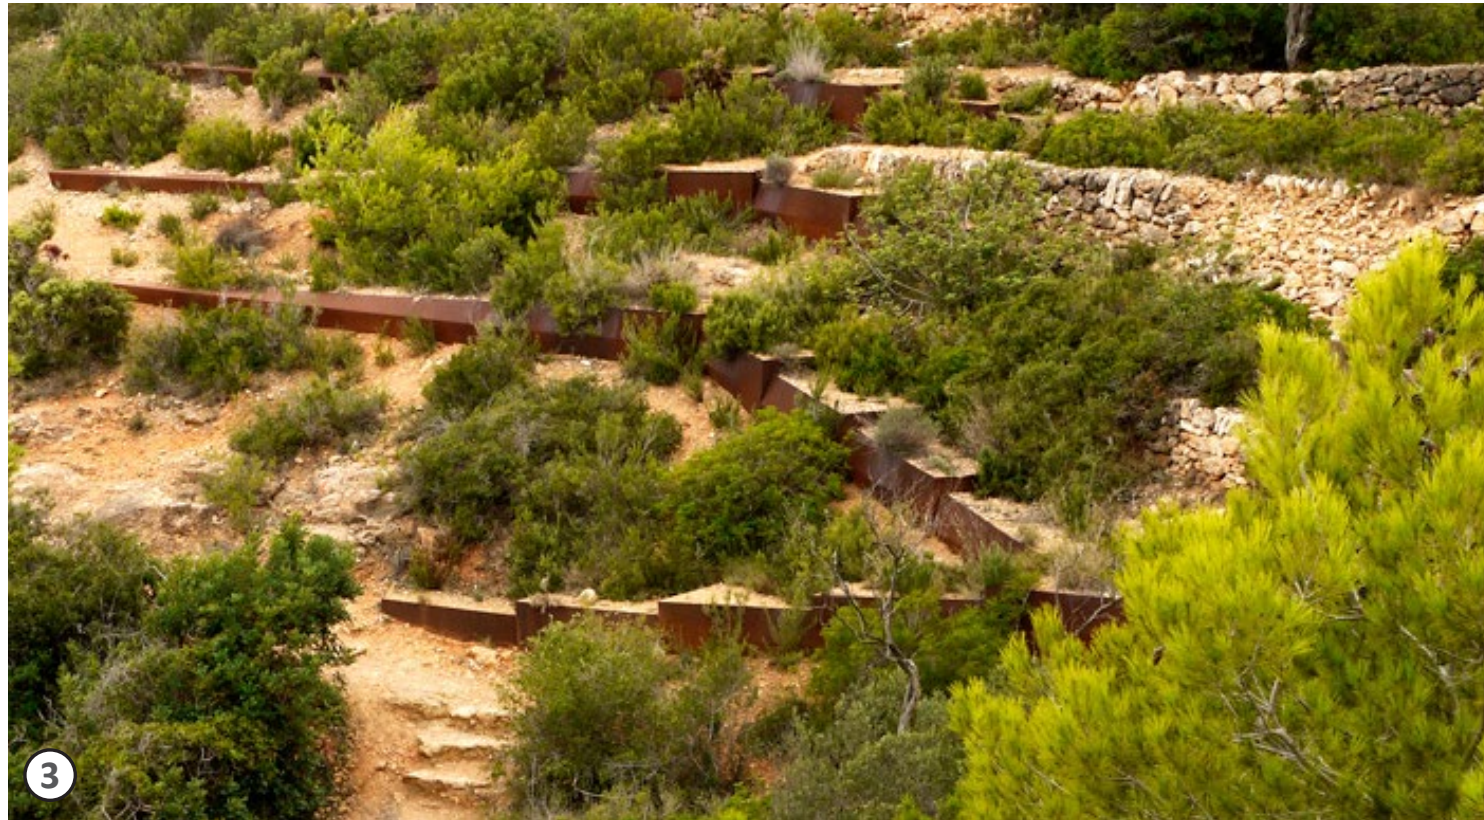
- 3 Coast side retaining walls subtly integrated into the slope of the site, planted with native species. Providing slope stabilisation and stepped access.

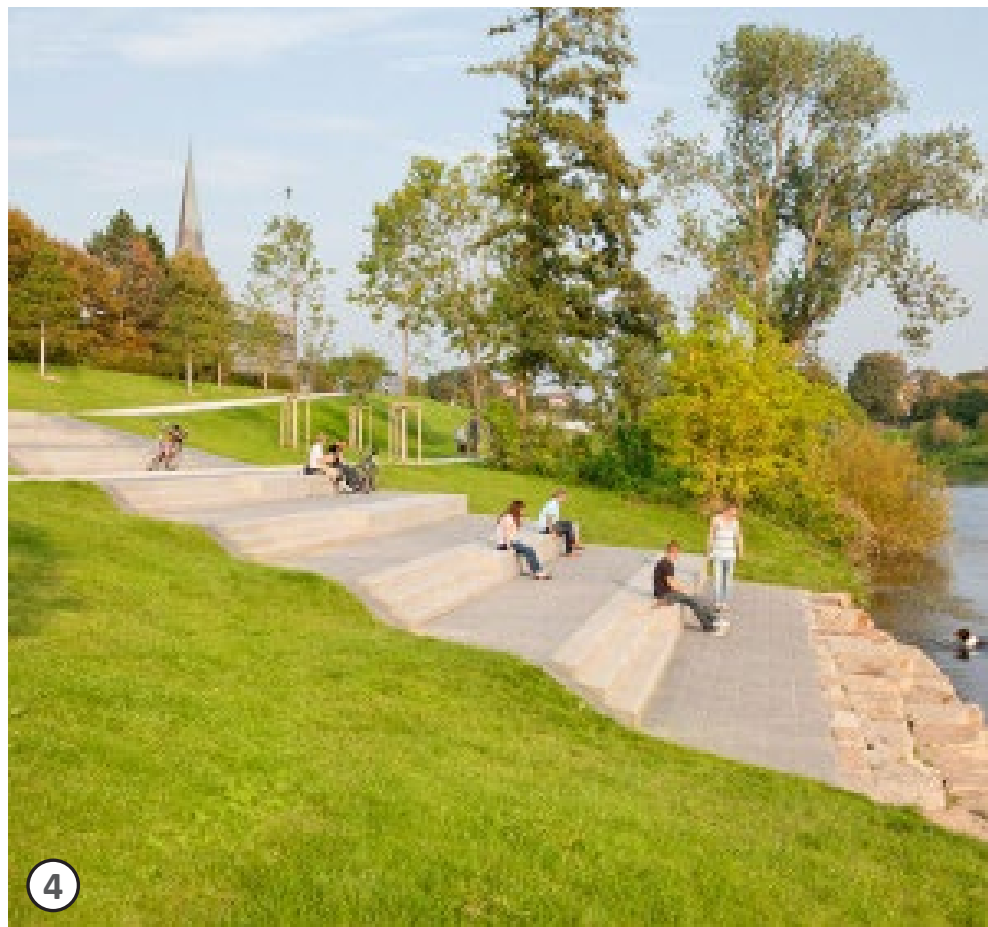
- 4 Wide terrace in sloped banks of river, with stone interface with water. Offers seating, viewing and access down the slope.

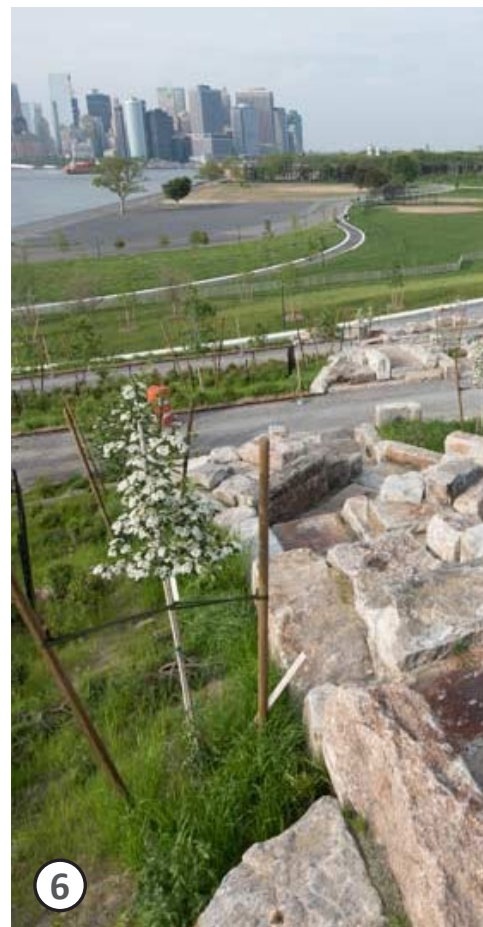
- 6 Utilising local stone to create an interesting access stair up the side of a hill.

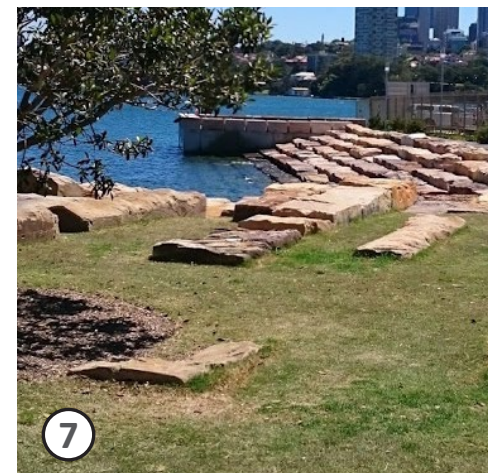
- 7 Sandstone blocks to create the feeling and character of a cliff edge.

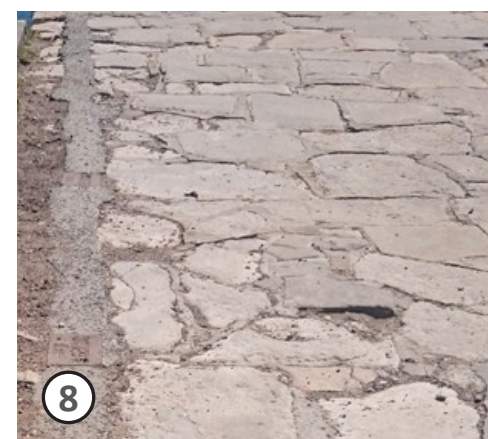
- 8 Irregular sandstone paving to maintain existing character and textures at lookout.
