Existing Conditions Analysis Diagrams

Project Title: **Thomas Hogan Reserve
Stage 2**

Drawing Name: **Existing Conditions Analysis Diagrams**
Drawing No: **SK.01**
Revision: **E**

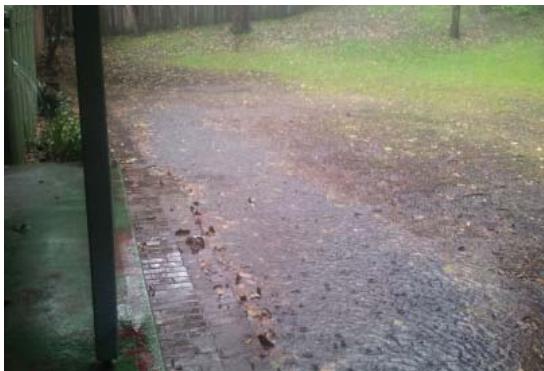
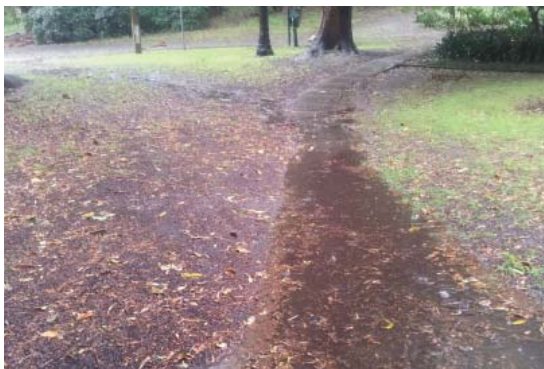
Flooding :
The park is the lowest point in the area and is subjected to the stormwater within this property as well as the surrounding properties, thus causing flooding in some parts of the reserve. This occasional flooding limits access to the Community Hall.

- New pathway connection between Stage 1 works and stairs coming down from Martin’s Avenue
- New accessible path to the community hall
- Upgrade and wheelchair access establishment to main entrance of Community Hall
- Addressing flooding issue around the Community Hall
- Creation of new Lawn in front of Community Hall
- Improve light and growth conditions for the historic fig and new lawn in front of hall by removing noted camphor laurels

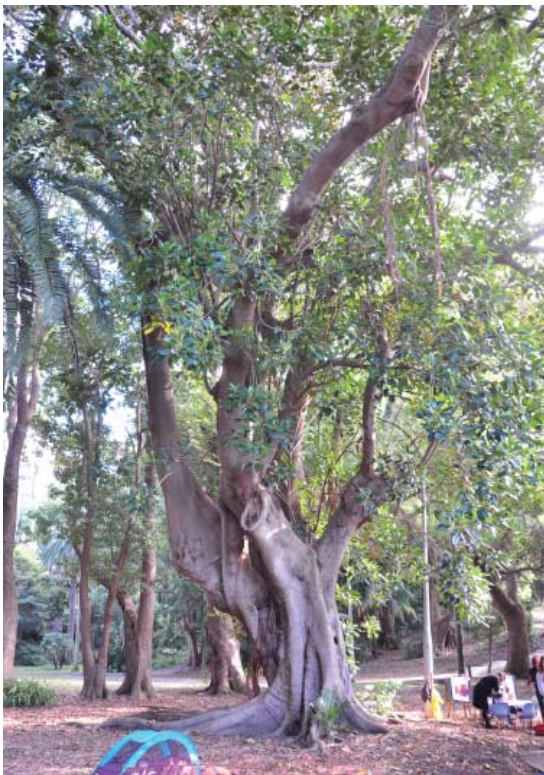
Historic Fig :
The Vegetation Management Plan identifies a large Moreton Bay Fig with historic significance, most likely from original 19th Century Schneider Landscaping.

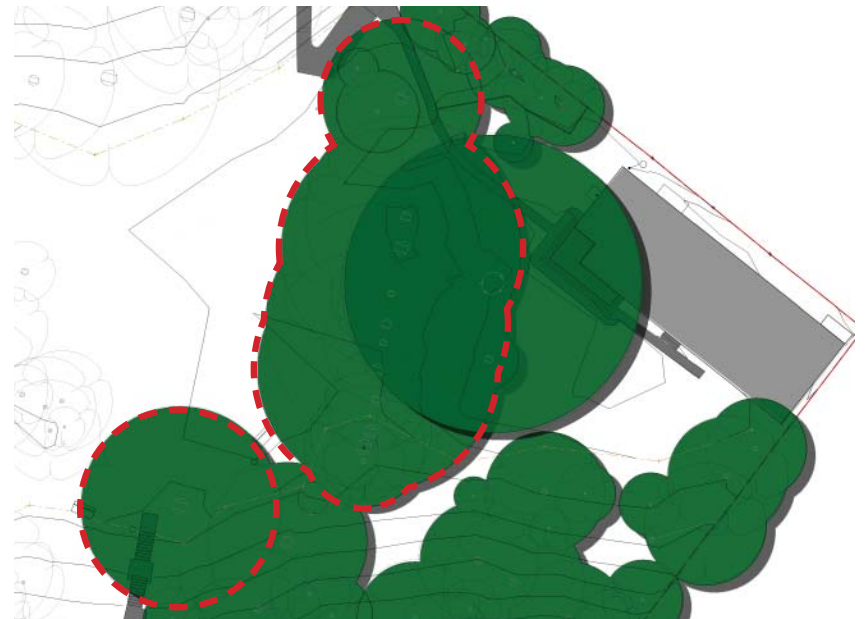
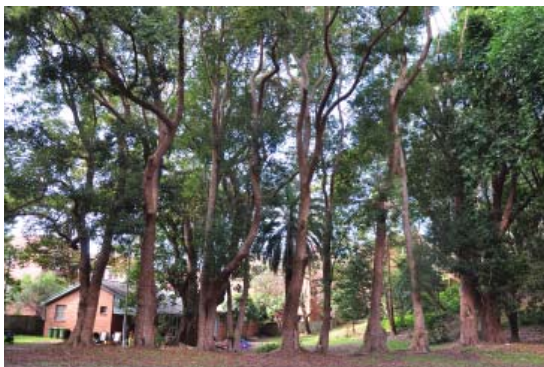
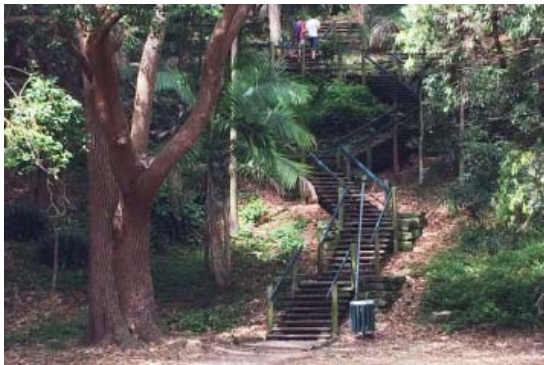
Trees recommended for removal :
These trees are Camphor Laurels which have soft wood and are likely to rapidly break down. 7 of the trees are identified as being an immediate risk in the Vegetation Management Plan, due to trunk decay and disease. The rest are noted for future removal since these are environmental weeds. All trees are in a copse with inter-twined roots. Thus it is advisable to remove the whole tree line at one go for safety reasons. The removal in turn will help provide space for the Historic Fig to flourish as well as provide much needed sunlight for the proposed lawn areas.

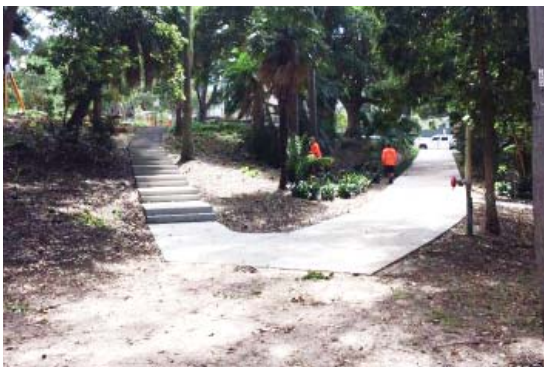
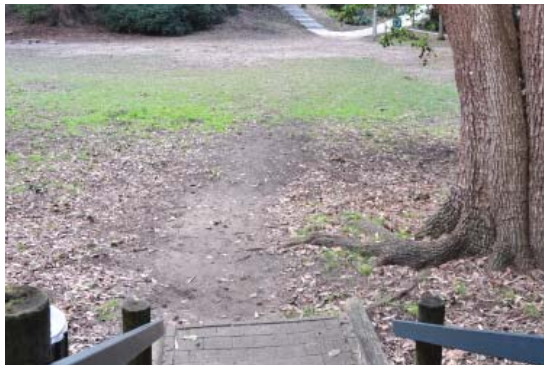
Path Connections :
Worn lawn desire lines show the popular connection between the path from Francis Street to Martin's Avenue Stairs.

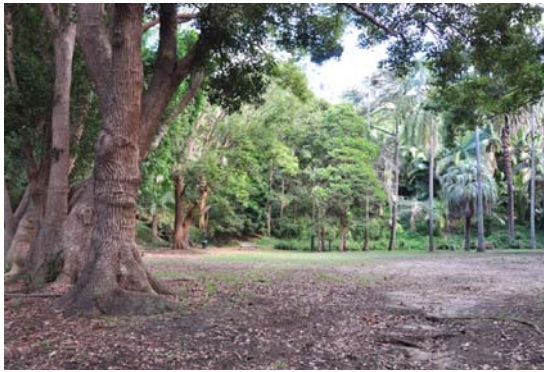
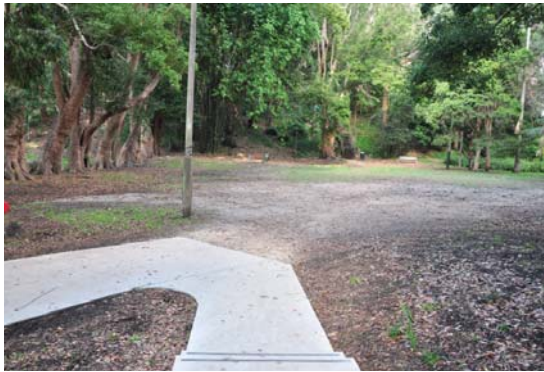
Existing Open Areas :
Partial damaged Turf exists in both the areas due to lack of sunlight for growth, water stagnation and lack of proper maintenance

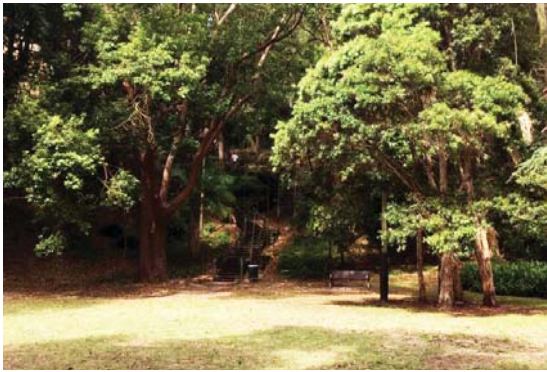
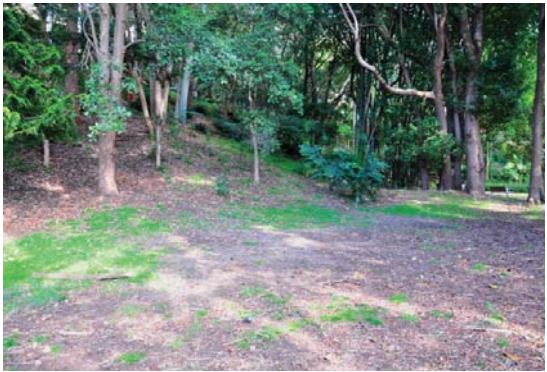
Important Views :
Important views of the Central Lawn Area and the Open space in front of the Hall will be maintained and enhanced with seats placement for maximum enjoyment

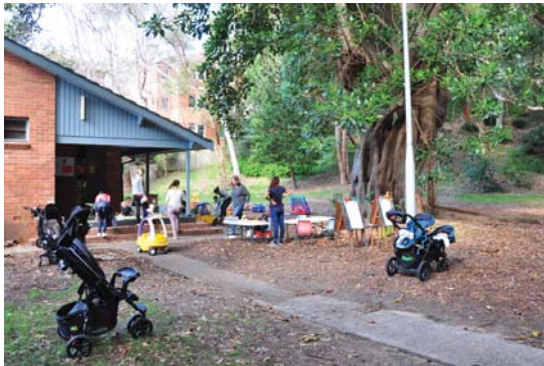
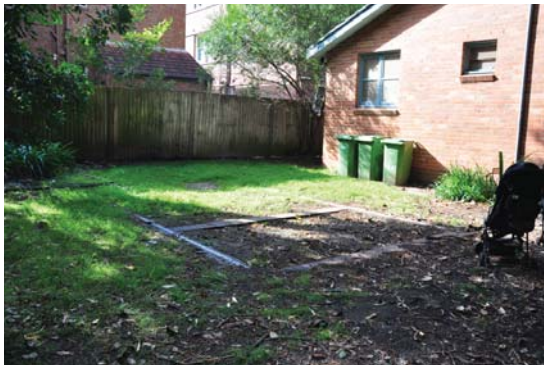
Usage of space around Community Hall :
The new works propose to enhance the current experience of space around the Community hall by demolishing the unused sandpit and introducing garden beds with sensory plants and a lawn area. A paved area in front of the hall allows for a larger space for groups to utilise.

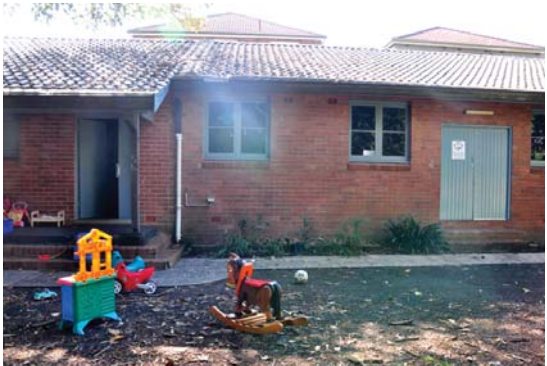
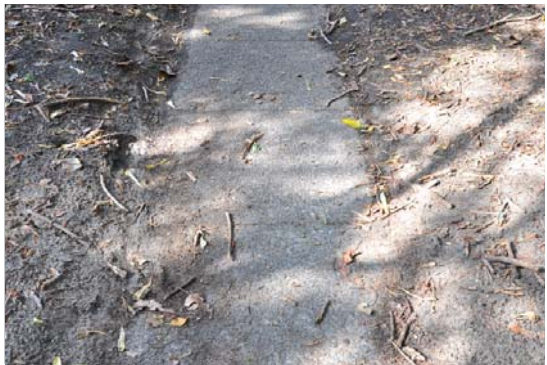
Wheelchair / Pram access Requirements :
Existing access into the hall is through steps or a steep ramp at the back. No wheelchair or pram can easily access the hall through the main entry.

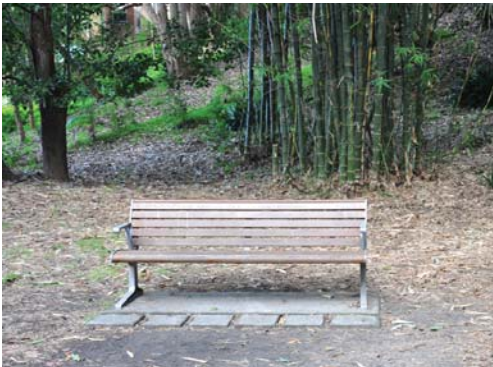
Seat to be reused

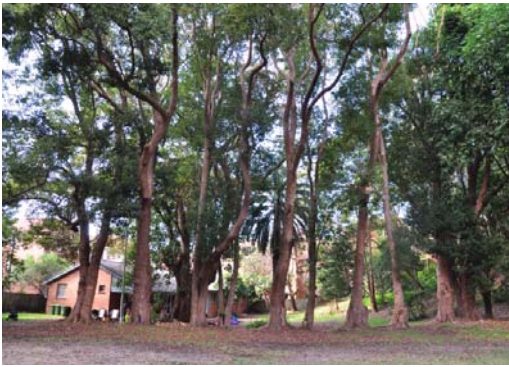
Row of Camphor Laurels to be removed

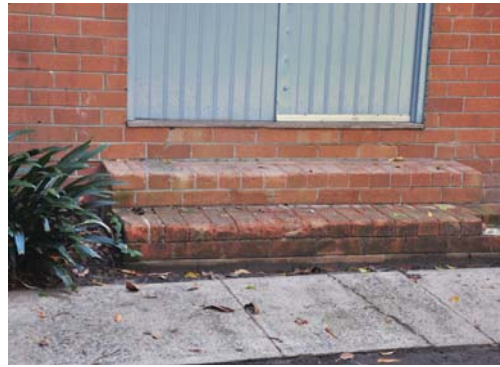
Existing main entrance to hall- to be upgraded
