# Curlew St Streetscape Upgrade Pre-Construction Concept Design Road Safety Audit

14 March 2023

## Pre-Construction Concept Design Road Safety Audit

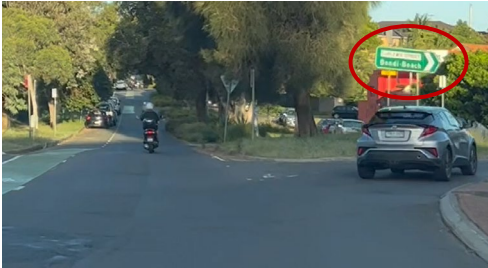
Item No.	Location	Descriptions of Findings	Design/ Photo	Likelihood	Severity	Risk Rating	Designer Response
1.	Diverge Point to Blair Street on Curlewis Street	<p>Drivers may not be aware of the diverge point on Curlewis Street as a result of the following issues:</p> <ul style="list-style-type: none"> <li>The sign plan does not show the existing direction sign for Bondi Beach. However it is likely to be relocated to make way for the proposed shared path.</li> <li>Pavement arrows give late notice of the split in traffic, road users not familiar with the area may make late lane change to avoid taking the wrong turn.</li> <li>The gore area is not well delineated with insufficient line marking and signage to emphasise its presence.</li> </ul> <p>Late lane change may cause turbulence in the traffic stream, which may increase the risk in side-swipe and rear-end collisions.</p> <p>Furthermore, the proposed shared path and crossing point are located directly behind the gore area which is not well delineated. There is a risk of errant vehicles colliding into the shared path which may result in conflicts with pedestrians and cyclists.</p>

Occasional	Moderate	Medium	<p>The risk is noted, and directional signage will be relocated and shown on final drawings. It is noted that the diverge is an existing condition and provision of the off-road cycleway improves the safety.</p>

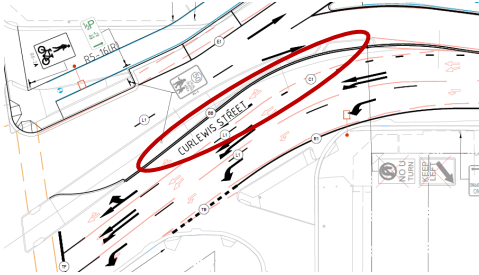
Item No.	Location	Descriptions of Findings	Design/ Photo	Likelihood	Severity	Risk Rating	Designer Response
3.	Old South Road and Curlewis Street intersection	<p>The shared through and right turn lane is 2.7m wide on Curlewis Street westbound, and may not be sufficient to accommodate the design vehicle along the curve towards the intersection, noting that the existing central median will be removed.</p> <p>Vehicles not staying within the lane may result in a side-swipe incident with vehicles in the adjacent lane.</p>

Improbable	Moderate	Low	<p>The lane widths are increased vs existing due to removal of on-road cycleway. However, it's noted the removed median does increase the risk. The risk is mitigated by the fact that only heavy vehicles sweep close to the extents of the BB line.</p>

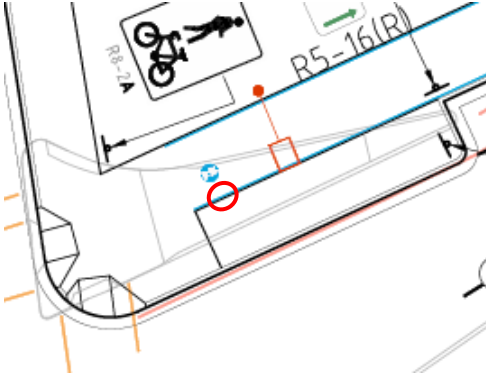
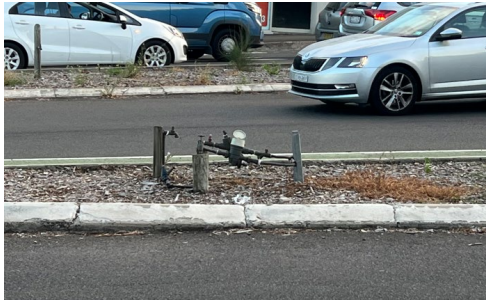
4.	Curlewis Street west of Old South Head Road	<p>Utilities located within the future shared path area, if retained, will become hazardous to pedestrians and cyclists.</p>

Occasional	Minor	Low	<p>Utilities within the zone of the future shared path will be adjusted clear.</p>

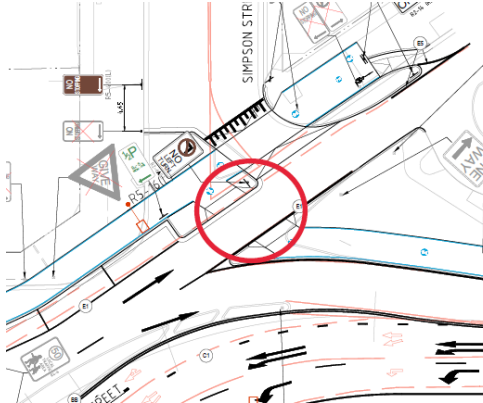
Item No.	Location	Descriptions of Findings	Design/ Photo	Likelihood	Severity	Risk Rating	Designer Response
5.	Curlewis Street and Blair Street intersection	<p>The design does not provide a crossing facility nor a clearly defined priority for shared path users at the crossing point in Blair Street.</p> <p>For cyclists travelling straight across Blair Street, this location is immediately following a diverge point.</p> <p>This may increase the risk of collisions with shared path users.</p>

Improbable	Moderate	Low	It is preferred to avoid a priority crossing for pedestrians/cyclists at this location due to proximity to the Old South Head Road intersection and potential impacts to that intersection

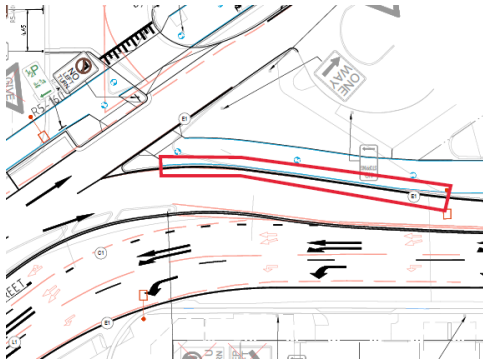
6.	Curlewis Street east of Blair Street	<p>No buffer is provided between the shared path and roadway. The TfNSW cycleway toolbox suggests that a minimum of 0.4m should be provided. A lack of clearance between the two will increase the chances of a side-swipe collision between vehicles and share path users.</p> <p>In the absence of a buffer, there is also no provision of physical separation from the travel lane along the outside of the curve. This would leave pedestrians and cyclists unprotected on the shared use path.</p> <p>This deficiency would increase the likelihood of conflicts between an errant vehicle and share path users.</p>

Improbable	Moderate	Low	Path width will be increased to provide buffer width in the final design - noting there is sufficient space available already, and sufficient width provided further east.

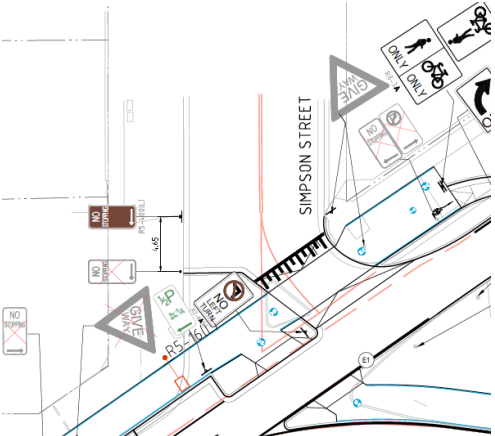
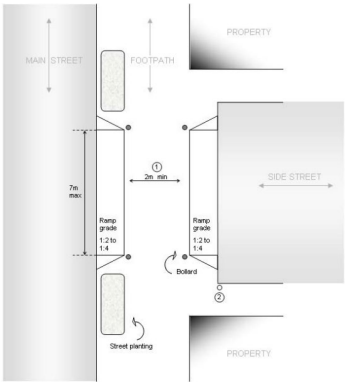
Item No.	Location	Descriptions of Findings	Design/ Photo	Likelihood	Severity	Risk Rating	Designer Response
7.	Blair Street and Simpson Street intersection	<p>The continuous footpath treatment is not designed based on the TfNSW specification stipulated in TDT2013/05.</p> <p>Inconsistency with the standard design may confuse road users, resulting in a lower degree of compliance when using the crossing facility. This would increase the likelihood of conflicts between road users.</p> <p>n.b. Piano key markings should not be provided.</p> <p>The gradient of the threshold should be as per the TDT2013/05 Continuous footpath treatment specifications.</p> <p>Recommend give way line marking adjacent the give way signage.</p>

<p>NOTES:</p> <ol style="list-style-type: none"> <li>1. Preferably 2m min, but will depend on original width of footpath. Path may need to be widened to accommodate the treatment.</li> <li>2. Stop, give way or warning signage required if vehicles exiting from side street across the treatment. R1-1, R1-2 or R2-10 or R6-1 and R2-2.</li> </ol>	Improbable	Moderate	Low	<p>The standard arrangement in TDT2013/05 is difficult to apply in this context due to the wide ramp needed to accommodate vehicle swept paths. That said, elements of TDT2013/05 will be incorporated in the final design where possible</p>

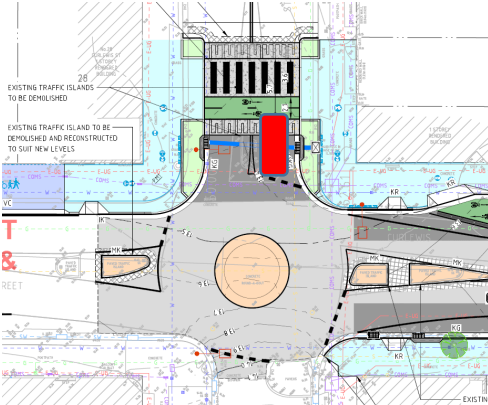
Item No.	Location	Descriptions of Findings	Design/ Photo	Likelihood	Severity	Risk Rating	Designer Response
8.	Wellington Street – Pedestrian Crossing	There does not appear to be 6m between the give way line marking on the Wellington Street north approach. Consequently, vehicles may encroach the cycleway crossing which may lead to conflict with cyclists. This safety concern is exacerbated when a large vehicle waits at the give way line.

Improbable	Moderate	Low	Currently around 5m clearance is achieved, suitable to accommodate most light vehicles. Unfortunately due to existing driveways it is not possible to set the crossing back any further. It is noted that any heavy vehicle would encroach on the crossing even with a 6m setback.

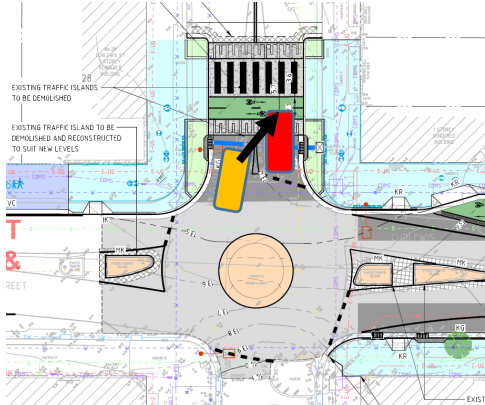
Item No.	Location	Descriptions of Findings	Design/ Photo	Likelihood	Severity	Risk Rating	Designer Response
9.	Wellington Street – Pedestrian Crossing	<p>Motorists waiting on the Wellington Street north approach to the roundabout may restrict visibility to motorists traveling northbound on Wellington Street.</p> <p>This would increase the likelihood of conflicts with cycleway users at this location.</p> <p>Lastly, if the pedestrian and cycle crossing is busy, the roundabout operation may become gridlocked which may lead to driver frustration and illogical driver behaviour.</p>

Improbable	Moderate	Low	<p>This configuration is true of any near-intersection raised threshold and the combination of the raised threshold and warning signage is relied upon to reduce vehicle speeds.</p> <p>Traffic analysis of the crossing has been undertaken which suggests the crossing will not have an adverse impact on roundabout performance.</p>

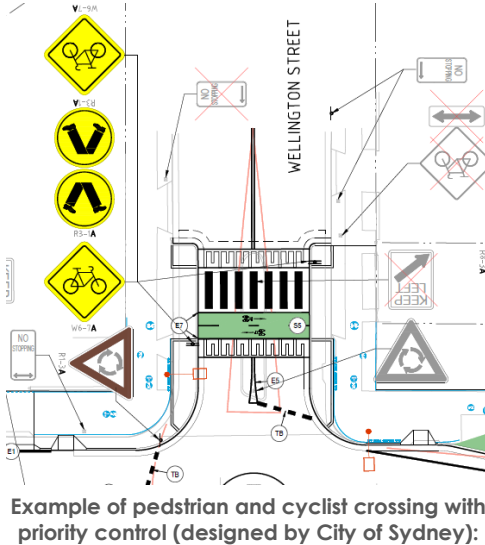
10.	Wellington Street – Pedestrian Crossing	<p>There is undefined priority between vehicles and cyclists which may cause confusion and false perception of priority over other road users. This may result in possible collisions involving vehicles, pedestrians and cyclists.</p> <p>The lack of Give Way signs may be perceived that motorists are not required to give way to cyclists crossing Wellington Street.</p> <p>An example design prepared by City of Sydney is provided which involves Give Way signs for vehicles.</p>

Improbable	Moderate	Low	<p>Replacement of Bicycle signs with Give Way (including "TO CYCLISTS" plate) is under consideration for final design</p>

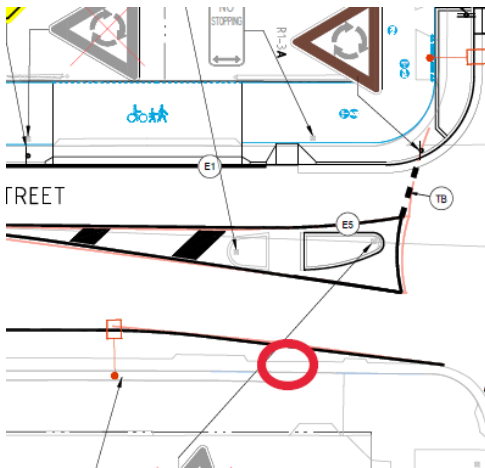
Item No.	Location	Descriptions of Findings	Design/ Photo	Likelihood	Severity	Risk Rating	Designer Response
11.	Wellington Street, Curlewis Street roundabout	<p>No kerb ramp has been provided on the south side of the west leg of the Wellington Street and Curlewis Street roundabout.</p> <p>Absence of the kerb ramp would not provide a smooth transition between the roadway and footpath for pedestrians with prams and in wheelchairs. They may walk in the roadway and cause conflicts with passing vehicles.</p>

Improbable	Moderate	Low	<p>This is an existing condition with no works proposed to the southern kerb line at this location. Consideration is being given to the feasibility of providing a kerb ramp here, which may be included in the final design</p>

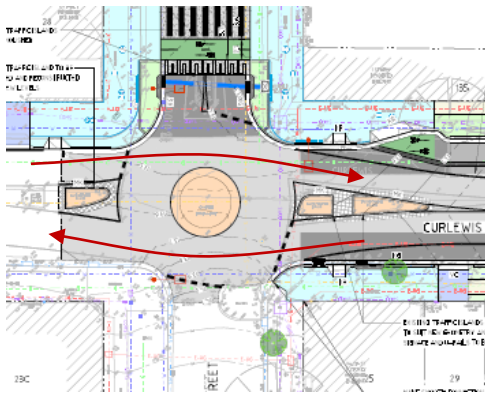
12.	Wellington Street, Curlewis Street roundabout	<p>Kerb build-outs on both Curlewis Street approaches to Wellington Street provide little deflection for motorists heading westbound and eastbound on Curlewis Street.</p> <p>Vehicle speeds may remain high when travelling through the roundabout, and increase the likelihood of collisions with other road users.</p>

Improbable	Moderate	Low	<p>Reconfiguration of the existing roundabout to achieve deflections in accordance with Austroads is beyond the scope of this project (and likely unachievable within the available footprint).</p>

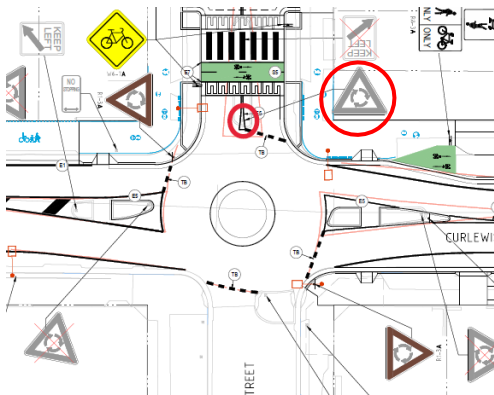
Item No.	Location	Descriptions of Findings	Design/ Photo	Likelihood	Severity	Risk Rating	Designer Response
13.	Wellington Street, Curlewis Street roundabout	<p>A 'Roundabout Give Way' sign is located within a small painted median island on the north leg of the roundabout.</p> <p>The signpost could be knocked down by turning vehicles in the absence of a raised median island. This could possibly cause injury to passing cyclists on the crossing or damage other vehicles.</p> <p>This could also result in vehicles not noticing the signage and entering the roundabout not expecting to give-way to other vehicles to their right, resulting in incidents.</p>

Improbable	Moderate	Low	The sign will be relocated to the LHS verge in the final design.
14	Wellington Street, Curlewis Street roundabout	<p>Confident cyclists cycling eastbound on Curlewis Street may avoid the shared path facility west of Wellington Street, however they may want to connect with the cycleway when it transitions to a bi-directional cycleway.</p>

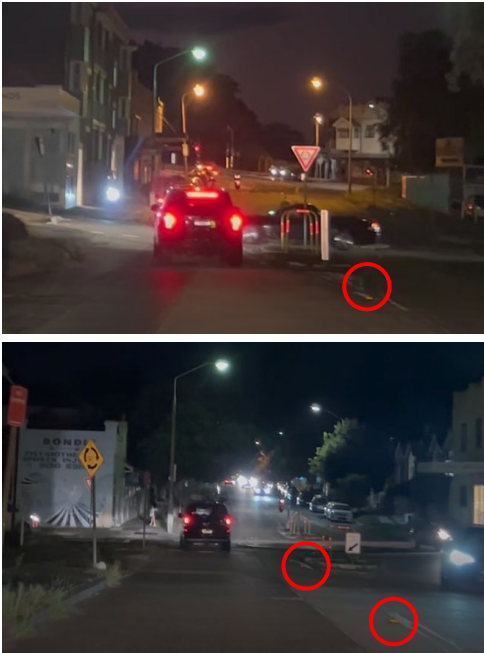
Item No.	Location	Descriptions of Findings	Design/ Photo	Likelihood	Severity	Risk Rating	Designer Response
15.	Wellington Street, Curlewis Street roundabout	The design plan does not indicate whether the existing Raised Retro-Reflective Pavement Markers (RRPM) would be replaced to delineate the shifted centreline in Curlewis Street, on approach to the Wellington Street roundabout.

-	-	Note only	Final drawings will clarify that linemarking is to be in accordance with TfNSW specifications R142 and R145 to ensure compliant RPMs are installed.

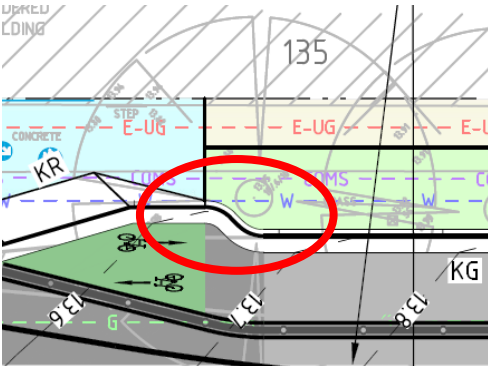
Item No.	Location	Descriptions of Findings	Design/ Photo	Likelihood	Severity	Risk Rating	Designer Response
17.	East of Wellington Street	There is a sharp change in kerb alignment for eastbound cyclists east of Wellington Street. Cyclists may not be aware of the change in alignment particularly during night-time conditions. This issue is exacerbated when following another cyclist when forward visibility is limited.

Improbable	Moderate	Low	This hazard is reduced by the adopted raised cycleway option, which removes the kerb at this location.

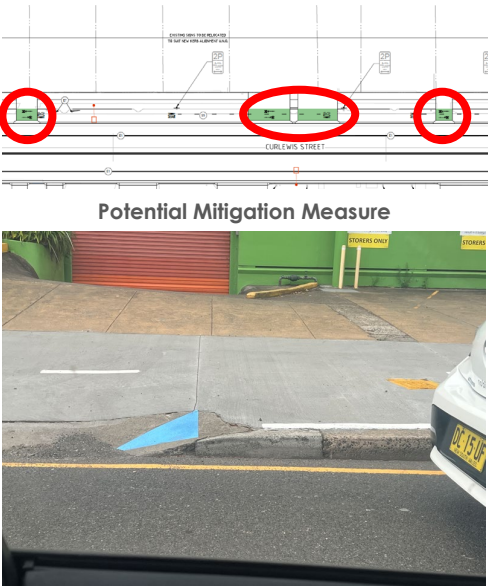
18.	General finding	<p>Cyclists travelling across the driveways would traverse the ridge of the layback which could be hazardous to cyclists.</p> <p>Consequently, cyclists may not expect the sudden dip and destabilise and lose control.</p> <p>Another possibility is cyclists may swerve to the opposite side of the cycleway to avoid the layback. This would result in conflicts with other cyclists in the opposite direction.</p>

<p>Potential Mitigation Measure</p>	Improbable	Moderate	Low	Cycle lane width of westbound cyclists to be measured from the back of laybacks, to ensure adequate width is available with that lane.

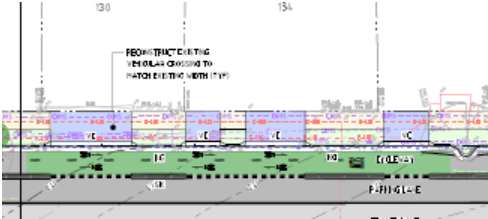
Item No.	Location	Descriptions of Findings	Design/ Photo	Likelihood	Severity	Risk Rating	Designer Response
19.	General finding	<p>There are several driveways along the route where motorists will be required to reverse across the proposed cycleway as there is insufficient area on-site to enter and exit in a forward direction.</p> <p>Inter-visibility between a cyclist and a driver turning into the driveway from Curlewis Street may be obstructed by vehicles parked in the parking lane.</p> <p>A motorist may not have full visibility of oncoming cyclists when reversing which may lead to them reversing into cyclists.</p> <p>Furthermore, vehicles awaiting a gap in traffic at a driveway may impede both directions of the cycleway. Likewise, vehicles entering a driveway from Curlewis Street may also impede the cycleway when they yield to pedestrians in the footpath.</p> <p>There is a potential risk to cyclists if motorists failed to cross the cycleway at an appropriate and safe time.</p>

Occasional	Moderate	Medium	<p>This item is unavoidable as any cycleway would require vehicles to cross it to move between properties and the roadway. Green surface treatment is provided at conflict points in accordance with the relevant specifications and guidelines.</p>

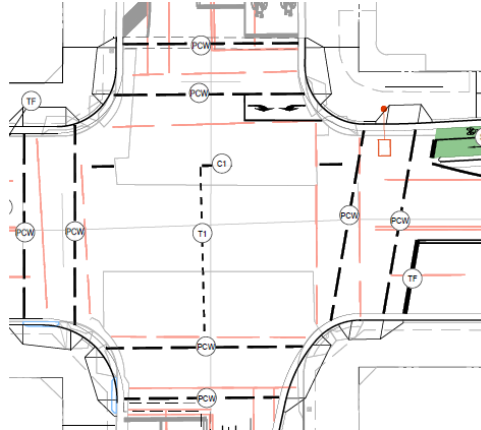
Item No.	Location	Descriptions of Findings	Design/ Photo	Likelihood	Severity	Risk Rating	Designer Response
20.	Glenayr Avenue and Curlewis Street intersection	<p>The hook turn bay is 4.3 to 5.2m long to accommodate eastbound cyclists waiting to turn right, and westbound cyclists waiting to turn left towards Glenayr Avenue southbound.</p> <p>Considering Austroads require 3m for the hook turn bay (one direction), the proposed bay is too short to accommodate two bicycles in opposite directions. This may result in conflicts between cyclists, or cyclists storing outside the hook turn bay.</p> <p>Furthermore, the hook turn bay has no bicycle line marking (i.e. green paint and bike symbol) and therefore may not be used correctly. Cyclists may ignore this and will use a conventional right-turn which has a greater risk of collision with vehicles.</p> <p>Of note, hook turns can be used as an alternative to a conventional right-turn from the centre of the road under the <i>Australian Road Rules (National Transport Commission 2012)</i>, however, there is no mention of left turn hook turns within the Austroads Guide.</p> <p>Lastly, consideration should be given to providing a hook turn for the Glenayr Avenue to Curlewis Street right turn movement.</p>

Occasional	Minor	Low	<p>This item will be further explored with TfNSW as the project seeks Approval In Principle for the TCS design.</p> <p>The left turn from Curlewis Street to Glenayr Avenue (southbound) is consistent with the intent of providing a safe turning opportunity and the absence of any sheltered facility may result in irrational cyclist behaviour (e.g. moving into the vehicular traffic stream).</p>

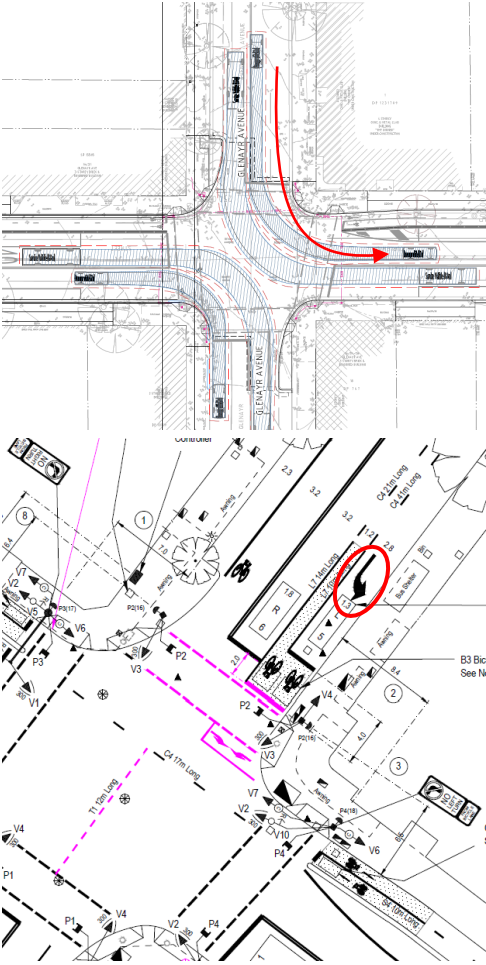
Item No.	Location	Descriptions of Findings	Design/ Photo	Likelihood	Severity	Risk Rating	Designer Response
21.	Glenayr Avenue and Curlewis Street intersection	The swept path assessment shows the left turn movement being made from the second lane (median lane) on Glenayr Avenue onto Curlewis Street rather than straddling both lanes. Consequently, motorists turning left from the kerbside lane may conflict with motorists turning left from the median lane.

Improbable	Moderate	Low	Swept paths will be confirmed to work while straddling the lanes.

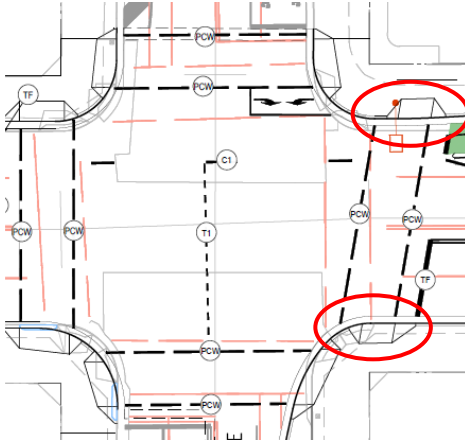
Item No.	Location	Descriptions of Findings	Design/ Photo	Likelihood	Severity	Risk Rating	Designer Response
22.	Curlewis Street, east leg at the Glenayr Avenue intersection	<p>The proposed kerb ramps are 2.3m wide in Curlewis Street and do not extend the full width of the marked foot crossings which are about 3.6m wide on Curlewis Street.</p> <p>RMS Guide to Traffic Signals Appendix D suggests kerb ramps should ideally be the full width of the crossing.</p>

-	-	Note only	Non-conformance to Appendix D to be accepted by TfNSW through Approval in Principle of the TCS design.

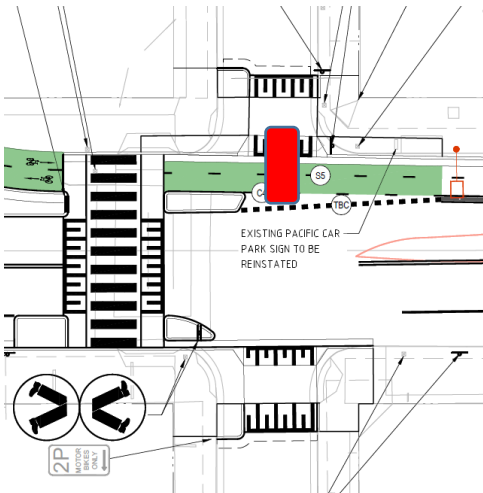
23.	Gould Street – north approach	<p>Motorists traveling southbound on Gould Street may not be able to see motorists traveling eastbound and westbound on Curlewis Street from where the Give Way signage is located i.e. north of the raised pedestrian facility.</p> <p>Traffic volumes on Gould Street are unknown, however it is anticipated motorists will wait on the cycleway when exiting Gould Street which may lead to conflicts with cyclists. Cyclists may use the travel lane to avoid queued vehicles which increases the risk of accidents.</p>

<p>Example of similar raised crossing (TfNSW Cycleway Toolbox):</p>	Improbable	Moderate	Low	<p>Gould Lane traffic volumes are not significant, and the installation of raised thresholds is intended to make it a less desirable "rat run".</p> <p>The GIVE WAY sign will be relocated to the southern side of the threshold. While this will encourage queueing on the pedestrian path, it will improve sight lines and serve to discourage queueing over the cycleway.</p> <p>The project team is exploring options where GIVE WAY signage/linemarking is provided at multiple locations to maintain cyclist priority. This may incorporate adoption of the 'Toolbox' solution outlined in Item 24.</p>

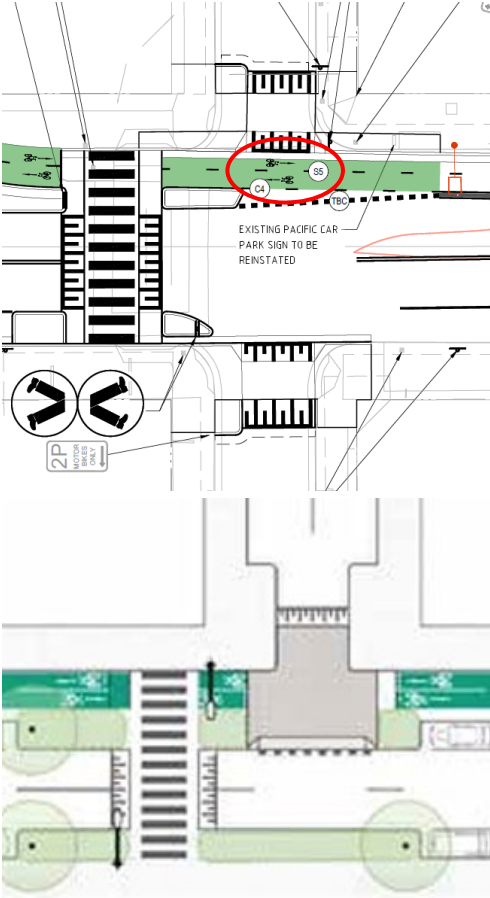
Item No.	Location	Descriptions of Findings	Design/ Photo	Likelihood	Severity	Risk Rating	Designer Response
24.	Gould Street – north approach	<p>The cycleway is not included in the raised continuous footpath treatment.</p> <p>An example design stipulated in TfNSW cycleway Toolbox involves an extension of the raised platform past the intersection.</p>

<p>EXISTING PACIFIC CAR PARK SIGN TO BE REINSTATED</p>	Improbable	Moderate	Low	<p>A raised threshold in accordance with the Toolbox is under consideration for adoption in the final design. This would assist with the issue raised in Item 23.</p>

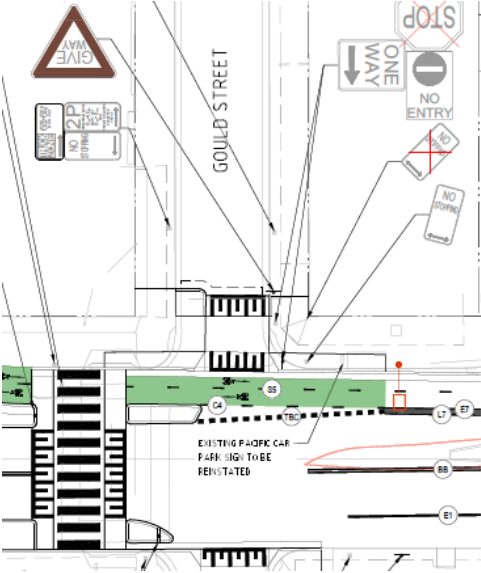
Item No.	Location	Descriptions of Findings	Design/ Photo	Likelihood	Severity	Risk Rating	Designer Response
25.	Gould Street – north approach	<p>No advance cycle crossing ahead signage is provided on the Gould Street north approach to Curlewis Street.</p> <p>Drivers may not be aware of the cycle crossing after the raised pedestrian facility and could collide with passing cyclists.</p>

Improbable	Moderate	Low	Additional advanced warning signage is under consideration for inclusion in the final design

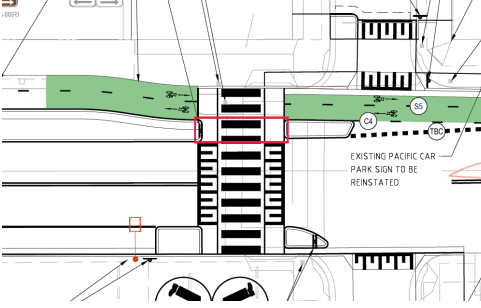
26.	Pedestrian crossing on Curlewis Street west of Gould Street	<p>The storage area for pedestrians travelling south on the pedestrian crossing between the cycleway and road is small.</p> <p>Pedestrians may store outside the storage area which may result in conflicts with cyclists or passing vehicles.</p> <p>Further, given this area is a decision point for pedestrians, it should not be marked as a pedestrian crossing.</p>

Improbable	Moderate	Low	<p>Pedestrians have priority over cyclists at this location so there is no need for storage. We consider the removal of pedestrian crossing linemarking here likely to cause additional confusion.</p> <p>Appropriate signage to inform cyclists to give way to pedestrians is under consideration for inclusion in the final design.</p>

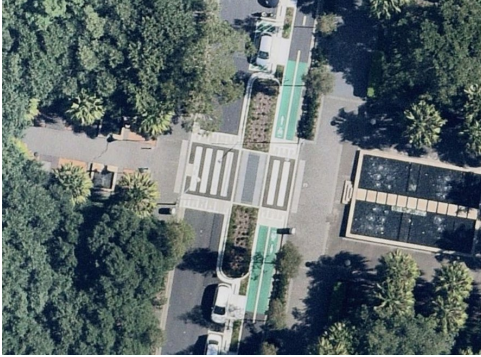
27.	Pedestrian crossing on Curlewis Street west of Gould Street	<p>Pedestrians queueing from the footpath may have their sight distance impeded by landscaping.</p> <p>The landscaping design plans indicate that <i>livistona australis</i> palms will be installed within the kerb build outs. Mature palms can grow 10 to 25 metres, which may impact sight visibility between pedestrians and cyclists.</p> <p>Insufficient sight visibility at the pedestrian crossing and cycleway increases risks to pedestrians as cyclists may not see pedestrians crossing in the northbound direction. Similarly, pedestrians may not see oncoming vehicles in the other direction.</p> <p>Landscaping within the kerb buildout should not be higher than 1.0m to allow for reciprocal visibility as per design principles in the Cycleway Design Toolbox.</p>

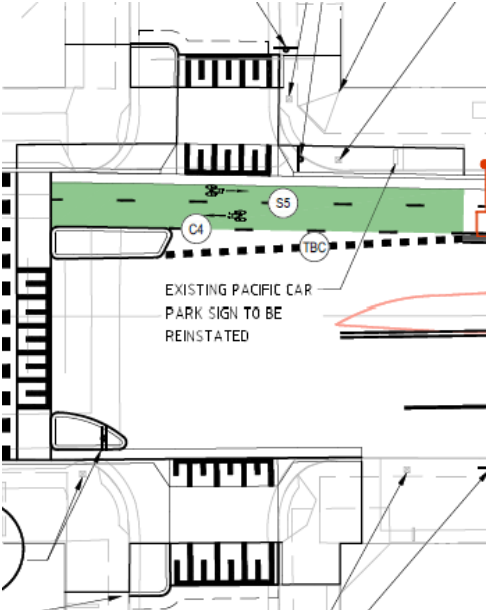
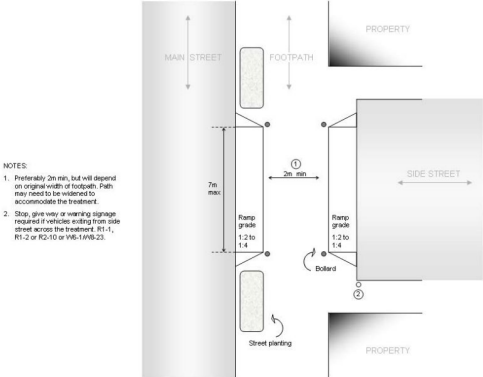
Item No.	Location	Descriptions of Findings	Design/ Photo	Likelihood	Severity	Risk Rating	Designer Response
28.	Gould Street, north and south of Curlewis Street	<p>The continuous footpath treatment is not designed based on the TfNSW specification stipulated in TDT2013/05.</p> <p>Inconsistency with the standard design may confuse road users, resulting in a lower degree of compliance when using the crossing facility. This would increase the likelihood of conflicts between road users.</p> <p>n.b. Piano key markings should not be provided.</p> <p>The gradient of the threshold should be as per the TDT2013/05 Continuous footpath treatment specifications.</p> <p>Recommend give way line marking adjacent the give way signage, if not shown.</p>

<p>NOTES:</p> <ol style="list-style-type: none"> <li>1. Preferably 2m min, but will depend on original width of footpath. Path may need to be widened to accommodate the treatment.</li> <li>2. Stop, give way or warning signage required if vehicles exiting from side street across the treatment. R1-1, R1-2 or R2-10 or min. (min R2-3).</li> </ol>	Improbable	Moderate	Low	Where practicable the design will be updated to reflect aspects of TDT2013/05.

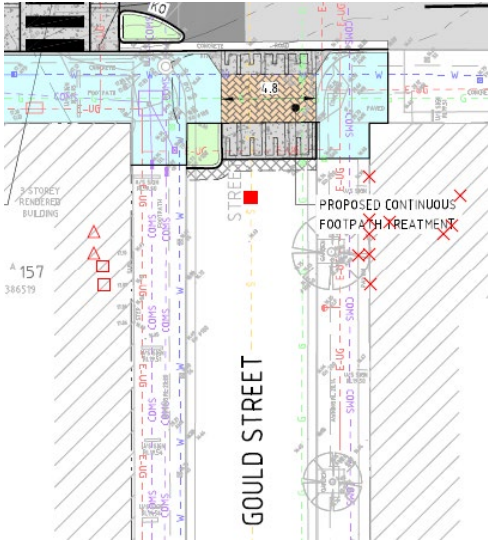
Item No.	Location	Descriptions of Findings	Design/ Photo	Likelihood	Severity	Risk Rating	Designer Response
29.	Gould Street south of Curlewis Street	<p>There is no provision of a street light directly above the proposed continuous footpath in Gould Street (south). Although an existing street light is located some 10m to the south, the illumination level may not be sufficient.</p> <p>Insufficient level of illumination at the continuous footpath increases the risk to pedestrians as drivers may not sight the facility and the users on it during the night time.</p>

Improbable	Moderate	Low	Lighting calculations have been undertaken along Curlewis Street to ensure compliance.

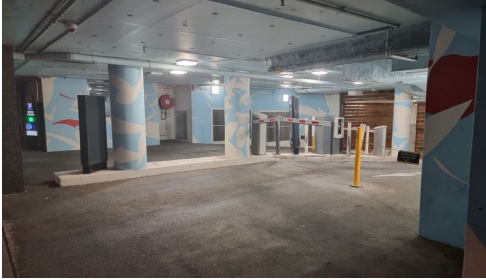
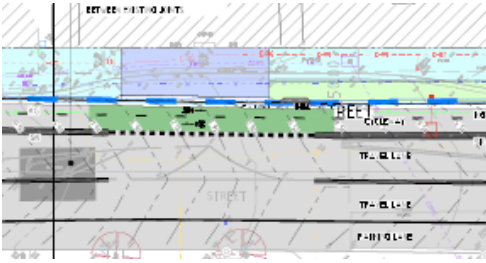
Item No.	Location	Descriptions of Findings	Design/ Photo	Likelihood	Severity	Risk Rating	Designer Response
30.	Pacific Car Park	<p>During busy periods, vehicles queueing for the boom gate when entering the car park may queue across the cycleway. This would increase the chance of a conflict between cyclists and queued vehicles.</p> <p>Cyclists may also use the roadway or footpath to avoid vehicles queued across the cycle lane which increases the chances of incidents with vehicles or pedestrians.</p>

Improbable	Moderate	Low	Noted, however this cannot be avoided. It is hoped that vehicle wishing to enter the carpark would queue on the road, without stopping on the cycleway. This may be monitored after construction and additional signage installed if compliance is poor.

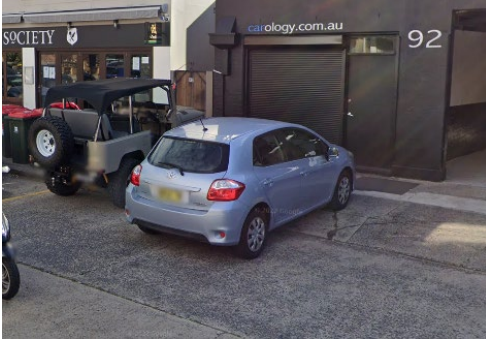
31.	Carlogy, east of Glenayr Avenue	<p>Outside Carlogy cars park in at a 90 degree angle across the driveway. In the future, these cars may park across the cycleway, however for the purposes of this audit it is assumed motorists would not park in this location in the future.</p>

-	-		Council will enforce legal parking as required.

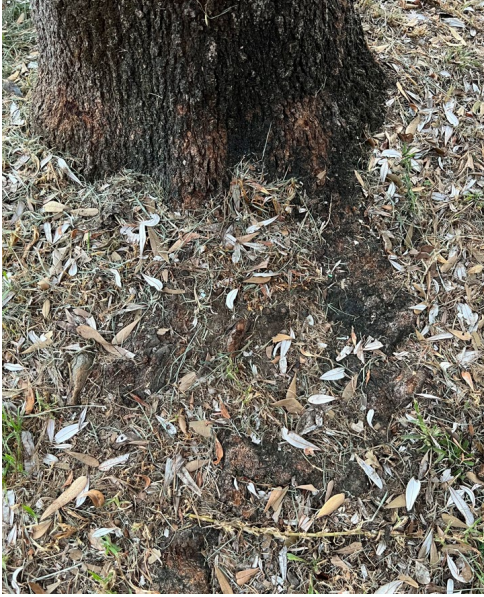
Item No.	Location	Descriptions of Findings	Design/ Photo	Likelihood	Severity	Risk Rating	Designer Response
34.	General comment	The existing trees to be retained adjacent to the cycleway have large tree roots that may disturb the cycleway pavement. Overgrowing roots may lift the pavement overtime.

-	-	Note only	Suitable pavements over the tree roots to minimise risk are currently being further explored

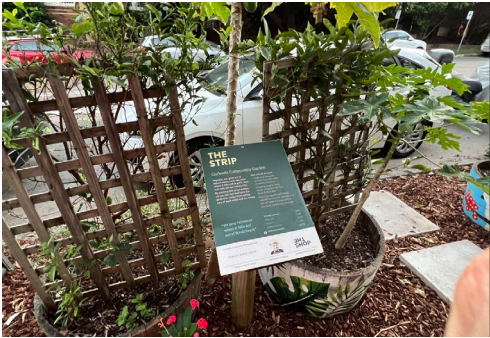
35.	North side of Curlewis Street, west of Glenayr Avenue	It is not clear whether the Curlewis Community Garden located within the footpath west of Glenayr Avenue can be maintained.

-	-	Note only	Retention of this garden is not included in the project scope

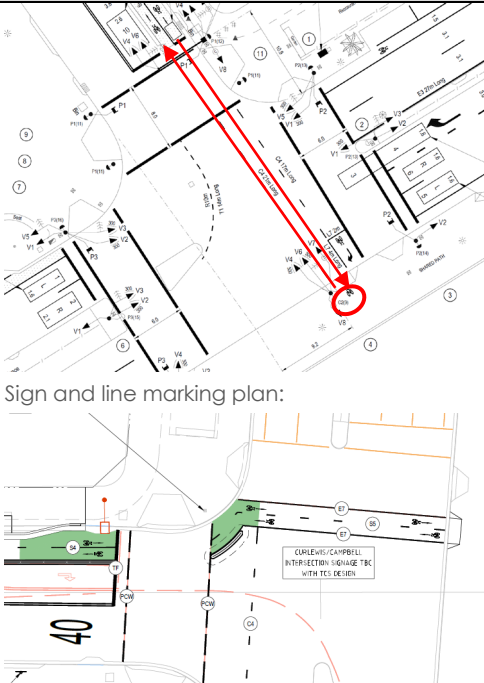
Item No.	Location	Descriptions of Findings	Design/ Photo	Likelihood	Severity	Risk Rating	Designer Response
	Street intersection	<p>The TCS plan indicates the existing C4 guideline permits cyclists to ride in both directions and access the bike ramp. However, the pavement markings on the southern SUP on Campbell Parade indicates northbound direction only. This may cause confusion for cyclists and result in potential conflicts between riders. Furthermore, the bicycle crossing and the kerb ramp are narrower than the width of the bi-direction cycleway in Curlewis Street. This may result conflicts between cyclists travelling in the northbound and southbound directions.</p> <p>Contrastingly, the sign and line marking plan indicates bi-directional bicycle crossing with a widened kerb ramp would be provided in Campbell Parade. However, a hook turn bay is not provided for cyclists turning right onto Campbell Parade.</p>

<p>Sign and line marking plan:</p>				Designs are subject to ongoing coordination and review with TfNSW and these comments are under consideration

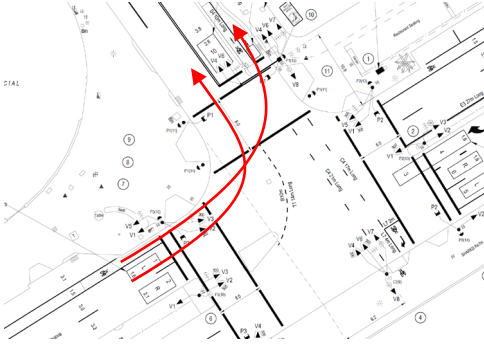
38.	West leg approach side of Campbell parade	<p>The design does not indicate any connectivity or restriction for cyclist turning movements from the existing on-road cycleway on Campbell Parade (west approach) to Curlewis Street. This would potentially cause confusion for cyclists and result in conflicts with other road users.</p> <p>In Phase A, when both cyclists and vehicles are given a green phase, cyclists can only go straight ahead along Campbell Road. However, cyclists may ride on the Campbell Parade footpath before joining the proposed cycleway.</p>

Occasional	Moderate	Medium	Designs are subject to ongoing coordination and review with TfNSW and these comments are under consideration

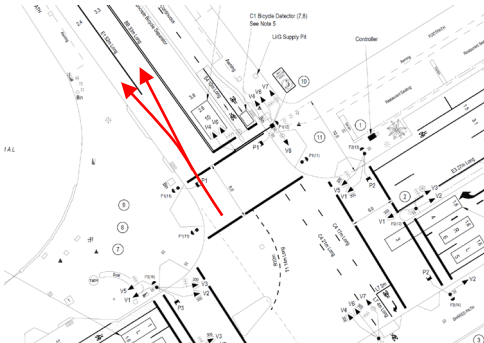
Item No.	Location	Descriptions of Findings	Design/ Photo	Likelihood	Severity	Risk Rating	Designer Response
		This may cause conflicts with the pedestrians on the footpath.	 				
39.	Curlew Street departure side	The E1 edge line on Curlew Street departure lane lacks a closed end or taper. This may potentially cause motorists misjudging their travel path and result in side-swipe conflicts when merge to the travel lane.

Occasional	Minor	Low	A taper is being considered for this edge line

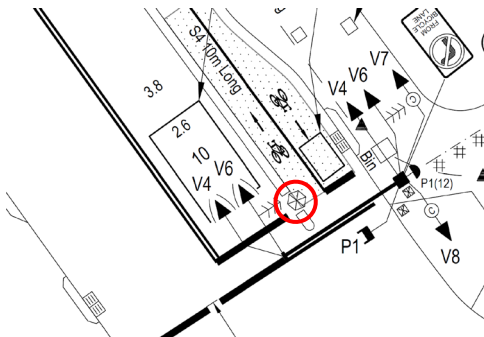
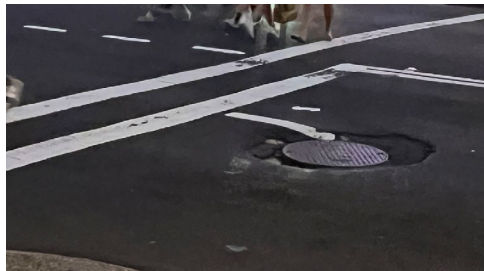
Item No.	Location	Descriptions of Findings	Design/ Photo	Likelihood	Severity	Risk Rating	Designer Response
40.	Curlew Street approach to the Campbell Parade intersection	<p>The ridge between the pavement and utility pit exceeds the surface tolerance of 10mm specified in Austroads Guide to Road Design Part 6A.</p> <p>If not repaired, the change in level of the surface may unseat a cyclist.</p>

Improbable	Moderate	Low	Adjustment of lid/pavement levels/both to be included in scope of work.
41	Curlew Street, near Campbell Parade.	<p>Signage should be provided to delineate the bidirectional cycleway and adjacent pedestrian footpath at the commencement of the facility, and the end of the facility.</p>
