WAVERLEY COUNCIL HAZARDOUS BUILDING MATERIALS SURVEY

WAVERLEY COUNCIL CHAMBERS CORNER OF PAUL ST AND BONDI RD, BONDI JUNCTION NSW 2022

REFERENCE No. S10345-R01

JULY 2018

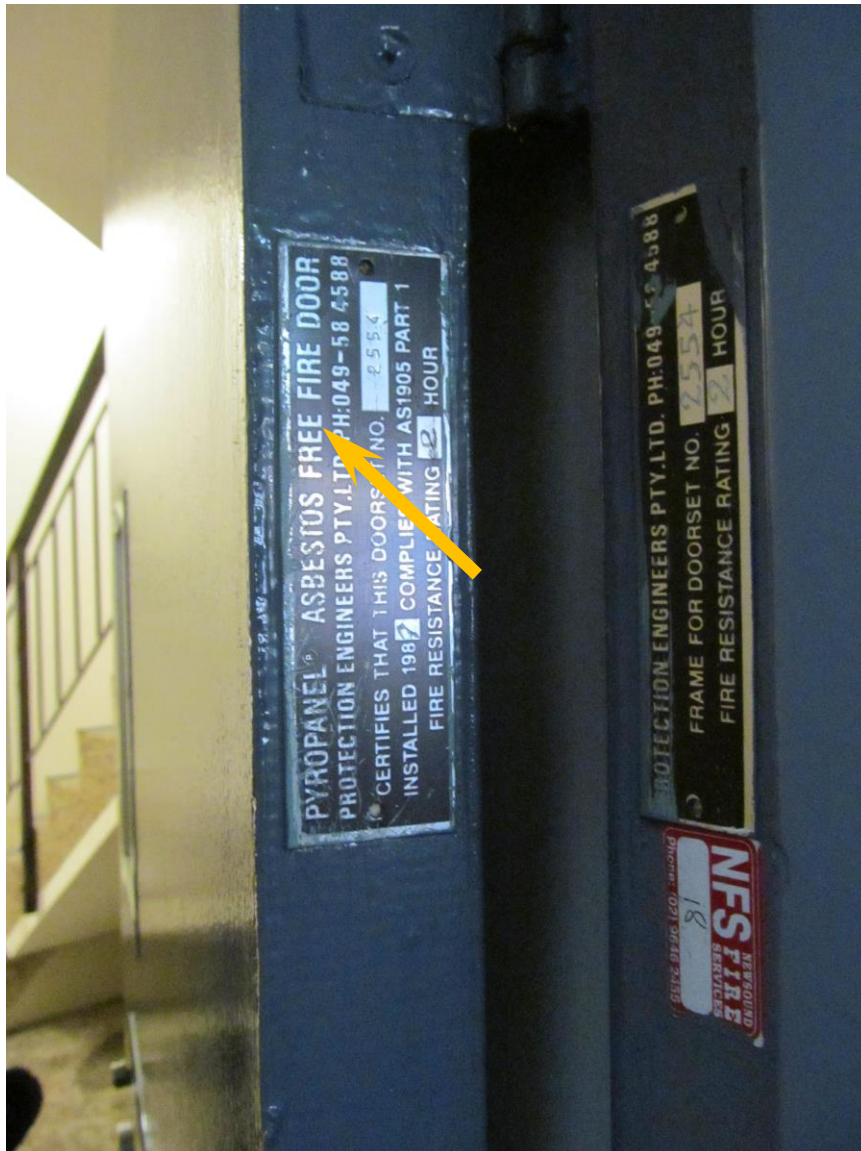
Photograph A18

Description: The yellow arrow points to a fire door which does not contain asbestos.

Recommendation: NA

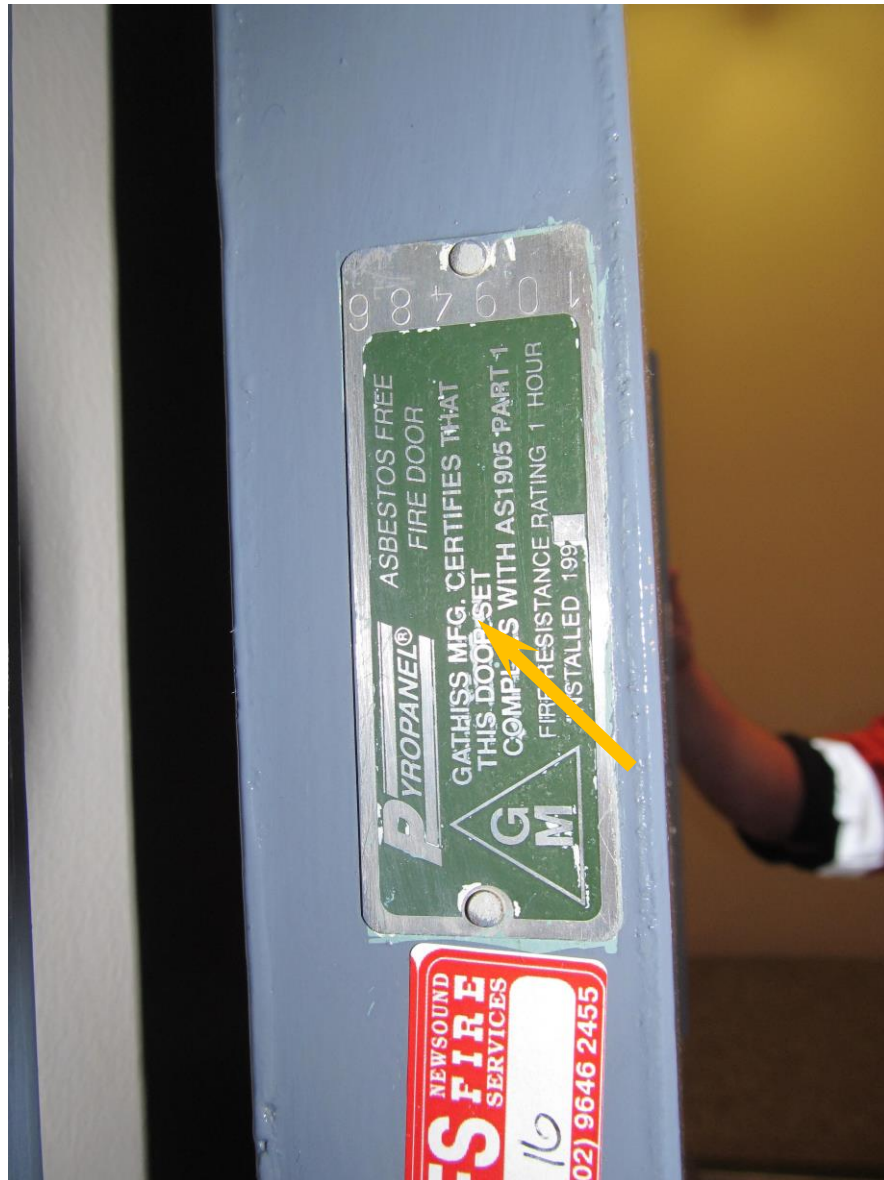
Photograph A19

Description: The yellow arrow points to a fire door which does not contain asbestos.

Recommendation: NA
