PANOV—SCOTT South Bronte Pump and Pumphouse Replacement

This presentation is made for public exhibition of the Concept Design for the South Bronte Pump and Pumphouse Replacement Project.

Waverley Council have asked PANOV—SCOTT along with CIVILLE to prepare the Concept Design for a new pump house, new dual pump system, new access stair and associated barriers, and rectification to the existing pool lining.

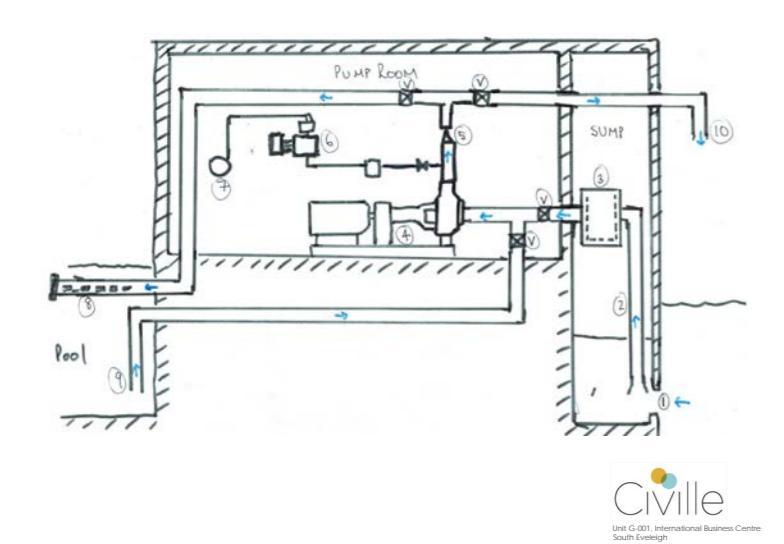
#### 375mm inlet

- 300mm diameter suction pipe
- Steel mesh basket strainer
- Centrifugal pump
- Non return valve Priming chamber and air release valve
- Vacuum pump
- Pool diffuser outlet
- Pool pump drain intake
- 10 Pumped outlet to ocean
- Valve

The components of the existing pump system are described in the above sketch, extracted from Civille's Bronte Ocean Pool - Pump House Assessment, noting this is a surface mounted centrifugal pump with secondary priming pump.

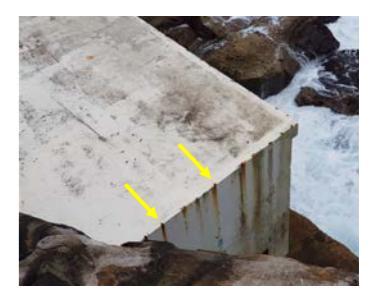
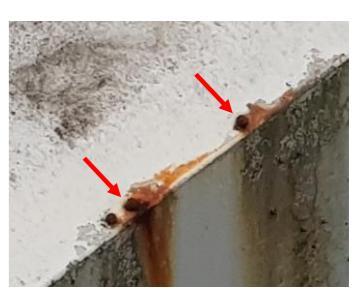
- Cracking, concrete spalling and corroded exposed reinforcing bar ends were determined during visual inspection by Acor.
- Unknown structural capacity, in relation to extent to which outer skin has been designed to rely on inner skin for structural integrity.
- The extent of deterioriation of the existing concrete and reinforcment is yet to be determined via hammer test and sample testing for chloride and carbonation, noting 50% of northern facade previously found to be drummy.
- M16-300 chemical anchors dowelled into existing slab/rock below the pump house may be an inadequate embedment for higher peak stresses expected.
- Lap length between anchors & wall reinforcement is also inadequate.
- Method for repair to the outer skin can be established, however, subject to testing noted above, this work is likely to be extensive.

Severe concrete spalling was evident during visual inspection by Acor, with large sections of concrete beginning to delaminate, voids found in the wall where concrete has spalled and delaminated, and extensive cracking determined during visual inspection.

- Corrosion stains as well as 1mm wide cracks evident on roof, which may be indicative of concrete spalling, along with corroded exposed reinforcing bar ends on edge of roof slab determined during visual inspection by Acor.
- Structural capacity of the roof is inadequate due to use of non-ductile F81 steel reinforcing mesh in the roof slab.

Above: Plan view of existing pump house which shows the original 1920's fabric in red, and the 1998 additional concrete skin shown in green

Right: Photographs detailing the deterioration of the outer concrete skin (4 from left), inner concrete skin (middle 4) and roof structure (4 from right)

- The inner skin of reinforced concrete was constructed in the early 1920's, to an unknown structural design. Its condition is noted as irreparable in various studies referenced in this report.
- The outer skin and roof, also of reinforced concrete, was constructed circa 1998 to encase and/or replace the existing structure.
- It is unknown if the outer skin was designed as an independent structure, or to act as a composite structure, relying on the inner skin to achieve its design capacity.

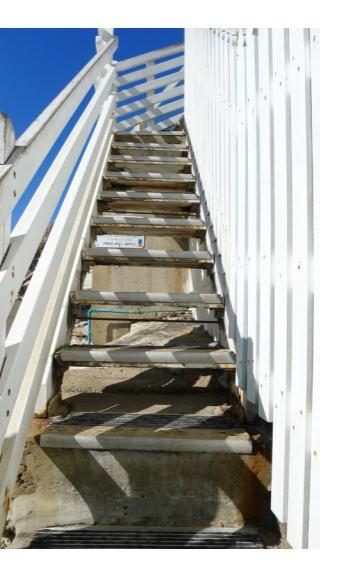
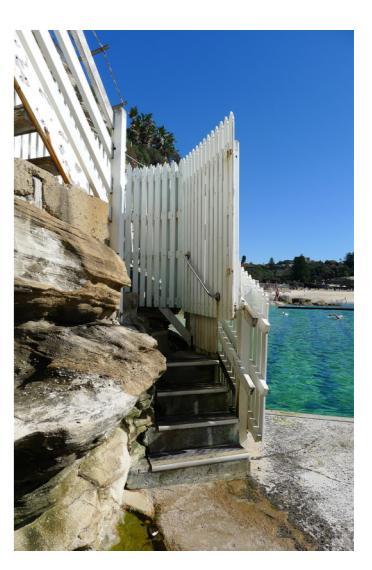
Despite the addition of non-slip stair nosings, the stair is non-compliant in the number, size and consistency of risers and treads as well as the steepness of the stair, its various balustrade styles and and general lack of handrails and tactile ground surface indicators. The timber components are in a deteriorated state.

Far left: Plan view of existing stair

Left to right: Photographs demonstrating the extent of screening & barbed wire barricades to deter climbing on and jumping from the cliff face into the pool; signage indicating the same; inconsistent construction & non-compliant stair elements pose a safety risk

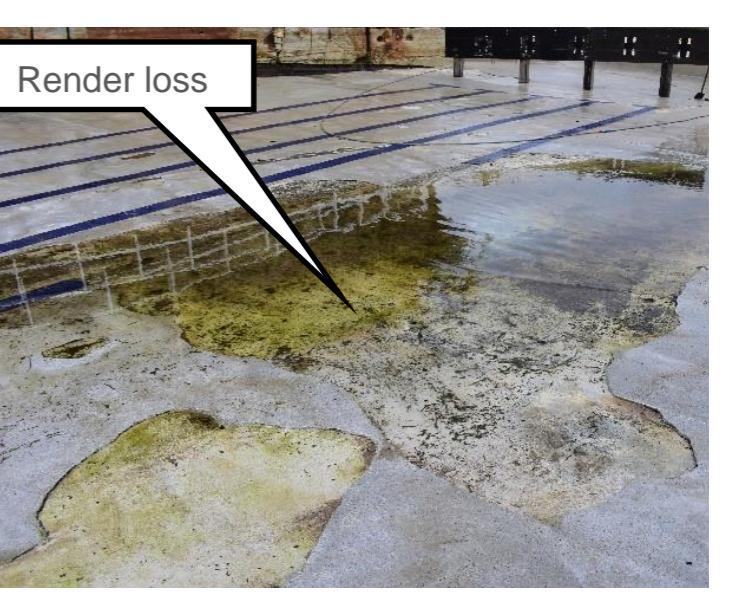
The existing Bronte Pool surface, which was installed in 2016, is deteriorating and has resulted in a patchy surface with larger areas where the underlying slab is visible.

In addition, cracked, 'drummy' or delaminated render was observed, including on the base of the pool where pressure relief holes have been drilled to relieve the render of upward pressure from seawater

Far left: Plan view of pool showing extent of surface loss in red Left to right: Photographs showing a loose piece of 15mm thick surface render with partial coating of adhesive; an example of delaminating surface render on the pool wall; an example of substantial surface render loss on the pool base

The causes of deterioration to the surface are likely to include pressure and abrasive forces exerted during weekly cleaning, wave loading on the pool structure, updward pressure from seawater travelling beneath the pool structure and possible inadequate surface preparation prior to application of the surface.

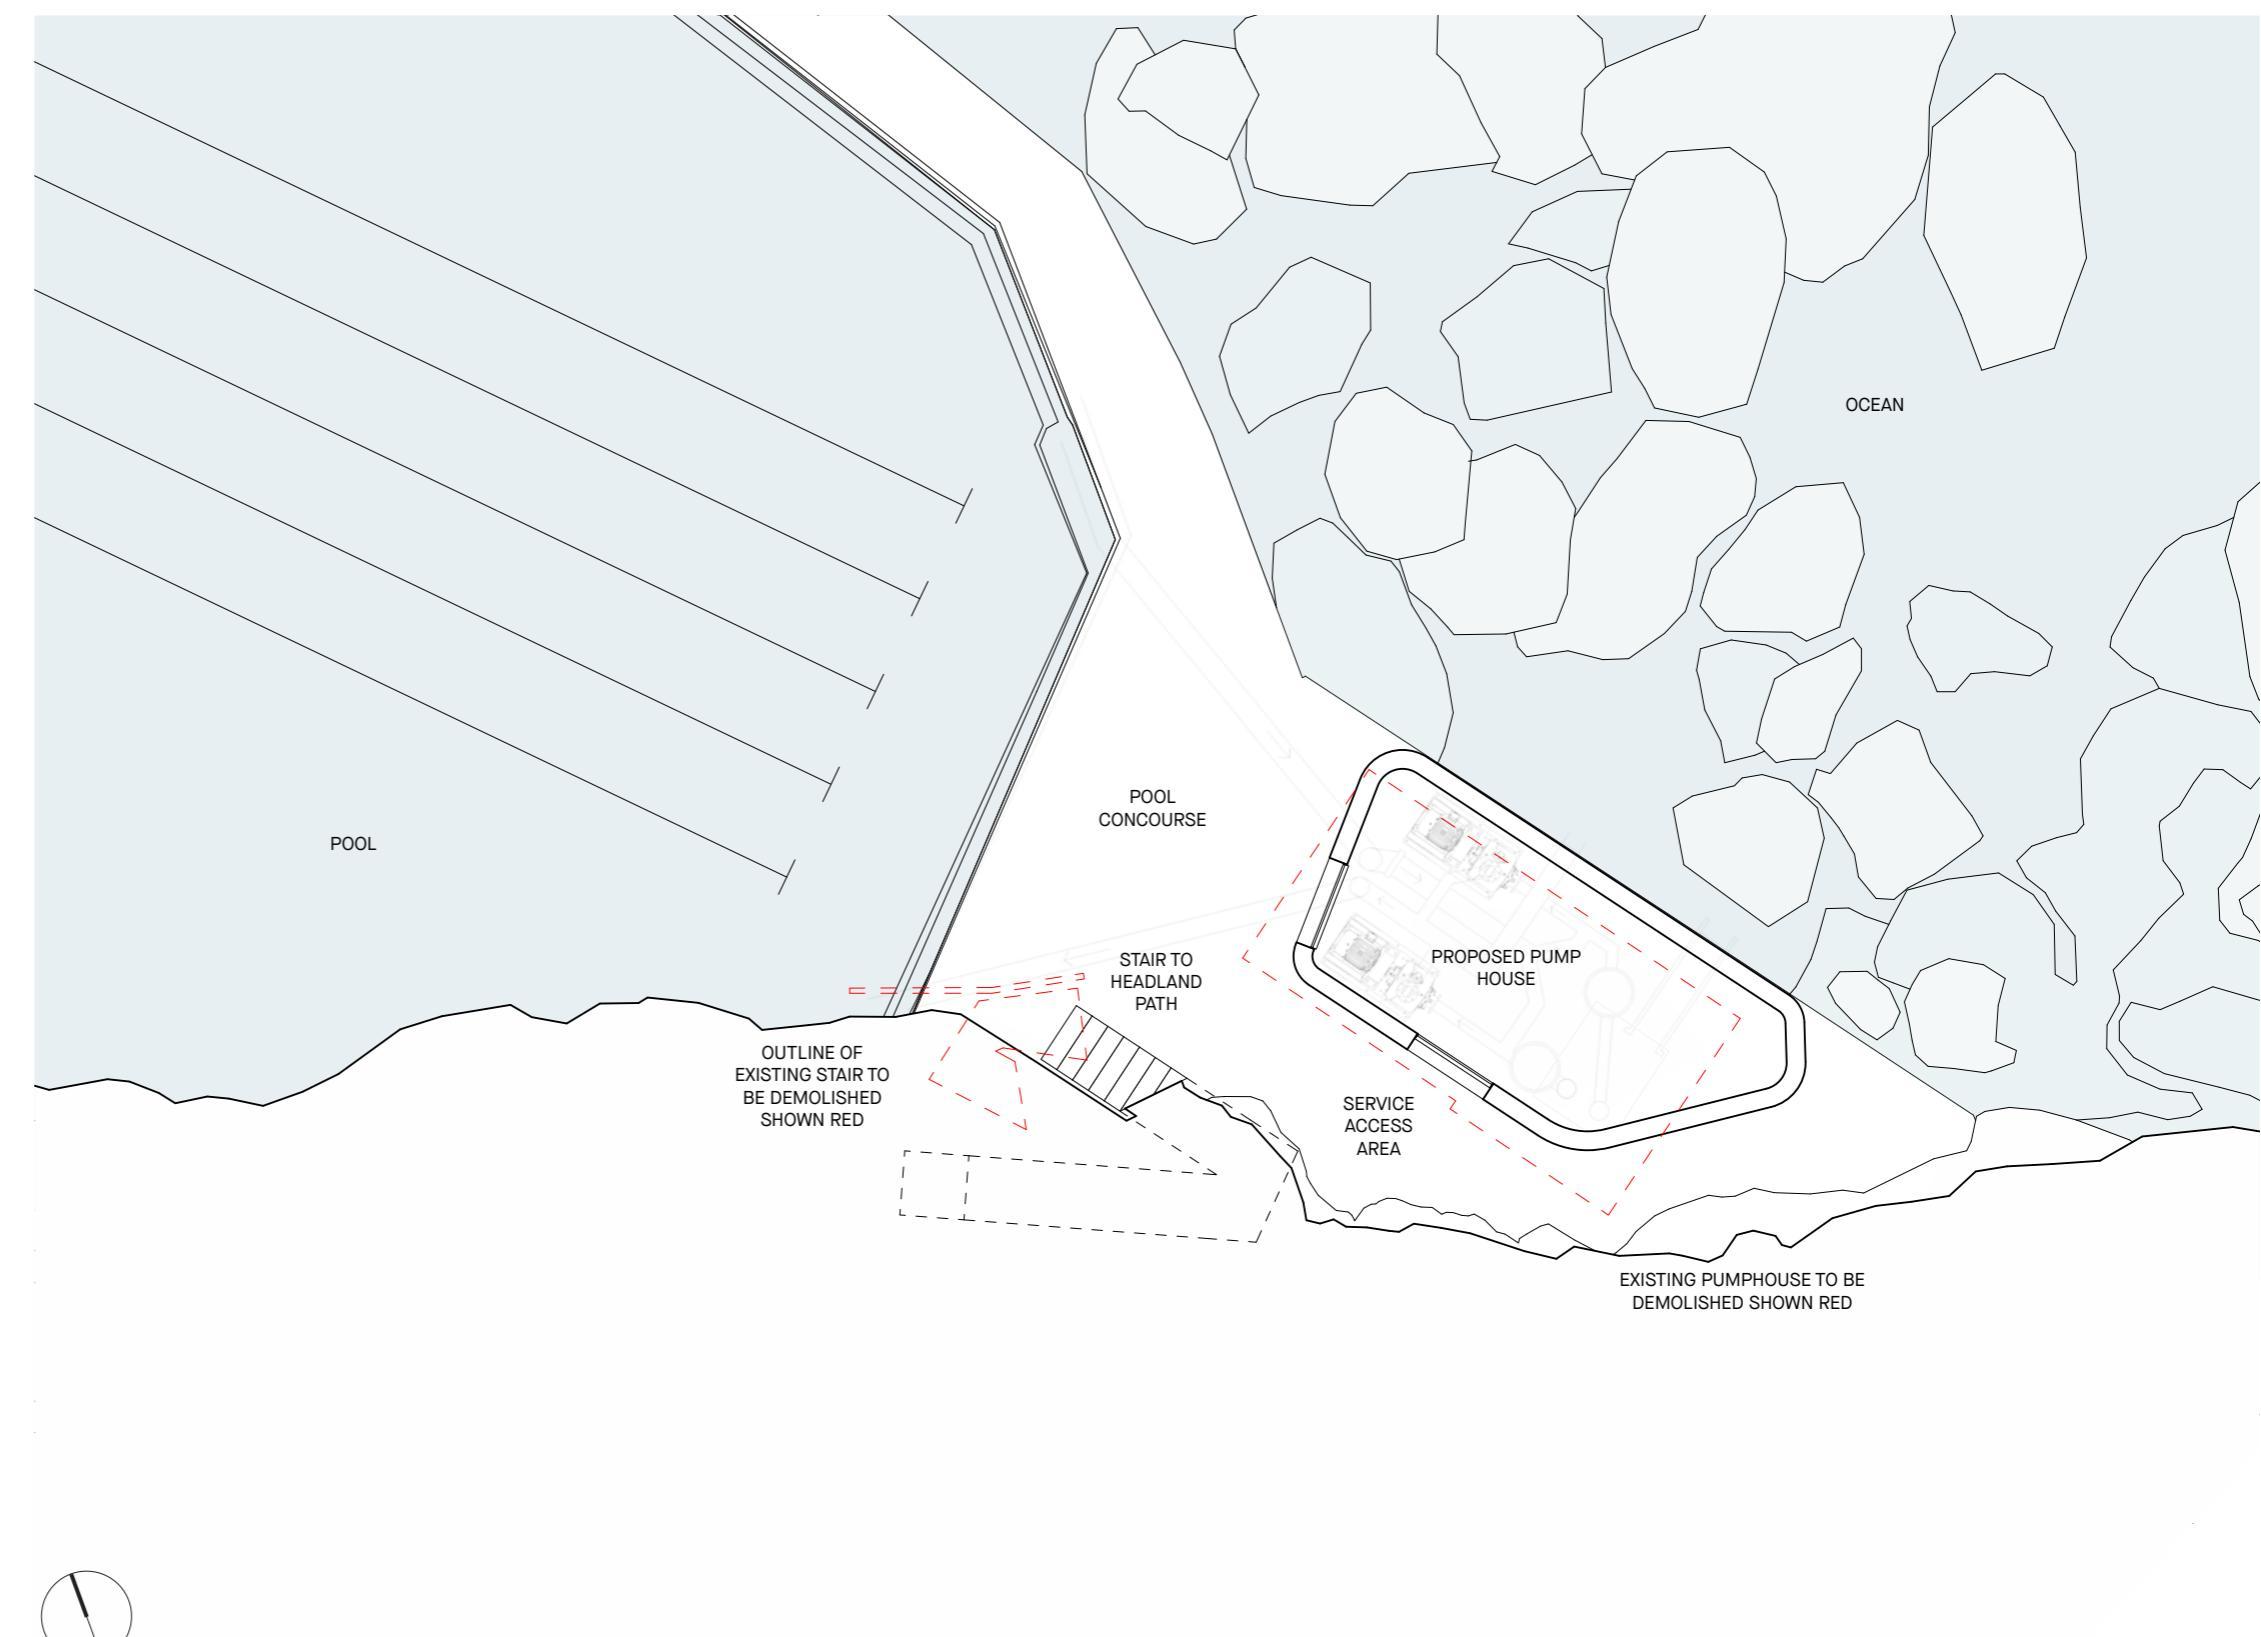
Concept site plan - at level of pool concourse & pumphouse

The proposed pumphouse will employ a material palette which is low maintenance and which responds to its natural landscape setting - a grey concrete base anchors the pumphouse to the pool concourse, with the walls above being a sand coloured concrete akin to the surrounding sandstone cliffs.

A large door is provided into the south western side of the pumphouse for daily access, with a second door facing the pool for additional access as required. This might double as a community signboard or recess for art and cultural interpretation. Doors will be detailed to withstand likely wave action.

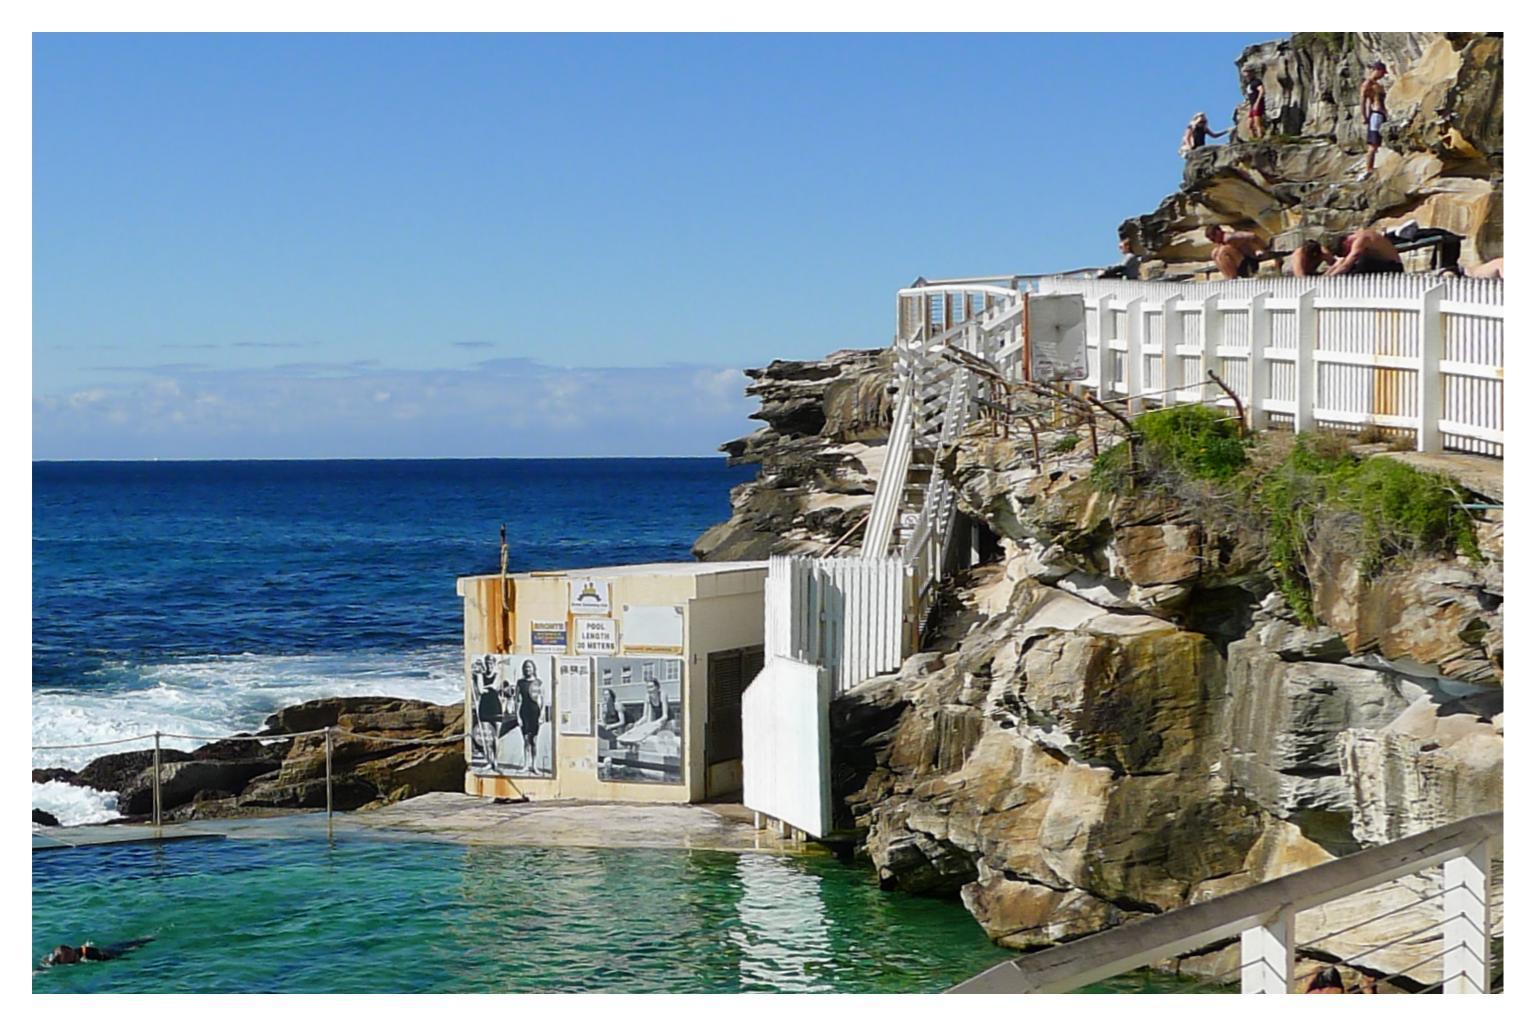
Reference photograph across Bronte Pool towards existing pumphouse and stair (above) and similar view of proposed pumphouse and stair (right) using 3D terrestrial scan survey of immediate context as base for modelling software.

The proposed pumphouse adopts a slender proportion, with splayed walls that relate to its natural and built context, and rounded corners to reduce its visual impact.

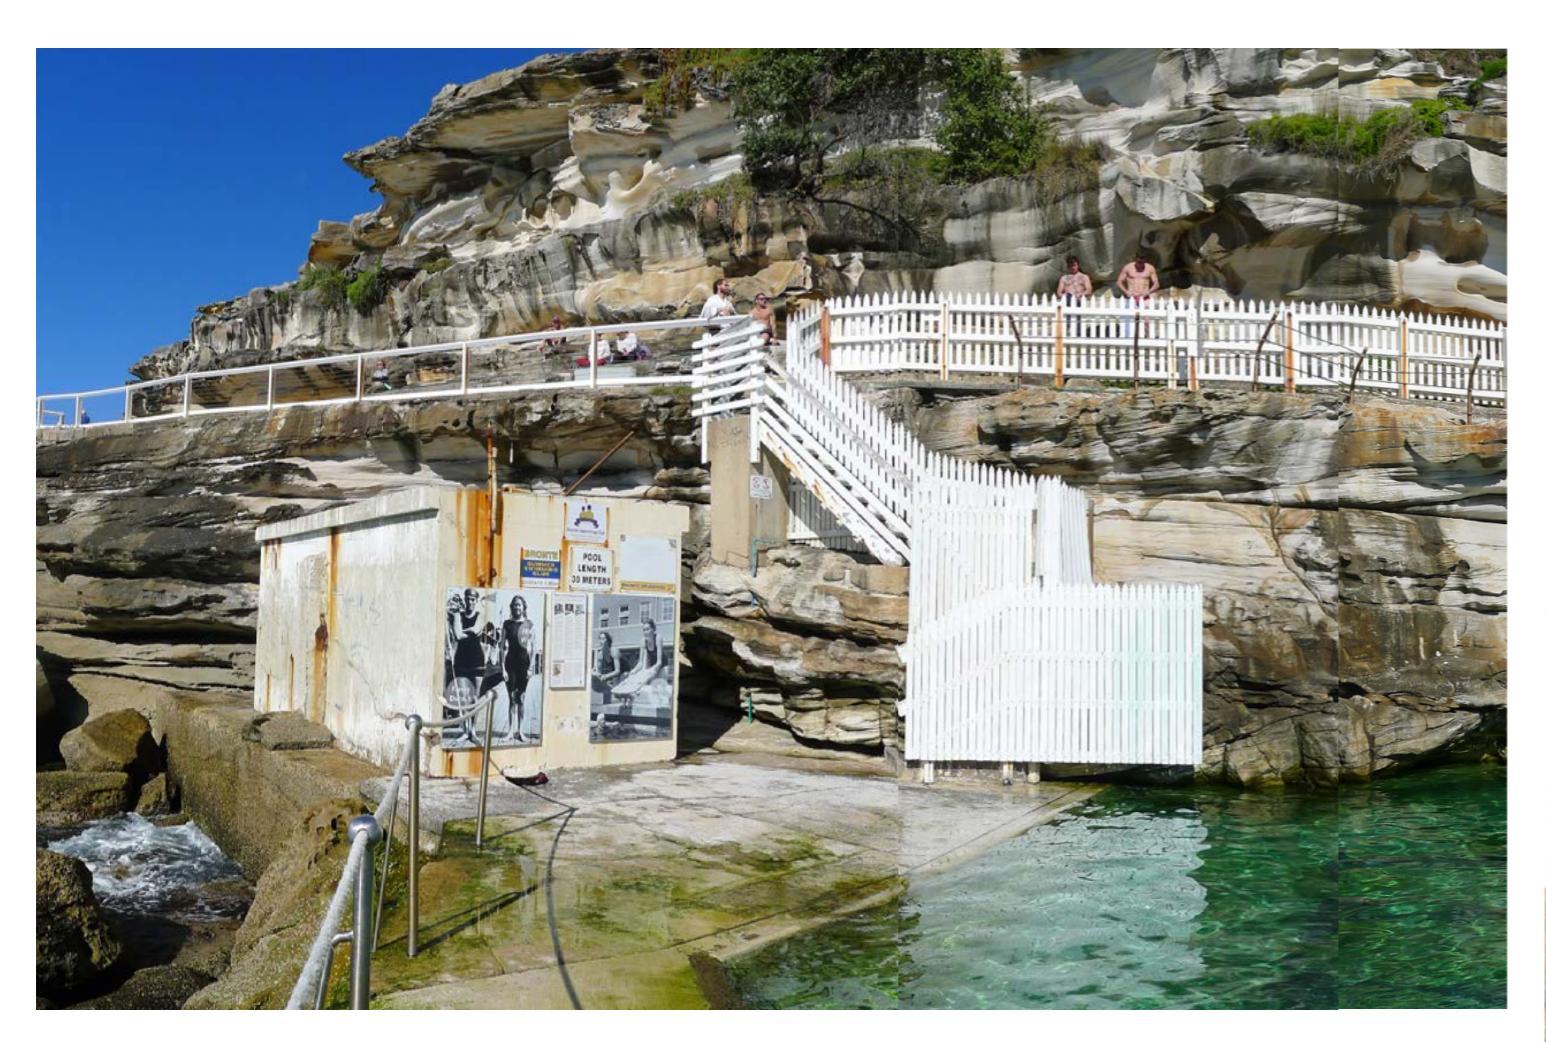
Reference photograph along Bronte Pool seawall towards existing pumphouse and stair (above) and similar view of proposed pumphouse and stair (right) using 3D terrestrial scan survey of immediate context as base for modelling software.

The proposed pumphouse adopts a slender proportion, with splayed walls that relate to its natural and built context, and rounded corners to reduce its visual impact.

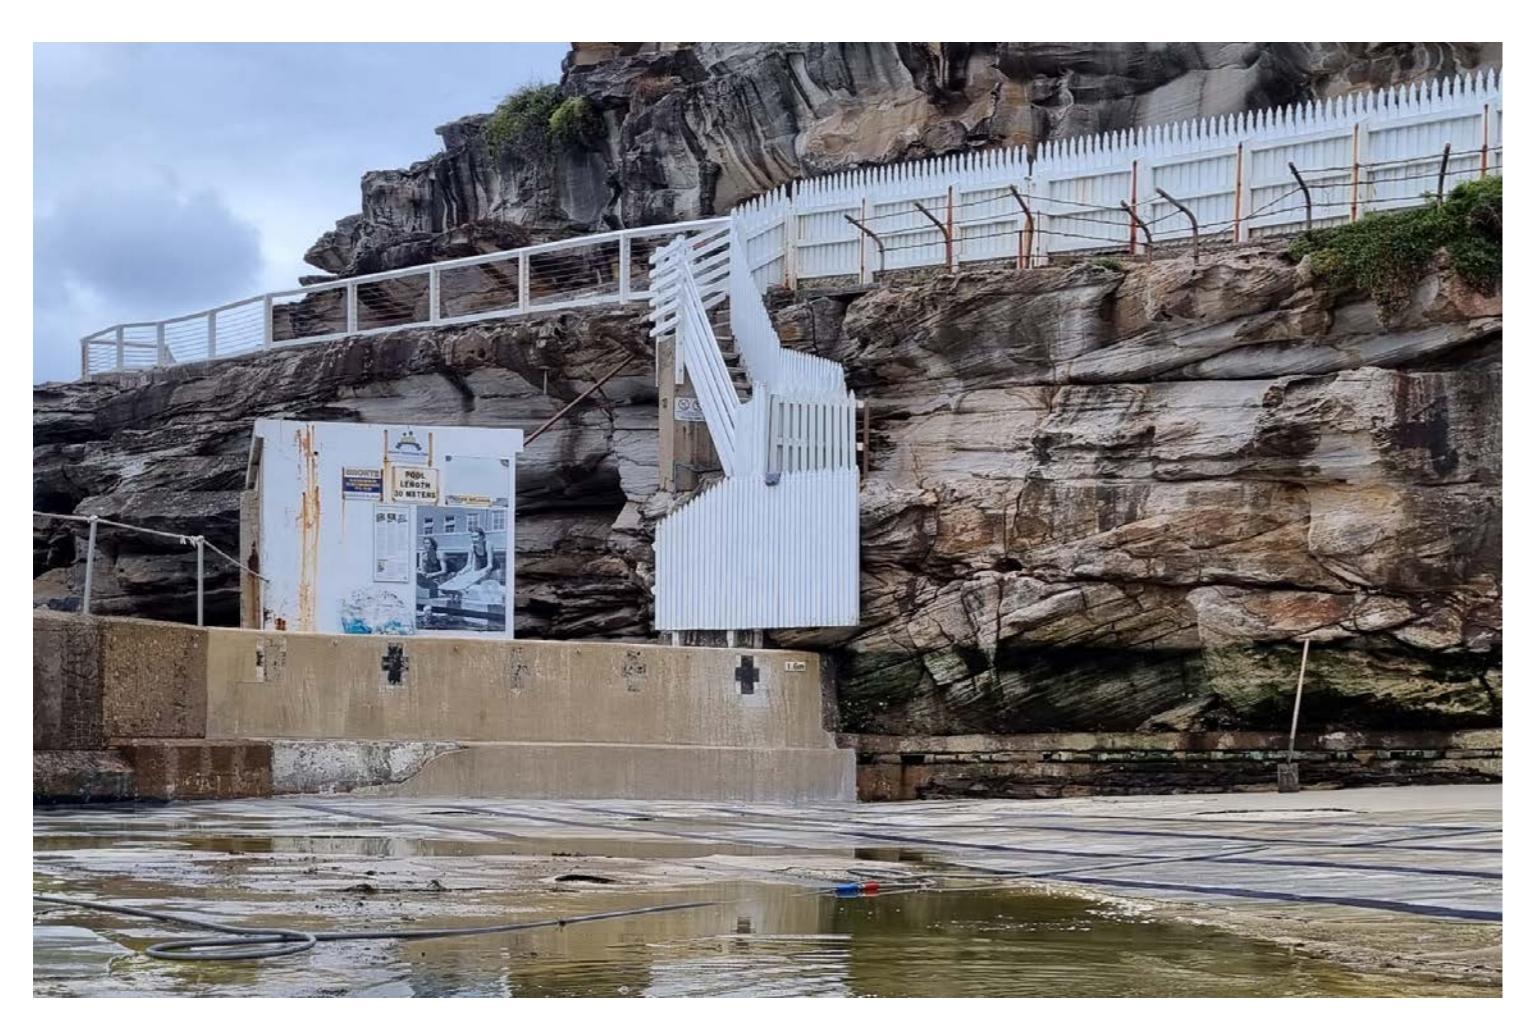
Reference photograph from in Bronte Pool when empty towards existing pumphouse and stair (above) and similar view of proposed pumphouse and stair (right) using 3D terrestrial scan survey of immediate context as base for modelling software.

The proposed pumphouse adopts a slender proportion, with splayed walls that relate to its natural and built context, and rounded corners to reduce its visual impact.

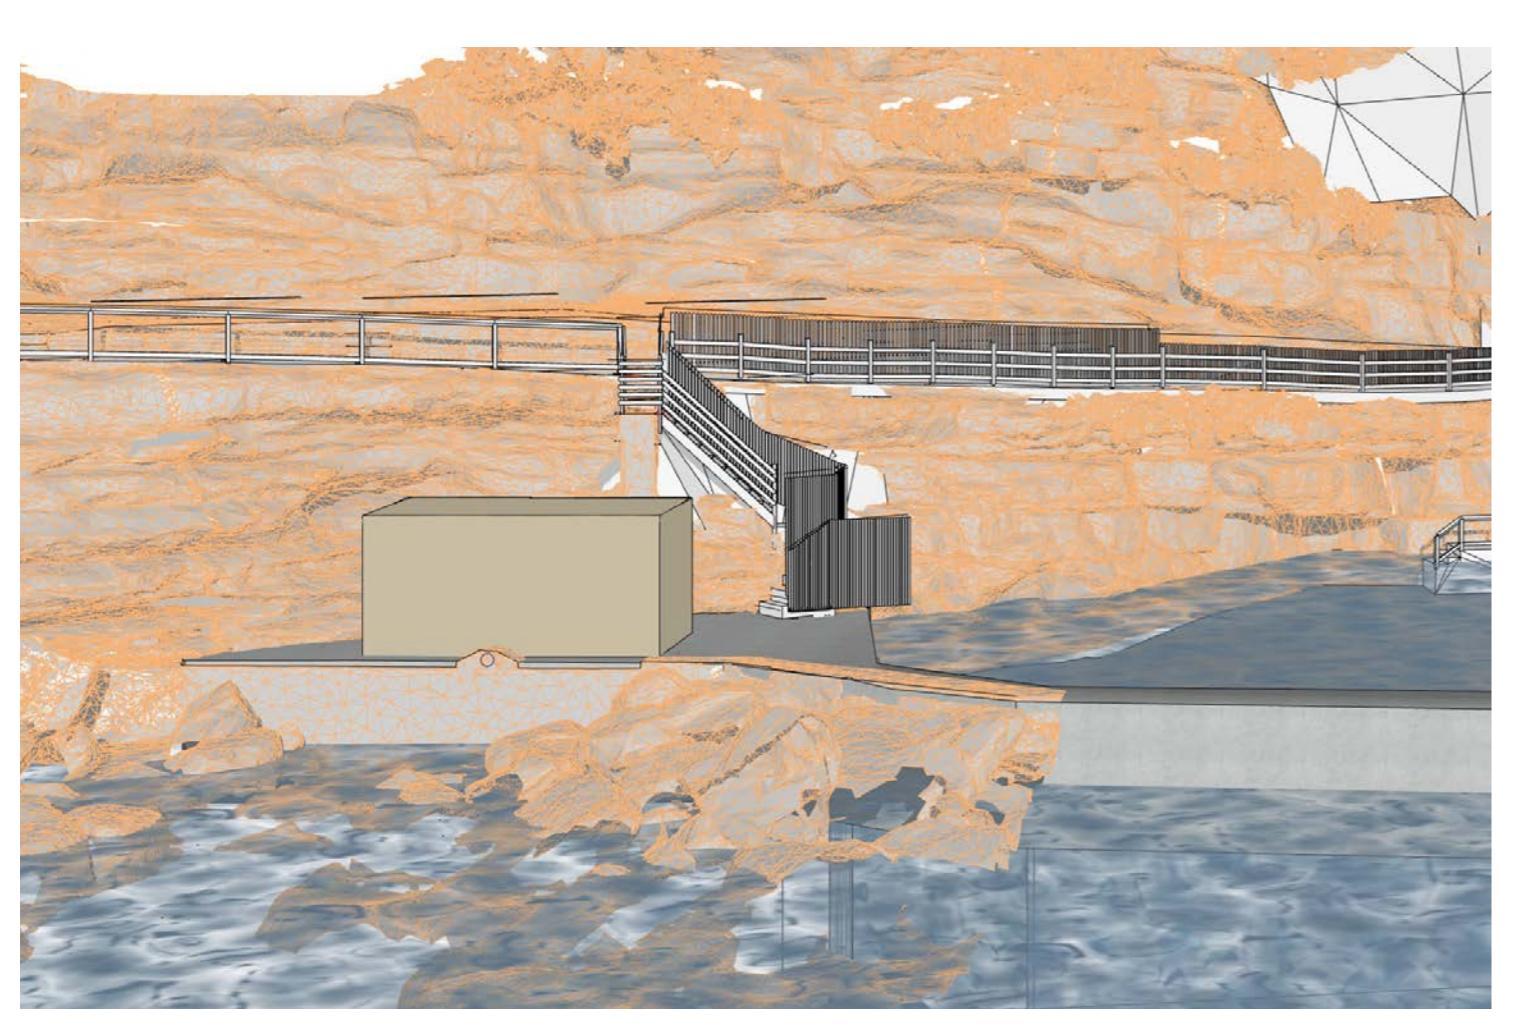
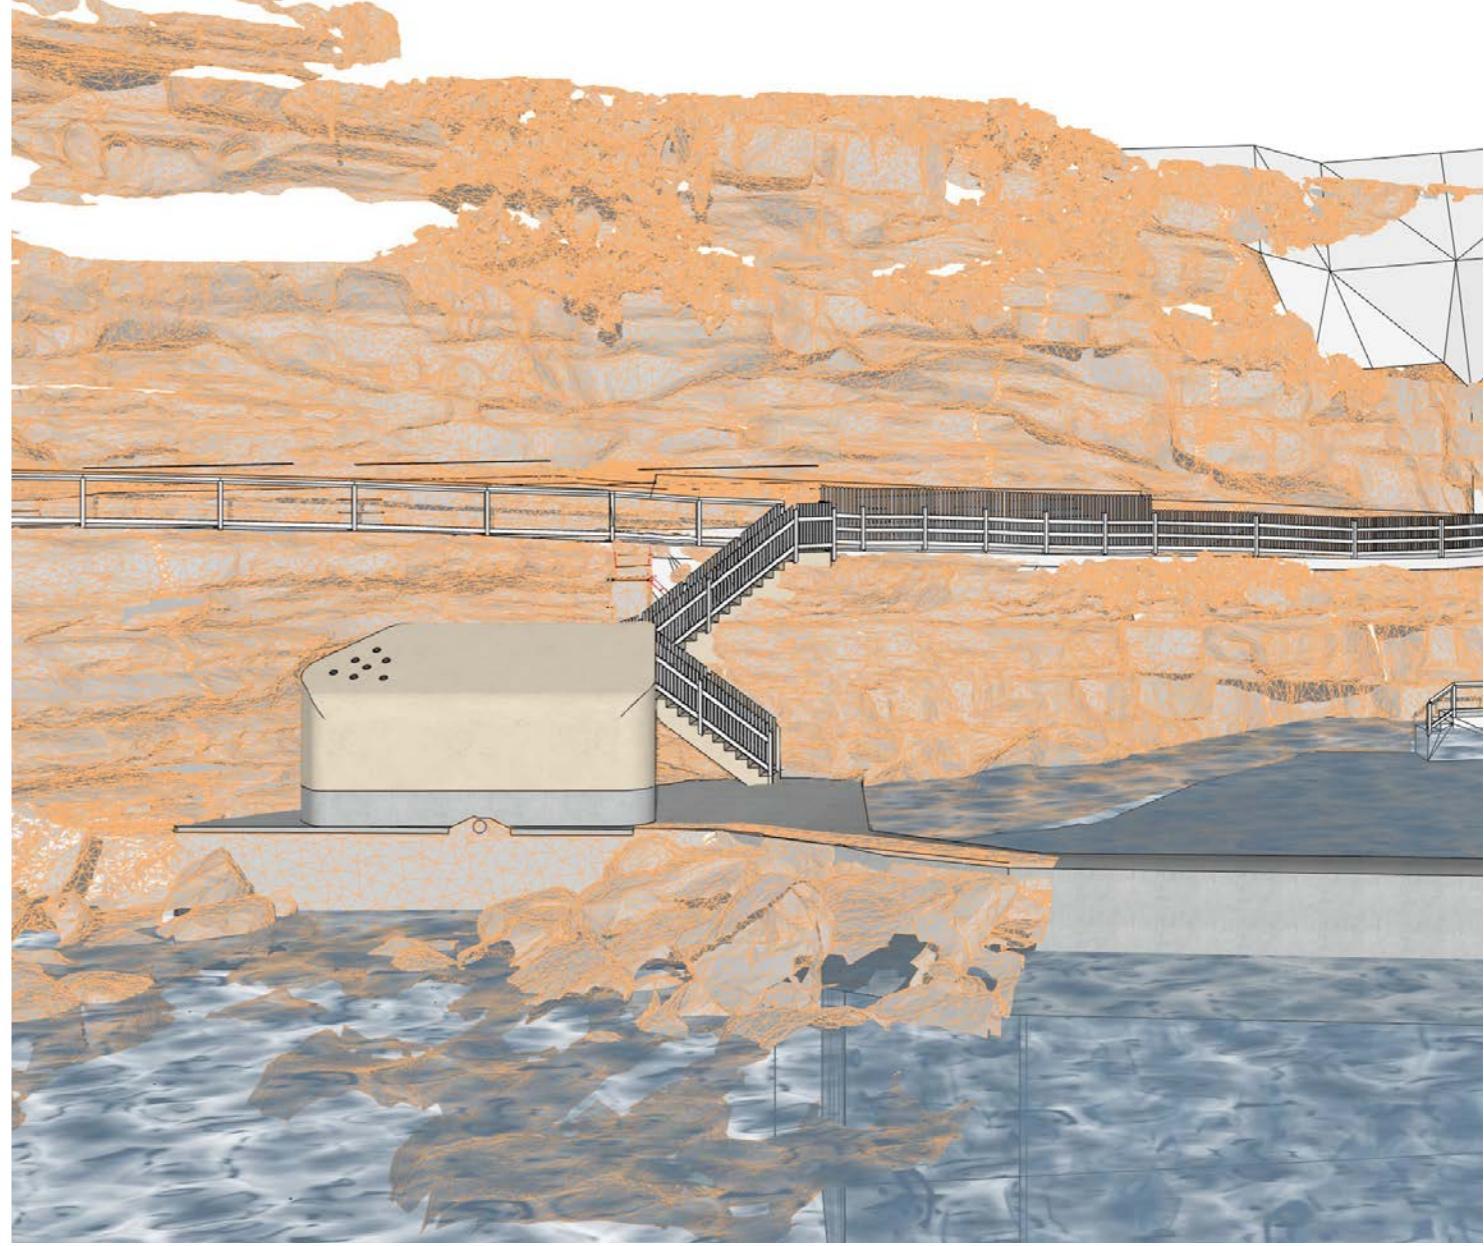
View from the ocean towards existing pumphouse and stair (above) and proposed pumphouse and stair (right) using 3D terrestrial scan survey of immediate context as base for modelling software

The proposed pumphouse adopts a slender proportion, with splayed walls that relate to its natural and built context, and rounded corners to reduce its visual impact.

The sloped roof will assist in reducing the impacts of wave inundation, while also providing a pleasing form which is seen in the round and which relates to the surrounding topography.
