28th March 2017

Waverley Council
Level 6
55 Grafton Street
BONDI JUNCTION NSW 2022

**BRONTE SURF LIFE SAVING CLUB
STRUCTURAL CONDITION REPORT**

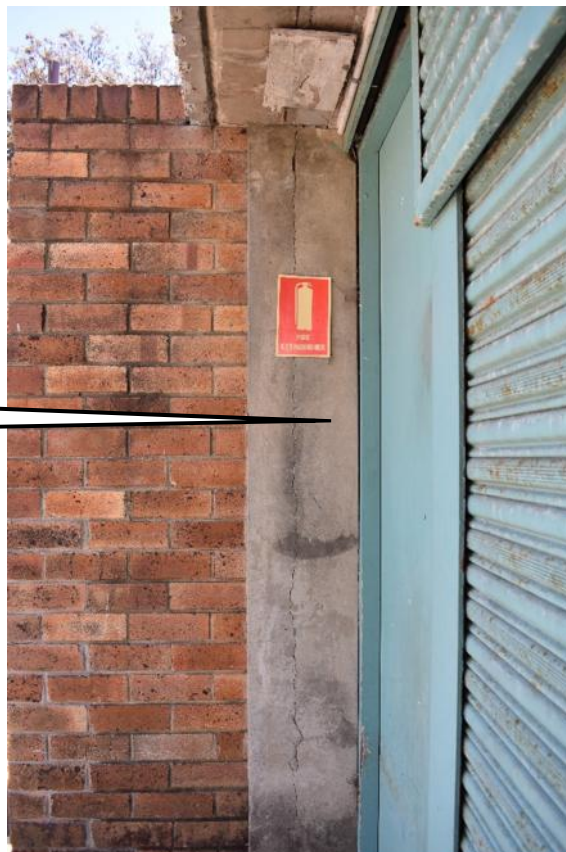
<p>A3</p> <p>3mm vertical crack</p> <p>2mm horizontal displacement</p>

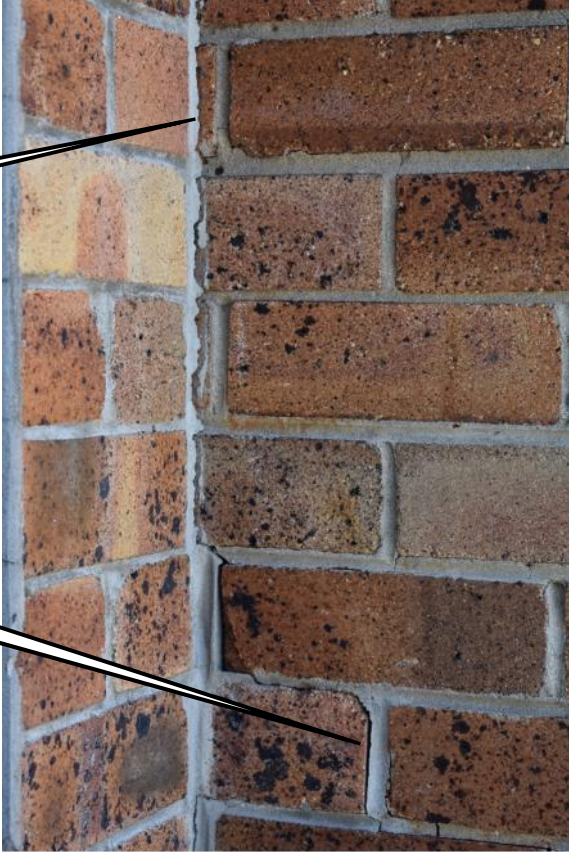
<p>A close-up photograph of a brick wall corner. A vertical crack is visible in the mortar joint between two bricks. A horizontal displacement of approximately 2mm is also visible in the mortar joint. Callout lines point from the text labels to the specific defects.</p>
<p>A4</p> <p>3mm vertical crack</p> <p>2mm horizontal displacement</p>

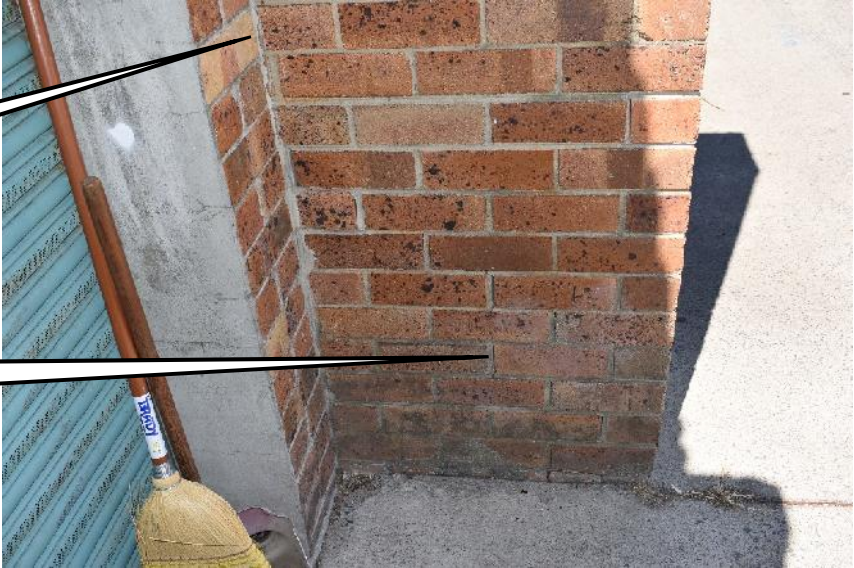
<p>A5</p> <p>3mm cracks</p>

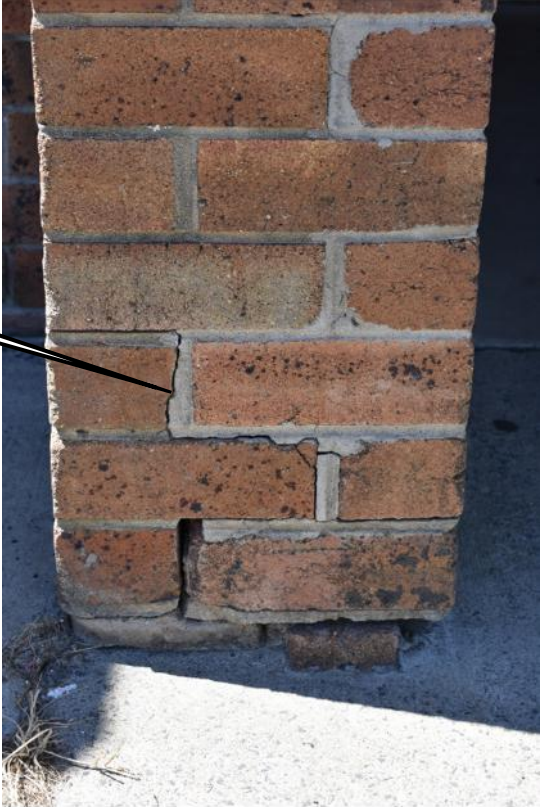
<p>A6</p> <p>2mm vertical crack</p>

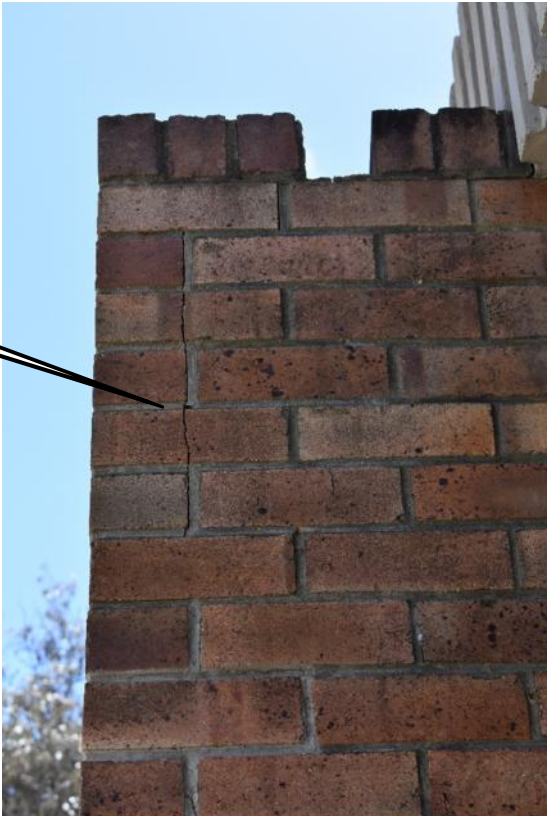
<p>A7</p> <p>0.3mm cracking</p> <p>Loose bedding bricks, offset 50mm from face</p>

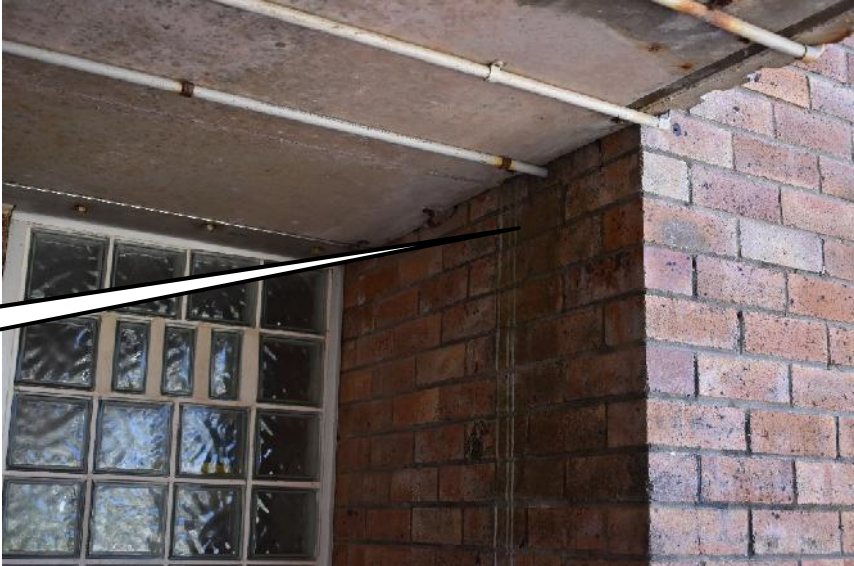
<p>A10</p> <p>2.5mm vertical crack</p>

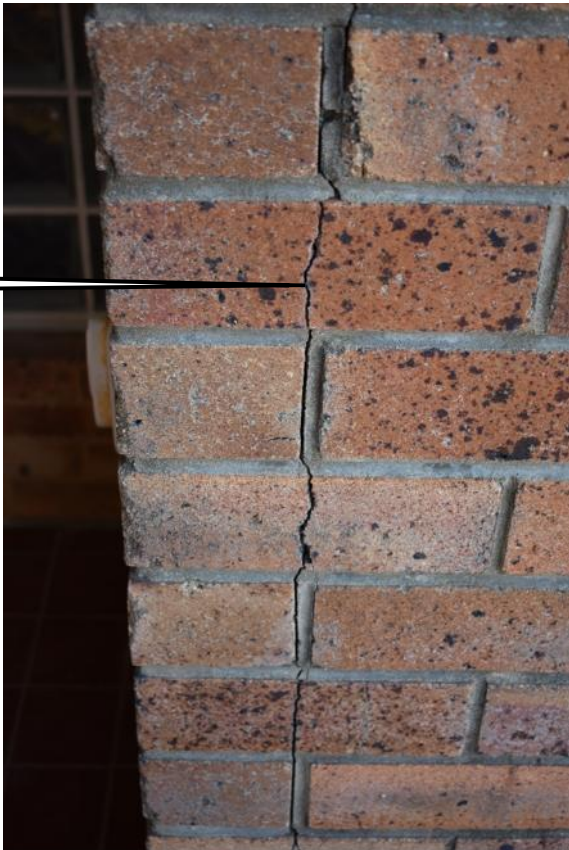
<p>A12</p> <p>Brickwork mortar loss bed joints & perpend</p>

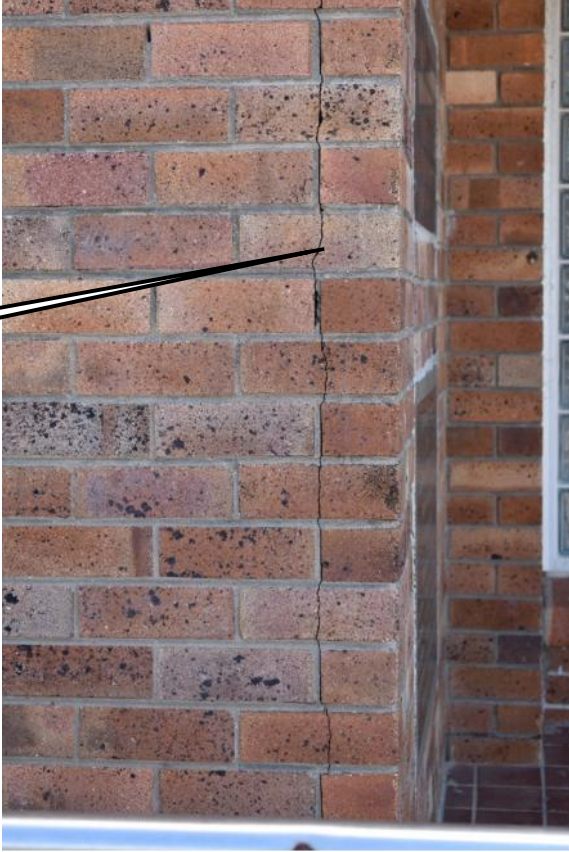
<p>A14</p> <p>3mm vertical crack</p>

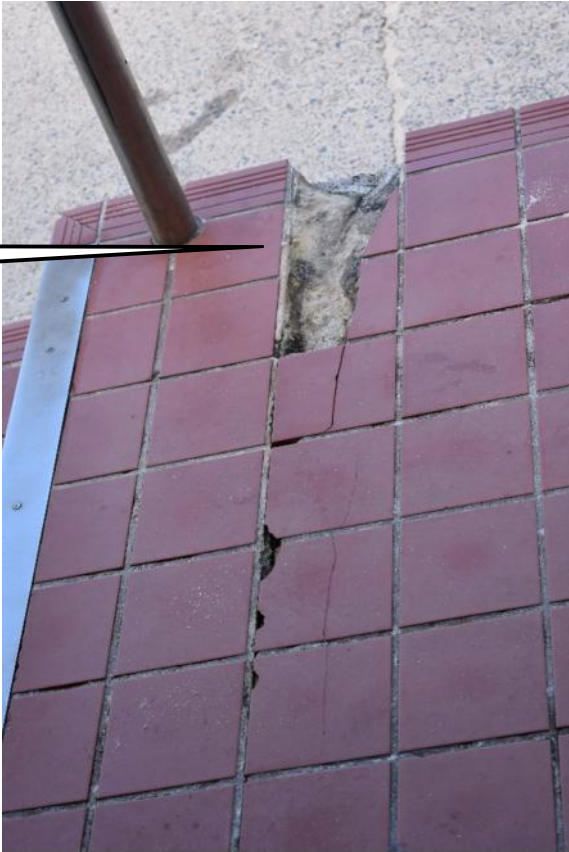
<p>A16</p> <p>Vertical crack with 10mm displacement</p>

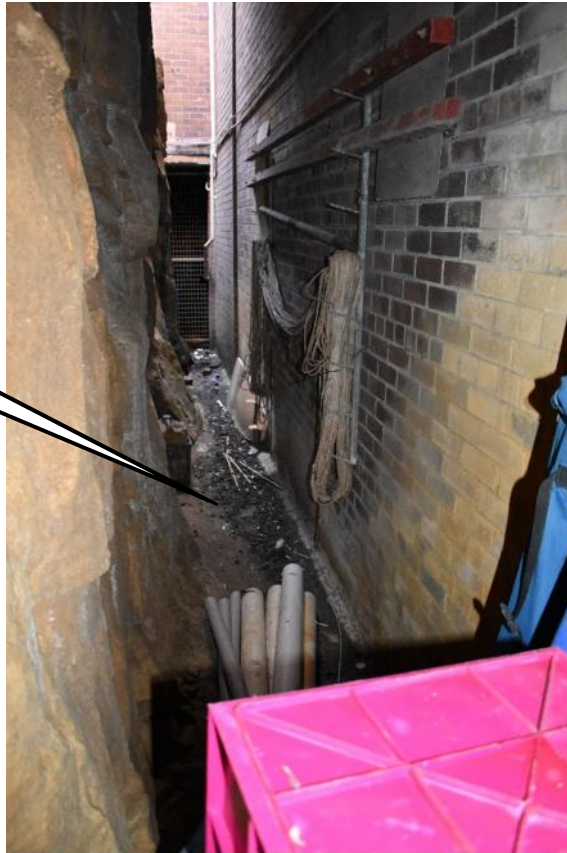
A38

Cracked wall corner,
5mm outward
displacement

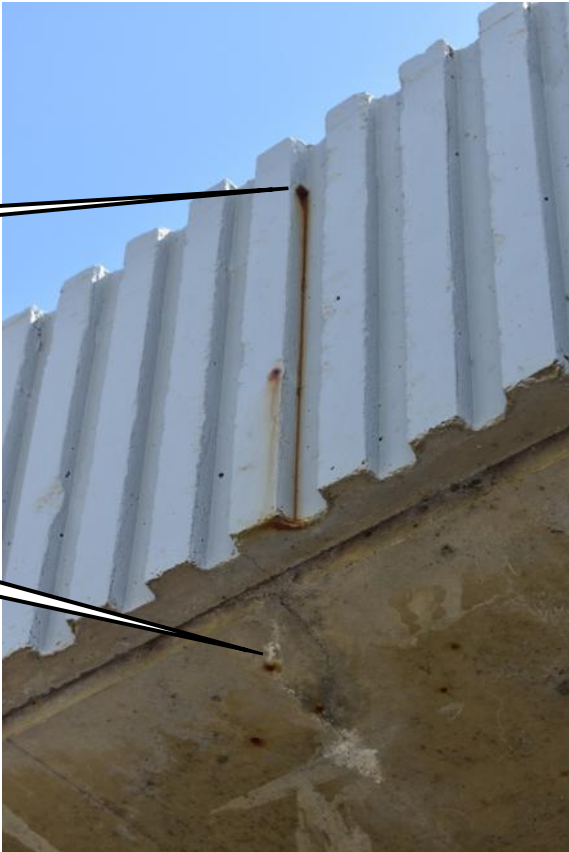
<p>B5</p> <p>Rust staining from old anchor bolts</p>

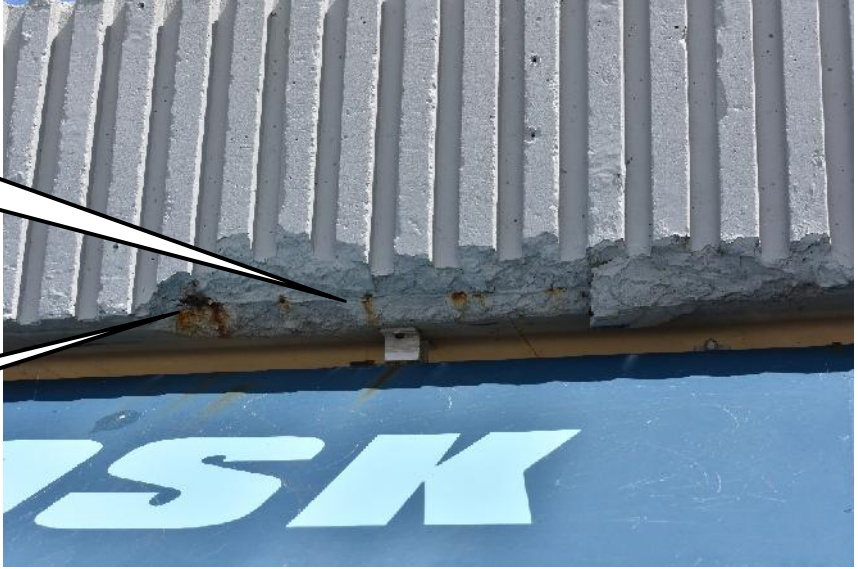
<p>B7</p> <p>Spalled concrete</p>

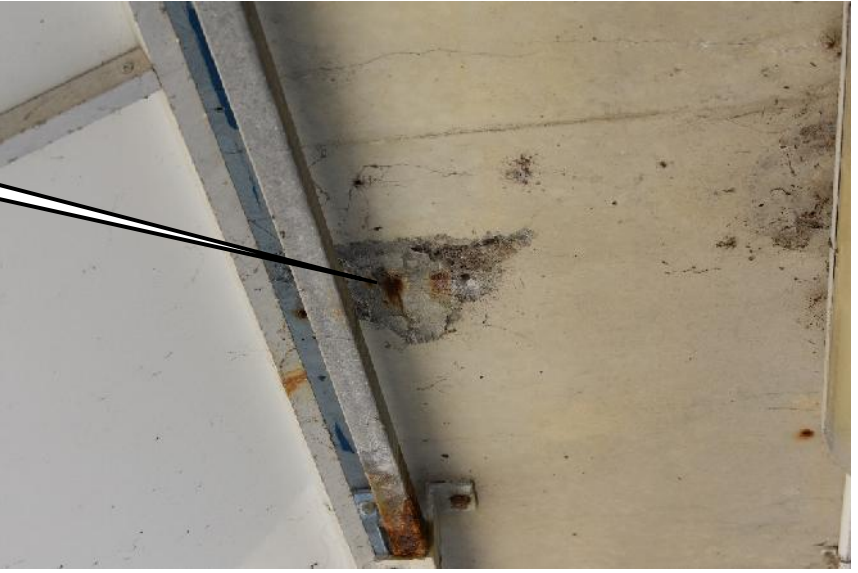
<p>B8</p> <p>Poorly installed core plug</p>

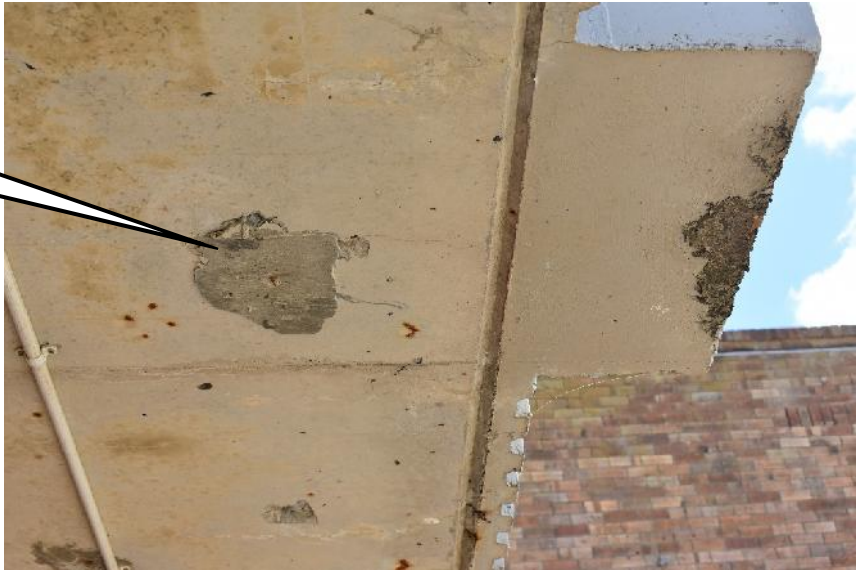
A photograph of a concrete wall. A dark, irregularly shaped core plug is visible, which appears to be poorly installed. A white pipe runs vertically on the left side of the wall. The wall is light-colored and shows some signs of weathering. A brick wall is visible in the background on the right.
<p>B9</p> <p>Cracked slab with signs of leakage</p> <p>Corroding reinforcement</p>

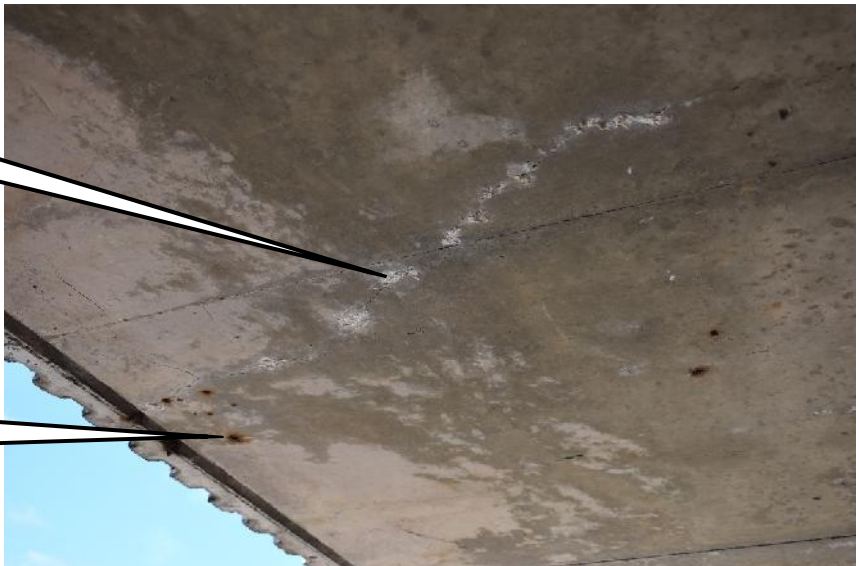
<div>B10</div> <div> <div>Slab cracks</div> <div>Slab cracks</div> <div>Corroding reinforcement</div> <div>Water penetration</div> </div>

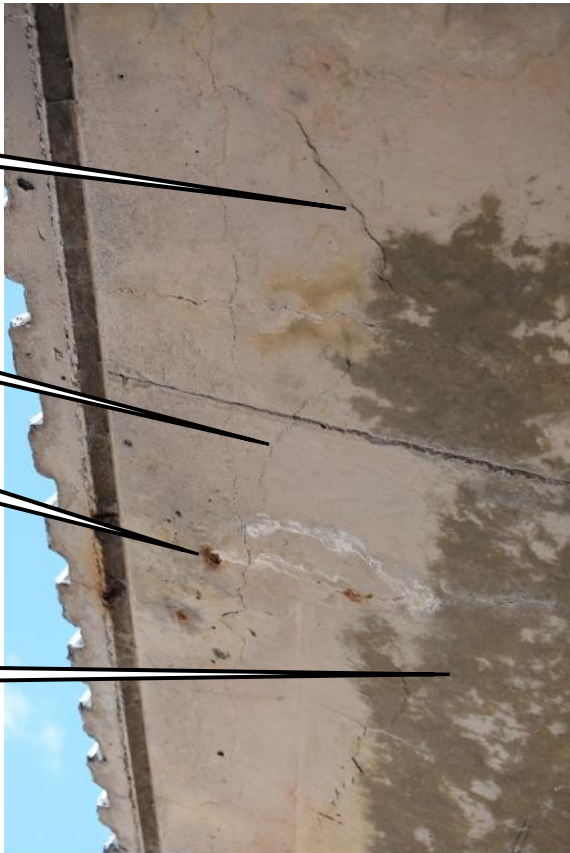
<div>B11</div> <div> <div>Cracked parapet</div> <div>Rust staining from old anchor bolts</div> </div>

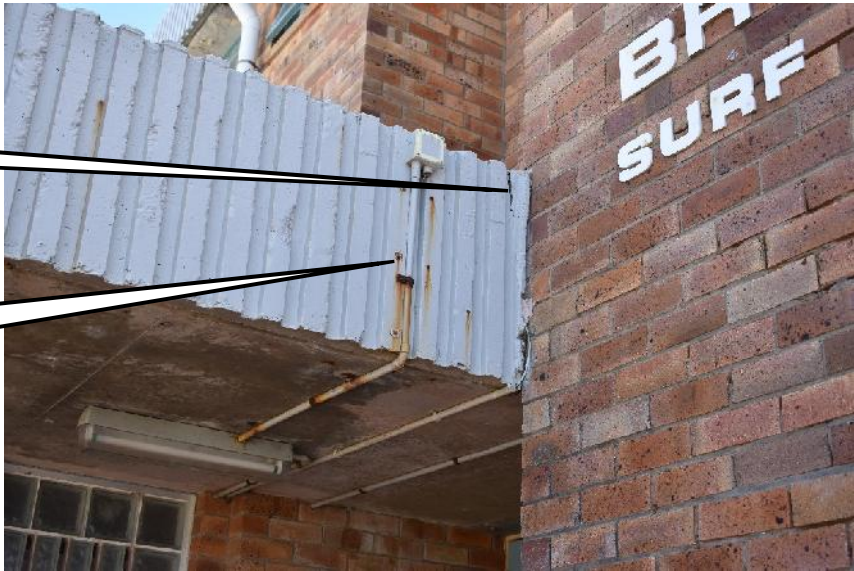
<p>B12</p> <p>Spalling concrete and corroded reinforcement</p> <p>Spalling concrete and corroded reinforcement</p>

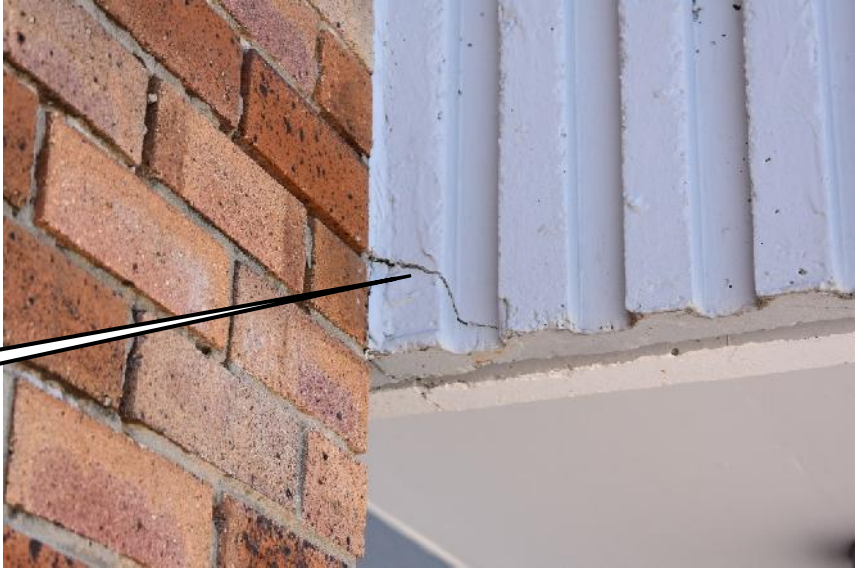
<p>B16</p> <p>5mm crack at brick wall and concrete parapet</p>

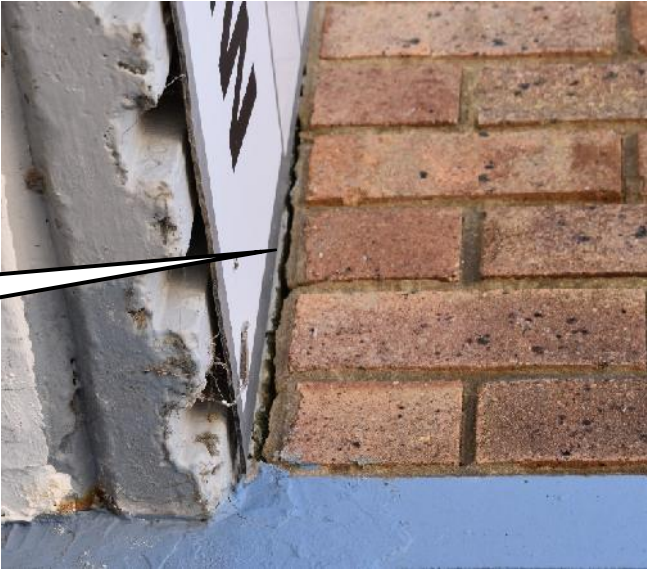
<p>B17</p> <p>Crack between concrete stair and wall</p>

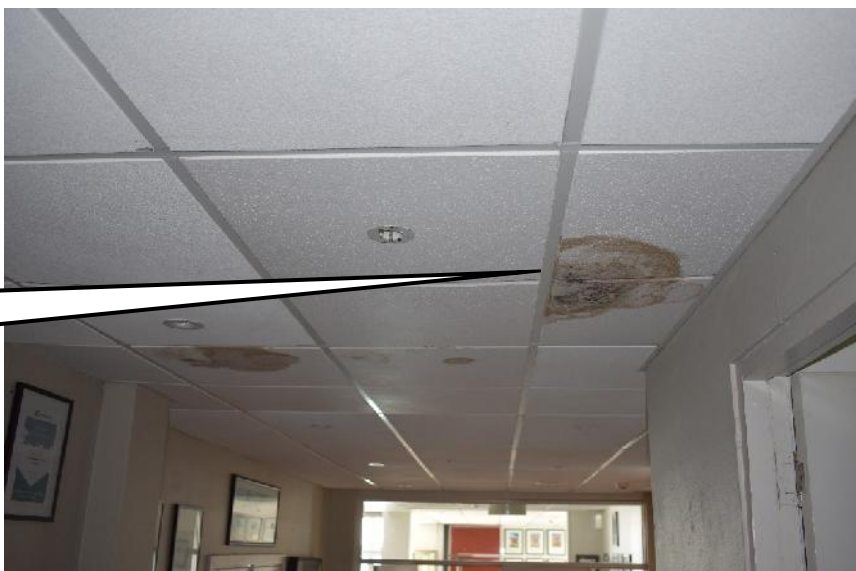
<p>B24</p> <p>Leaking roof slab with calcification</p>

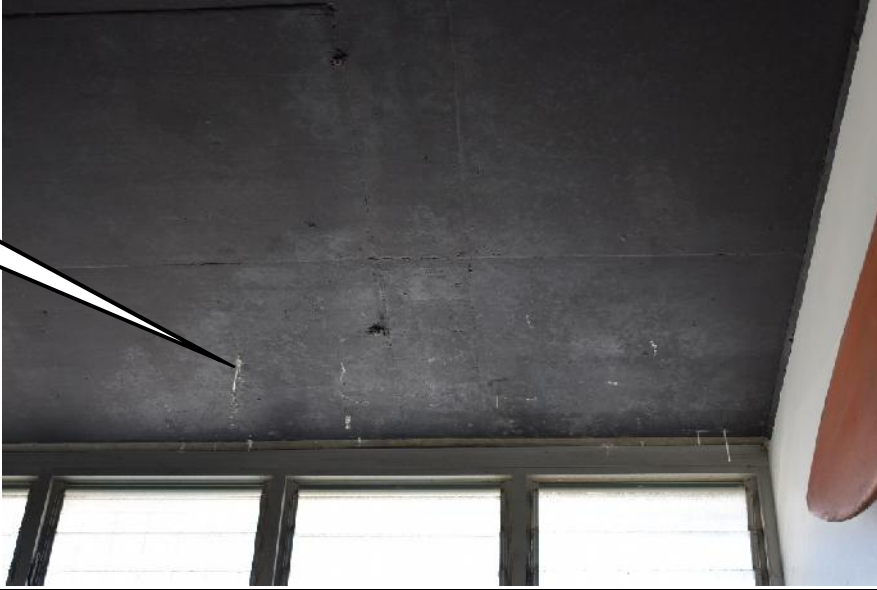
<p>B25</p> <p>Leaking roof slab with calcification</p>

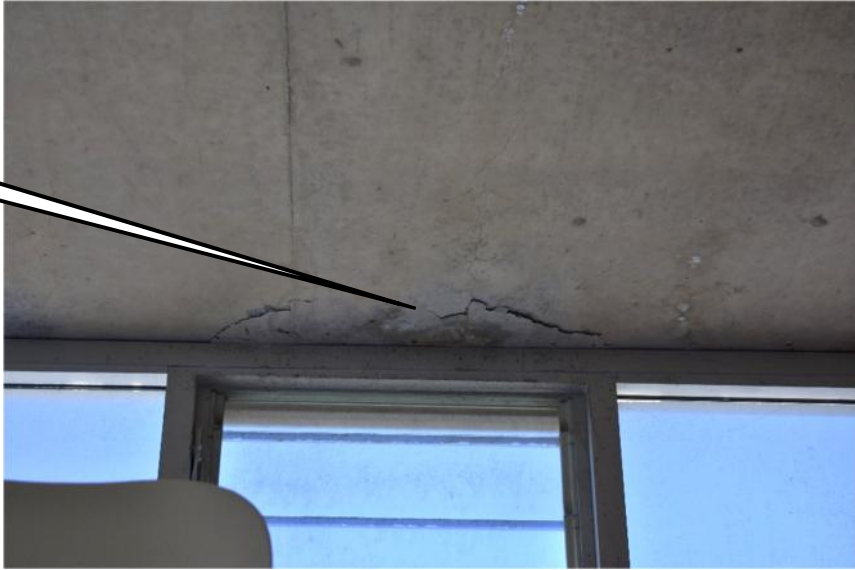
<p>B27</p> <p>Concrete spalled edge</p>

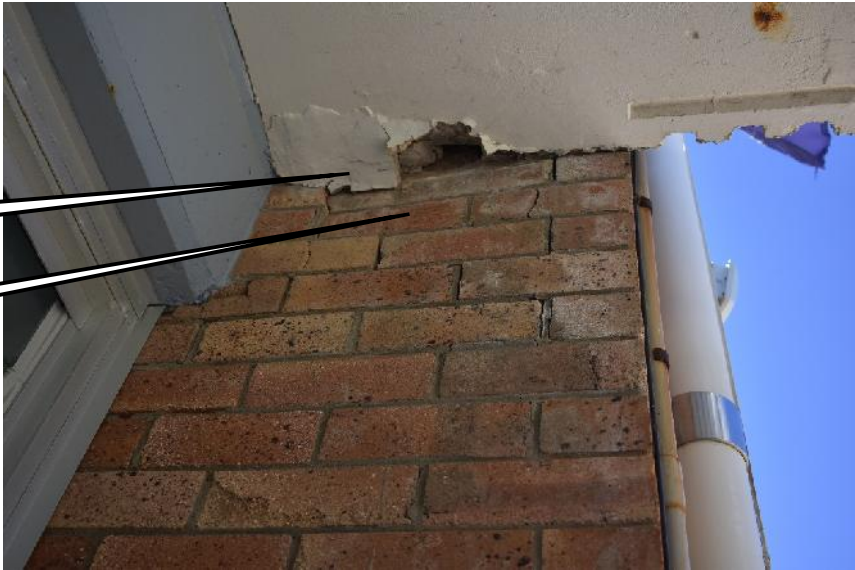
<p>B28</p> <p>Concrete spalling</p> <p>Displace brickwork</p>

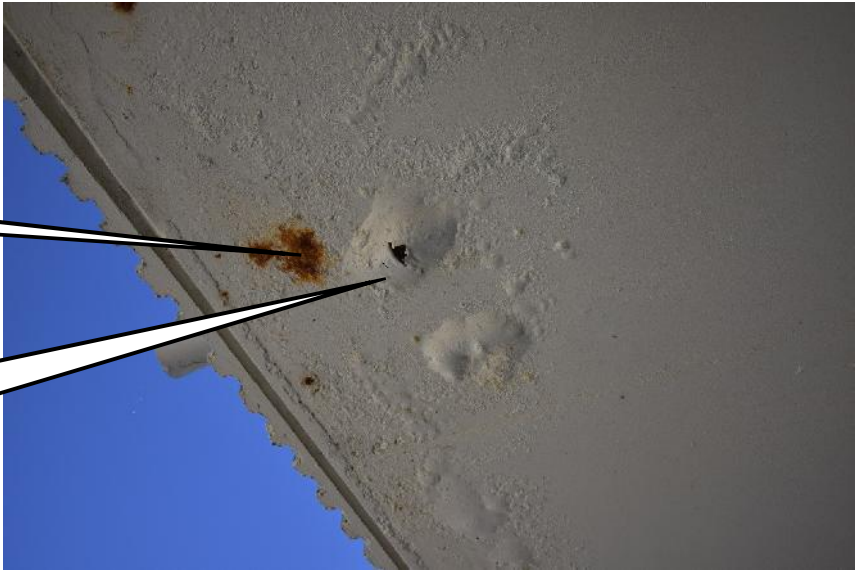
<p>B29</p> <p>Rust staining</p> <p>Previously spalled concrete with membrane</p>

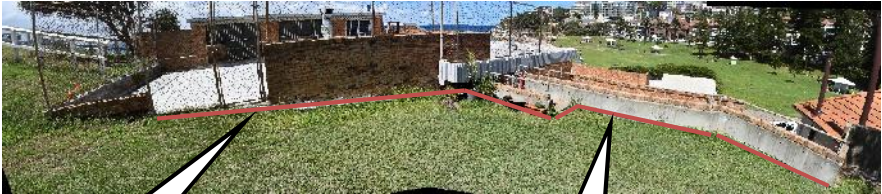
<p>C8</p> <p>Blocked and mis-aligned grated drains</p> <p>Blocked and mis-aligned grated drains</p>

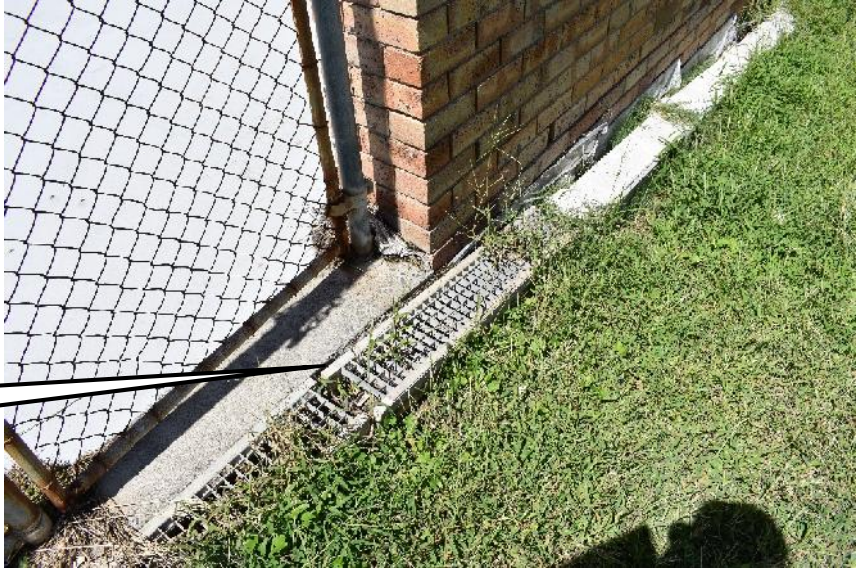
<p>C9</p> <p>Ineffective grated drain</p>

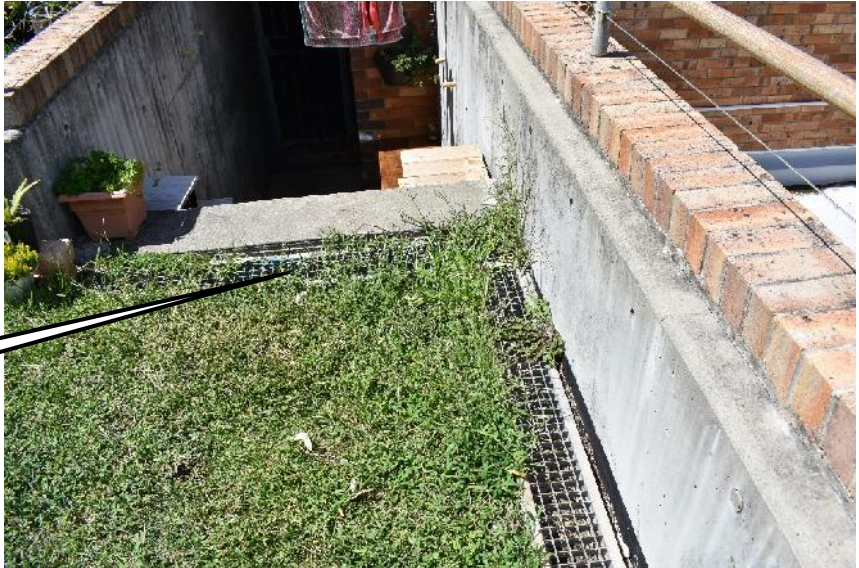
<p>C10</p> <p>Blocked grated drain</p>

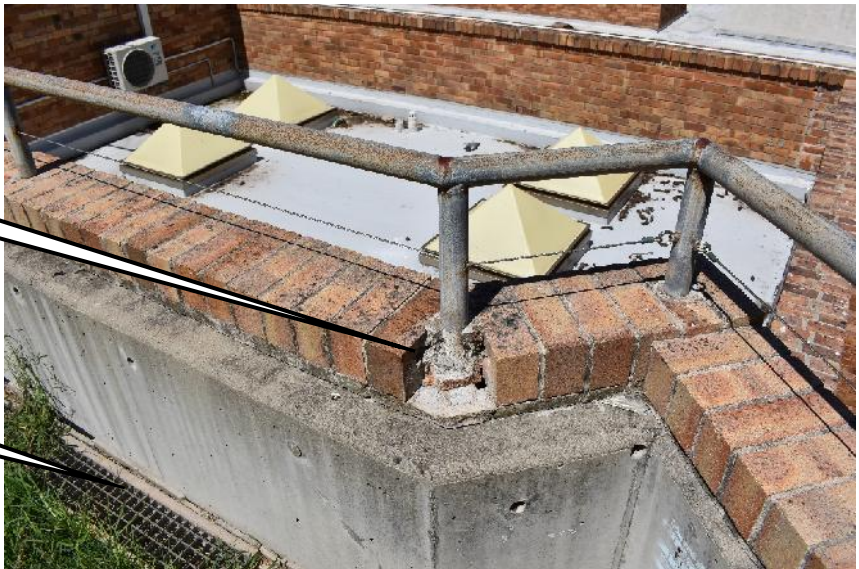
<p>C11</p> <p>Missing brick</p> <p>Blocked grated drain</p>

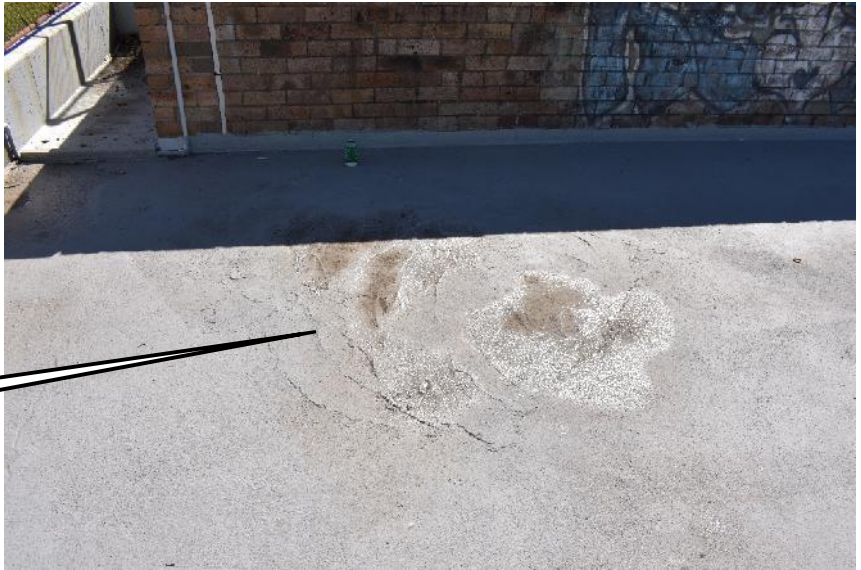
<p>C12</p> <p>Patch repair</p>

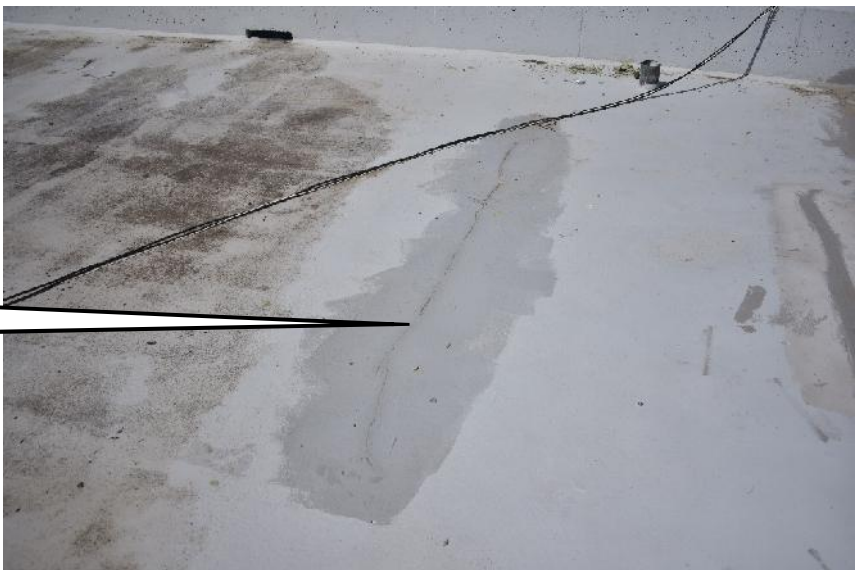
<p>C13</p> <p>Cracked membrane with over-patch</p>

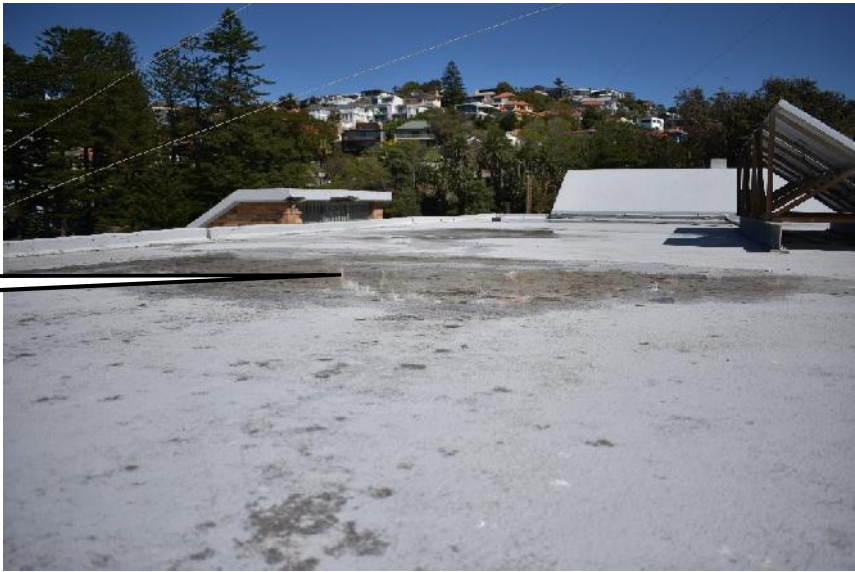
<p>C22</p> <p>Water ponding</p>

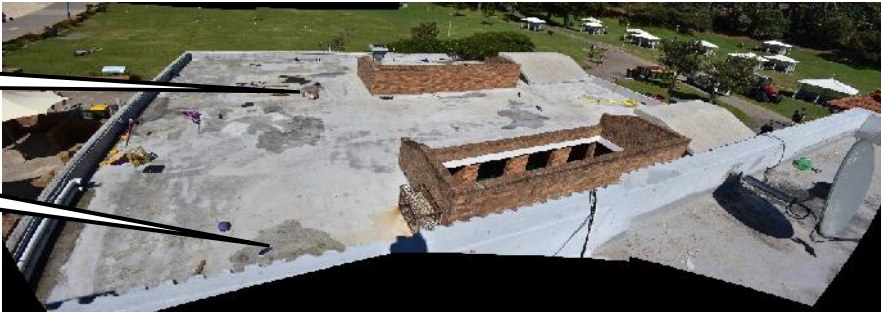
<p>C23</p> <p>Debris</p> <p>Water ponding</p>

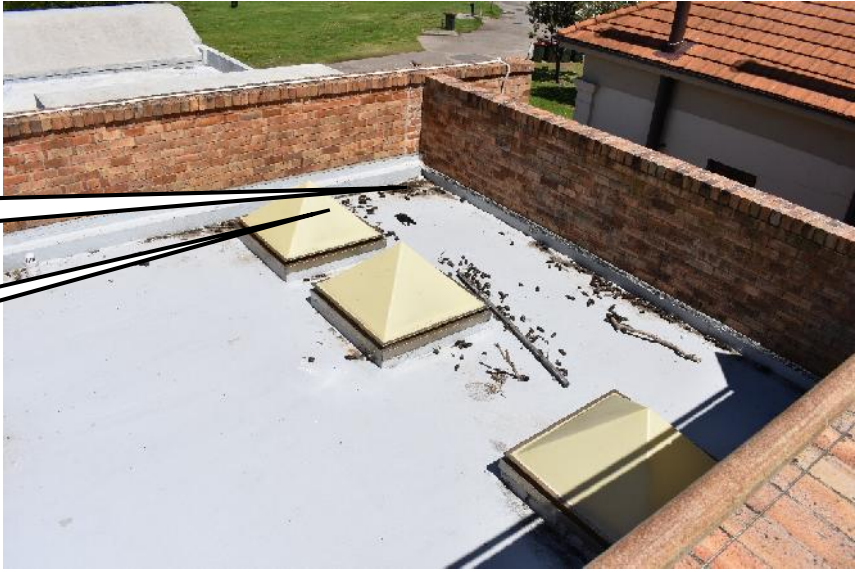
<div>C24</div> <div>Water ponding No overflow</div> <div>Broken skylight</div>
